No. AS365-52.00.29

ALERT SERVICE BULLETIN

DOORS - Emergency exit
Emergency evacuation labels for helicopters
installed with fixed parts of FLIR system

Corresponds to modification MC90B73

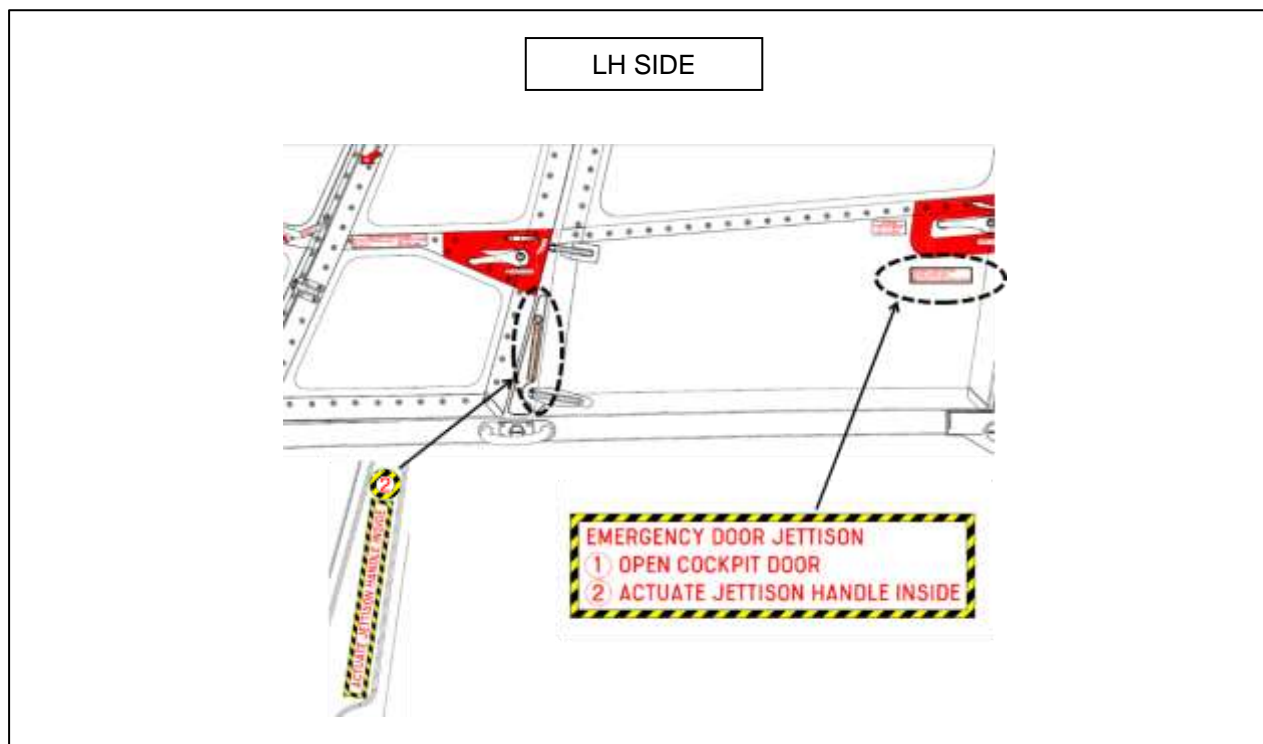
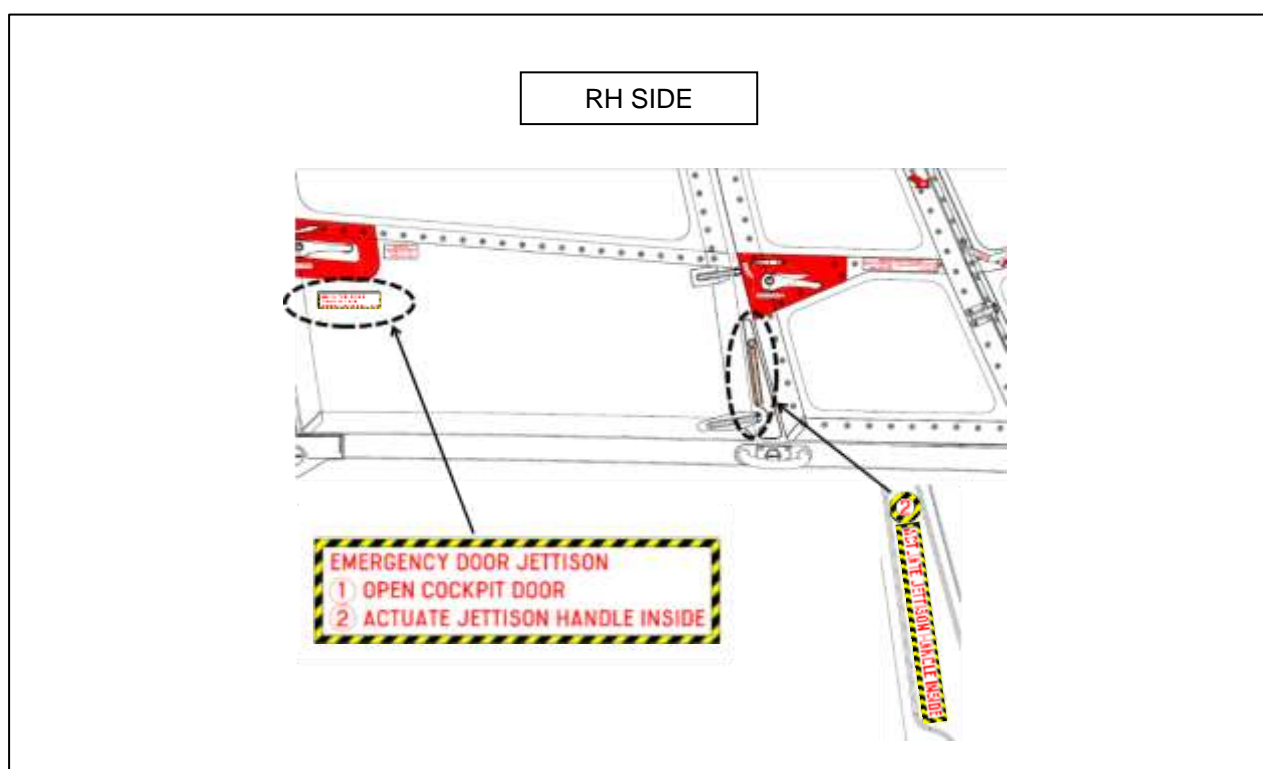
This ALERT SERVICE BULLETIN installs labels on the external LH and RH side of the helicopter to give instructions to the rescuers on how to operate the jettison handles.

This ALERT SERVICE BULLETIN consists in installing English labels on the helicopter in the area of the front passenger doors. The labels are installed on the LH and RH sides of the helicopter.
