No. EC120-32A014

ALERT SERVICE BULLETIN

LANDING GEAR - Landing gear Inspection for corrosion on the landing gear

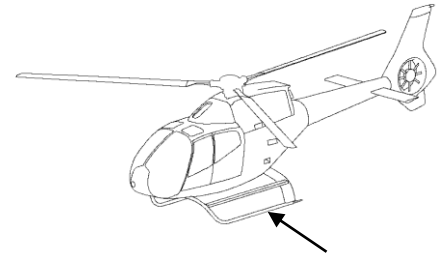
During a landing gear inspection, corrosion was found on the rear and front crossbeams and on the junction of the crossbeam and the skid.

Airbus Helicopters thus makes the inspection of the landing gear of EC120 helicopters mandatory to make sure that there is no corrosion on the external and internal sides of the landing gear tubes.
