No. EC120-53A017

ALERT SERVICE BULLETIN

FUSELAGE - Rear Fuselage Corrosion on the tail boom

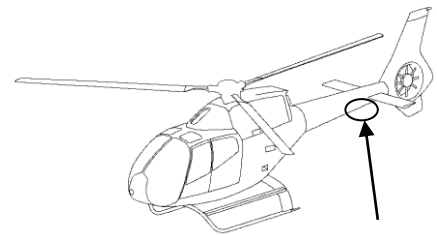
Corrosion was found on the external tail boom skin, under the VHF antenna ([Figure 1](#)).

This galvanic type corrosion is due to:

- a contact between the aluminium skin and the stainless steel antenna attachment inserts,
- the protection which is not sufficient.

Example of corrosion and aluminium oxide

The purpose of Revision 1 of this ALERT SERVICE BULLETIN is to provide a repair solution introduced through Service Bulletin No. 53-018 (see paragraph 3.B.2.b.), which must be complied with if corrosion and/or cracks are found at the VHF antenna attachments on the tail boom.

- removing the VHF antenna,
- making sure that there is no corrosion or crack under the VHF antenna,
- interpreting the results:
 - . if there is no corrosion and no crack, during reinstallation of the VHF antenna, embodying modification C008A0345050,
 - . if there is corrosion and/or crack, complying with Service Bulletin No. 53-018 (Repair at the tail boom VHF attachment).
