No. EC155-04A014

ALERT SERVICE BULLETIN

LIMITATIONS - Control rod double bearing Tail Gearbox (TGB)

ATA: 65

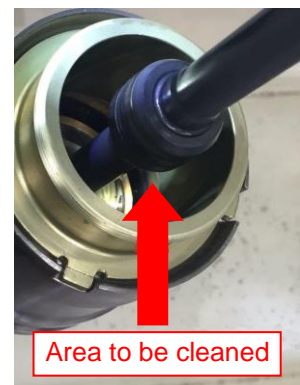
DETAIL C

- 2) Insert WHITE SPIRIT (2) (for example using a can) in the area of the control shaft (b) that must be cleaned. (**See [DETAIL C Figure 2](#)**).
 - . Manually turn the control rod (c) several times to wash the double bearing (d) by draining the WHITE SPIRIT (2).

Make sure that the area pointed out in [DETAIL C Figure 2](#) is clean.
