ALERT SERVICE BULLETIN

TITLE: Servo-control system - Check of the connection between the upper ball bearing end and the main rotor servo-control

Model:	EC155
Helicopters affected:	B , B1
Component affected:	SC8037 and SC8037-1

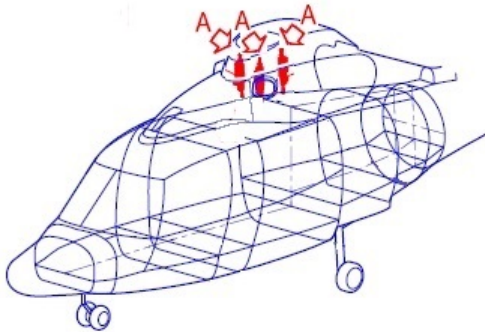
GENERAL ILLUSTRATION

The purpose of this ALERT SERVICE BULLETIN is to check the nut tightening torque of the upper ball bearing end of the main rotor servo-controls.

- Check of the nut tightening torque of the upper ball bearing end
- Check condition of threads of the main rotor servo-control if the nut tightening torque of the upper ball bearing end is out of tolerance.
