ALERT SERVICE BULLETIN

TITLE: Servo-control system - Check of the connection between the upper ball bearing end and the main rotor servo-control

Model:	EC155
Helicopters affected:	B , B1
Component affected:	SC8037 and SC8037-1

ASB EC155-67-30-0001

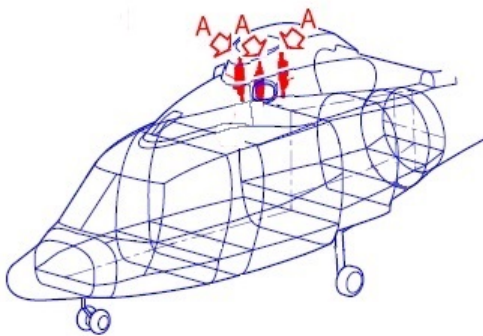
GENERAL ILLUSTRATION

The purpose of this ALERT SERVICE BULLETIN is to check the nut tightening torque of the upper ball bearing end of the main rotor servo-controls.
