EMERGENCY ALERT SERVICE BULLETIN

TIME LIMITS - MAINTENANCE CHECKS - Upper fin
Inspection of the spar and attachment screws of the upper fin
 ATA: 55

HELICOPTER CONCERNED	NUMBER	Version(s)	
		Civil	Military
AS350	05.00.90	B3	/
AS355	05.00.76	E, F, F1, F2, N, NP	/
AS550	05.00.66	/	C3
AS555	05.00.56	/	AF, AN, AP, SN, UF, UN

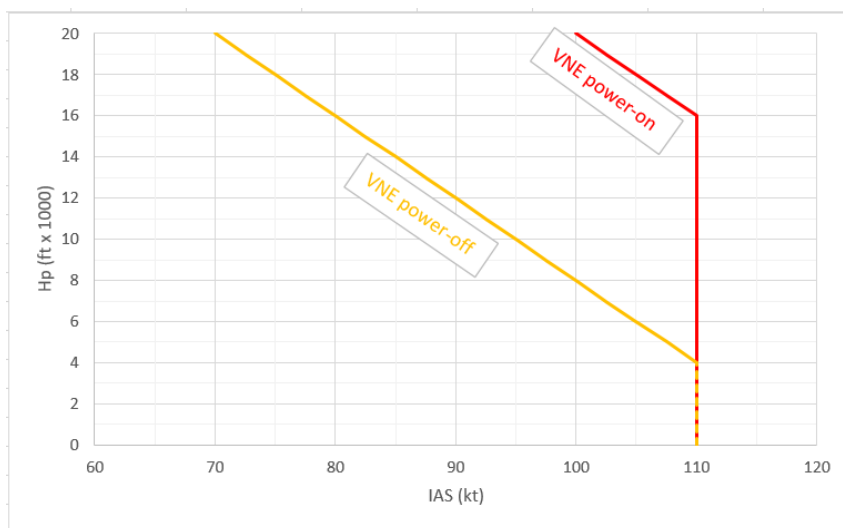
Figure 4

Analyzes following this new crack lead Airbus Helicopters to limit the VNE.

IN COLD WEATHER, REDUCE THE VNE AS FOLLOWS: 20KT (37 KM/H) WHEN OAT IS BELOW -25°C, WITHOUT DROPPING BELOW 65KT (120 KM/H).

. VNE power-on: refer to Figure 4.

. VNE power-off: refer to Figure 4.
