EMERGENCY ALERT SERVICE BULLETIN

Tail Gear Box (TGB) P/Nos. 365A33-6005-09 and 365A33-6005-10

HELICOPTER(S) CONCERNED	NUMBER	Version(s)	
		Civil	Military
AS365	01.00.71	N1, N2, N3	F, Fi, K, K2
AS565	01.00.24		MA, MB, MBe, SA, SB, UB
EC155	04A016	B, B1	
SA366	01.31		GA

Airbus Helicopters has recently been informed of a case of chip detection on a control rod double bearing of a TGB P/N 365A33-6005-09.

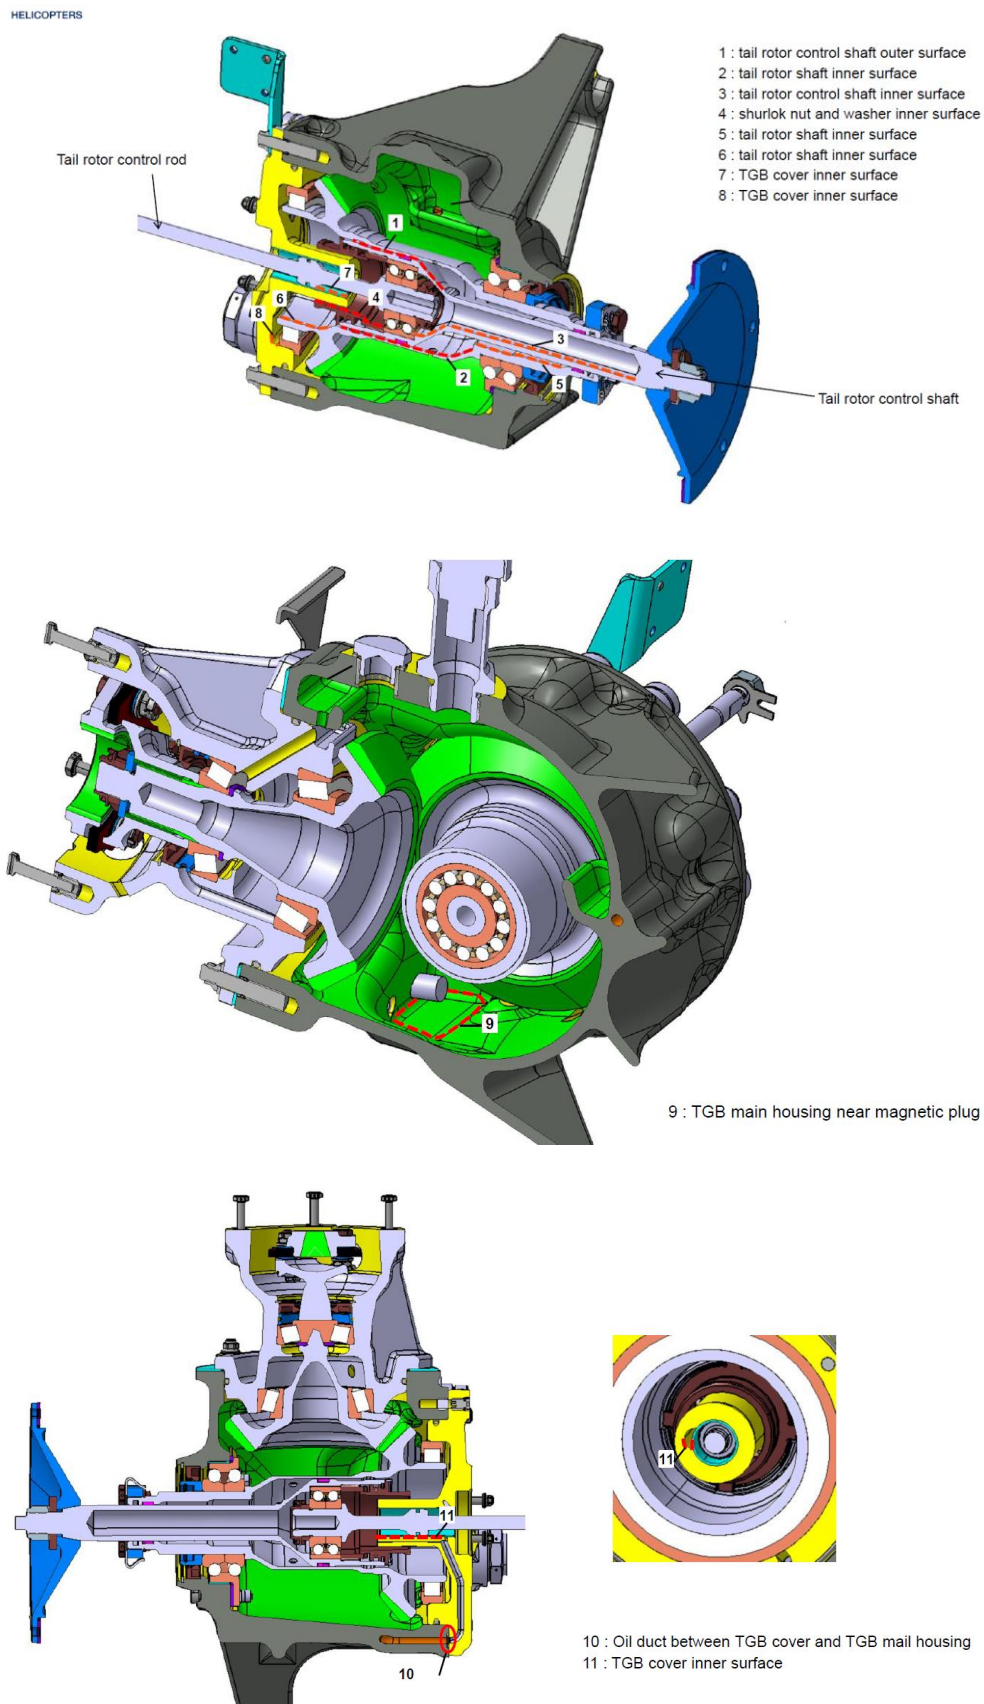
Figure 3

- Check that there are no particles in the lubrication hole of the TGB cover (Area No. 11, [Figure 3](#) of APPENDIX 4.B.).
- Install the TGB control shaft/rod assembly as per Work Card 65-21-00-701 (MRM) or as per Task 65-20-01-066 (AMM).

AREA No.	Description	Particles collected		Material of particles	Type of particles (as per MTC 20-08-01-601)	Number of particles	Surface of collected particles (mm ²)
		YES	NO				
9	TGB main housing near the chip detector						
6	Internal face of the rotor mast, toothed wheel side						
2	Internal face of the rotor mast, center area of the mast						
5	Internal face of the rotor mast, rotor side						
10	Lubrication duct of the housing						
9a	TGB main housing near the chip detector
