- 1. Planning Information
 - A. Effectivity
 - (1) Hartzell Propeller Inc. Raptor-series turbine propeller models 5D3-NK366A1 with serial numbers listed in Table 1 are affected by this Service Bulletin.

HARTZELL PROPELLER INC. SERVICE BULLETIN <u>HC-SB-61-393</u>

Propeller Mounting Nut/Torque Inspection

Document No. HC-SB-61-393 Date of Issue: Mar 04/21 Revision: N/A Rev. Date: N/A

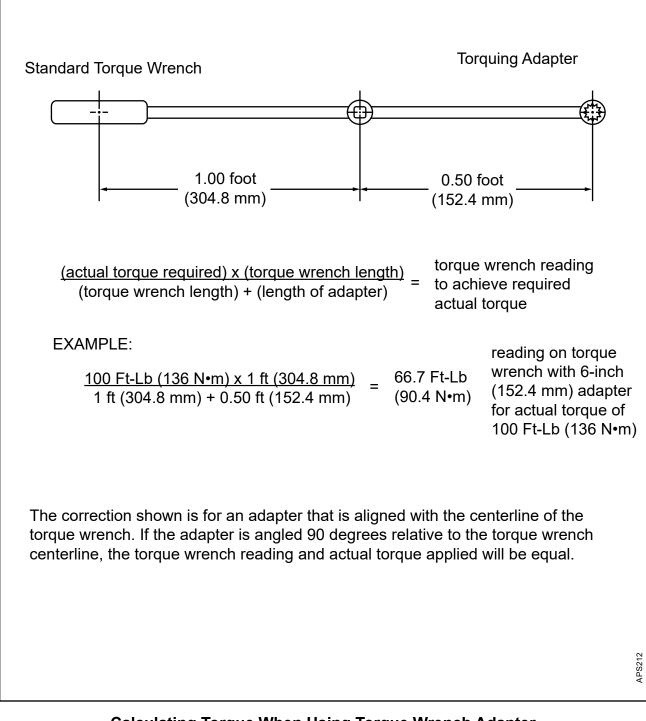
Calculating Torque When Using Torque Wrench Adapter Figure 4

- B. Torque Information for Propeller Mounting Nuts
 - <u>CAUTION 1</u>: TORQUE VALUES WITH "WET" NOTED AFTER THEM ARE BASED ON LUBRICATED THREADS WITH APPROVED ANTI-SIEZE COMPOUND MIL-PRF-83483().
 - <u>CAUTION 2</u>: REFER TO FIGURE 3 FOR PRELIMINARY TORQUE VALUES AND PROPER TORQUING SEQUENCE FOR THE PROPELLER MOUNTING NUTS.
 - CAUTION 3: REFER TO FIGURE 4 FOR TORQUE READING WHEN USING A TORQUE WRENCH ADAPTER.

- (5) Using a calibrated torque wrench and torque wrench adapter TE642, verify that the breakaway torque on each of the eight mounting nuts is equal to or greater than 90 Ft-Lbs (122 N•m) torque by loosening each nut and noting the breakaway torque.
