BY TEXTRON AVIATION

# Multi-Engine Turboprop Communiqué

Communiqué ME-TP-0028  
November 2021

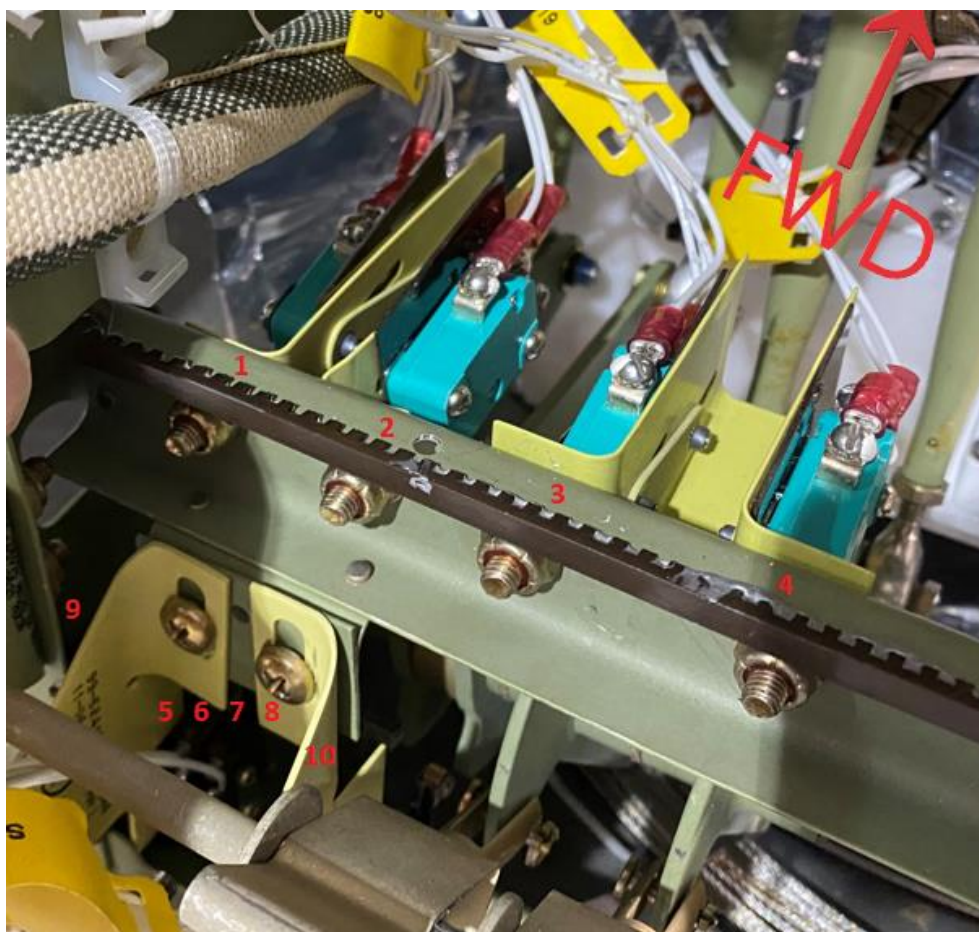
1. Power lever sense Landing gear warning LH Ref. 32-60-09;
2. Power lever sense Landing gear warning RH Ref. 32-60-09;
3. No.1 Prop lever Reverse not Ready switch, Ref. 61-40-03;
4. No.2 Prop lever Reverse not Ready switch, Ref. 61-40-03;
5. 5,6,7, and 8 are Auto Feather Arm switches, Ref. 61-21-03;
6. 9 and 10 are Ground Idle Drop out switches, located with the outside of the bracket surrounding the Auto Feather Arm switches, Ref.76-10-15.

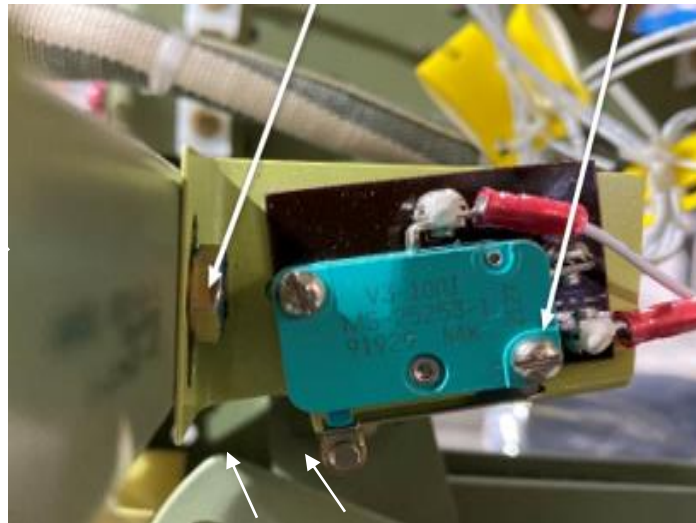
Proper adjustments are achieved by either mounting brackets, switch body or cam adjustments. Left reverse not ready switch shown.

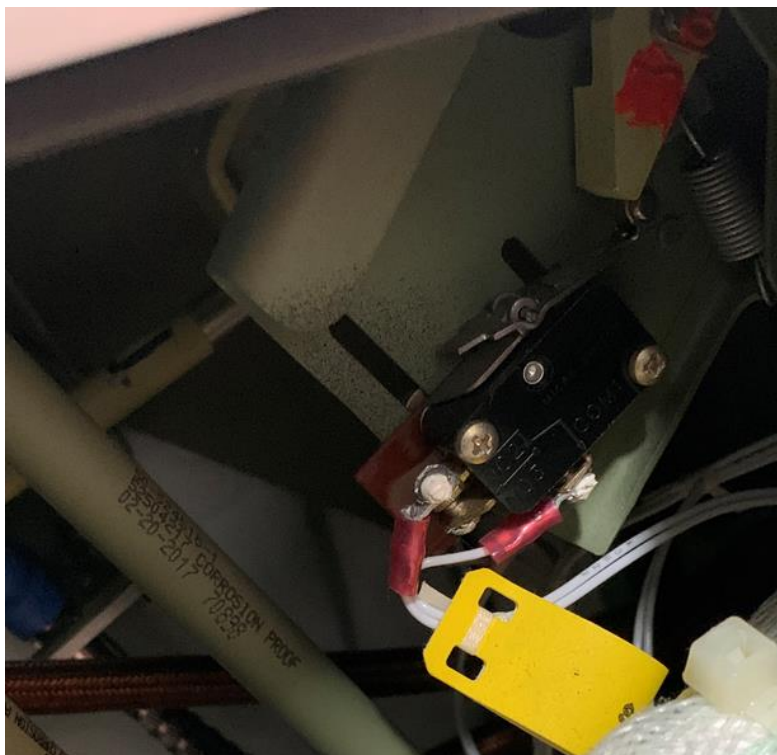
Power lever ground low pitch stop switch under power levers 76-10-17.

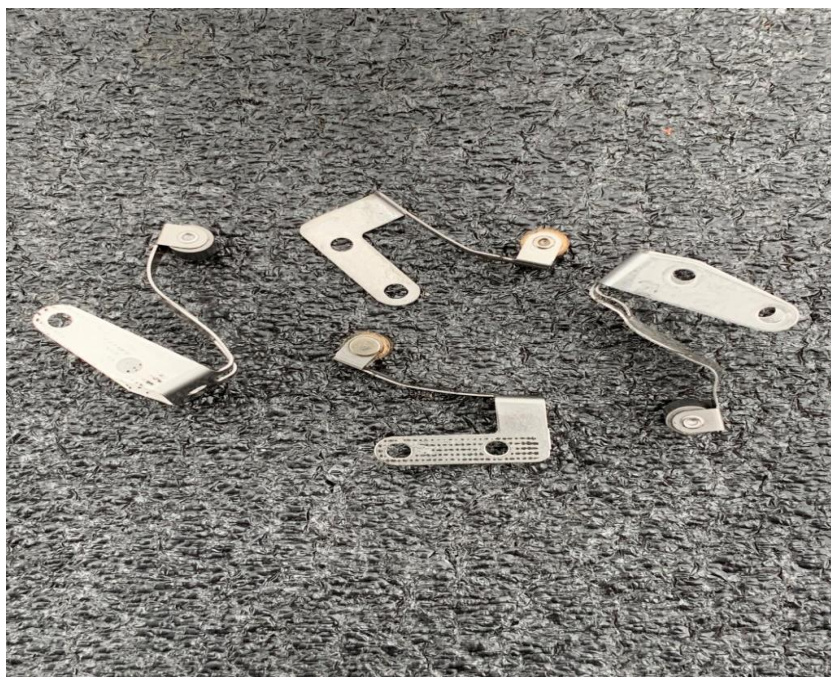
**Damaged Switch Actuators**

The set of micro switches installed on the power lever quadrant in the King Air control various systems in the airplane and they are critical to the safe operation of these systems. These switches need to be adjusted to the specifications found in the Maintenance Manuals. It is critical that these adjustments are done correctly. A short cut to this procedure is to bend the actuator arm which is not the correct procedure; this practice will lead to unreliable results and damage to other components associated with this installation. The pictures that follow provide samples of the damage that this practice causes. We have also included the correct adjustment technique that should be used.

**Worn hardware (i.e. spacers, washers, worn cams) may prevent achievement of a positive switch adjustment. Replace worn hardware as required.**
