BY TEXTRON AVIATION

Multi-Engine Turboprop Communiqué

Communiqué ME-TP-2016-08 Rev 1
Original Issued July 2016
Revision Issue December 2021

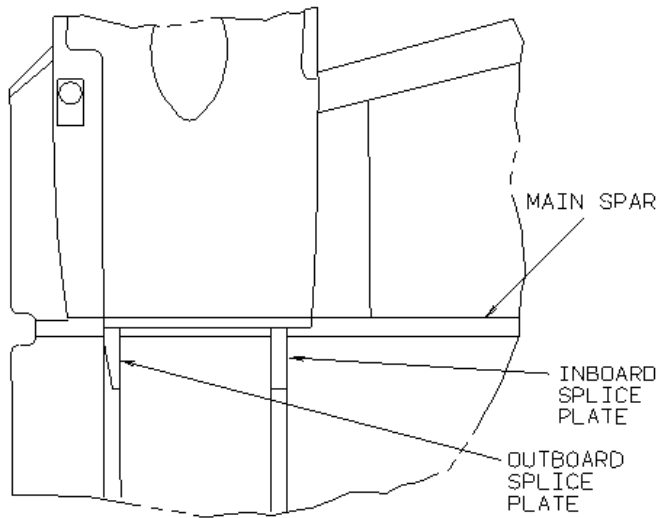
VIEW A

The nacelle splices plates are located under the nacelle turtle back. There are two per side and they run longitudinal. Refer to the illustrations on the following pages. For airplanes without wing lockers, the turtle back should to be removed. As an alternative, the nacelle splice plate edge may be inspected through the main landing gear wheel well. For airplanes with wing lockers, the splice plates are exposed when the lockers are removed. Model 350ER airplanes will have to deal with external fuel tanks, but the intent of the inspection is met by inspecting the edge of the part as seen through the main landing gear wheel well area. This inspection procedure is included in the SIRM

VIEW LOOKING DOWN ON LH SIDE OF THE CENTER SECTION WITH NACELLE SKIN REMOVED

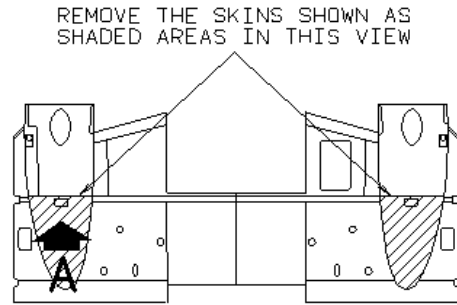
VIEW LOOKING DOWN ON TOP OF THE CENTER SECTION
