BY TEXTRON AVIATION

Multi-Engine Turboprop Communiqué

Communiqué ME-TP-0036
May 2024

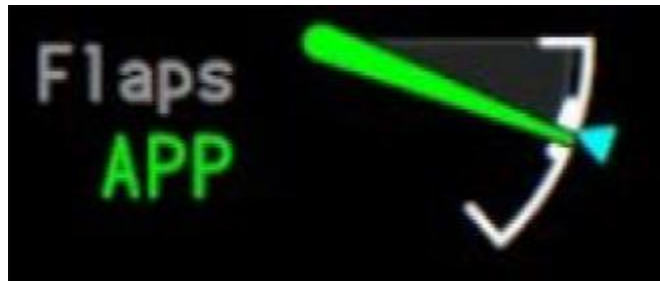
Normal Operation

The cyan pointer corresponds to the position of the selector handle and the green pointer corresponds to the position of the flaps.

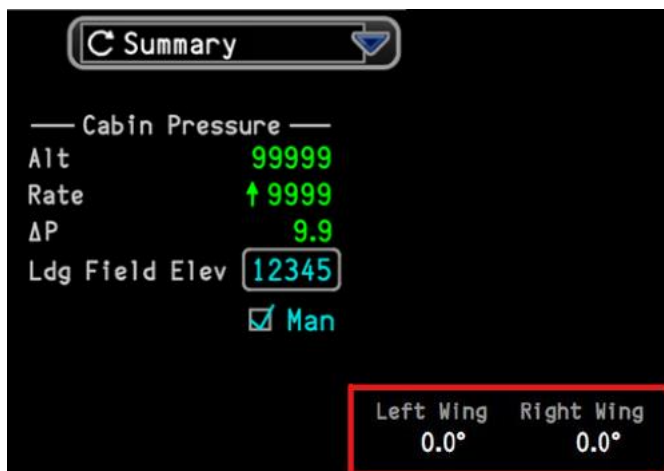
To read RVDT outputs as degrees of flap travel, install the shorting plug in the 37pin D sub maintenance port at the aft end of the pedestal. The MFD's "Summary Page" will now display the RVDT position in degrees. This can then be directly compared to a protractor/angle finder at the flaps themselves. This will only appear when on the ground with the shorting plug installed.

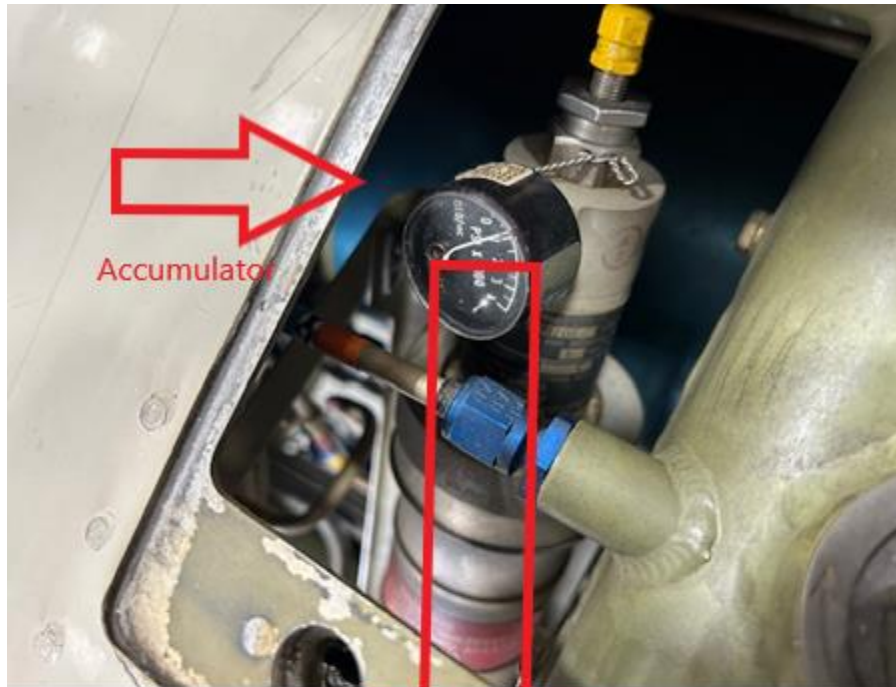
1. Cap for the Line to the Reservoir

Picture 1 below shows where to connect air pressure to the line to the reservoir to apply the head pressure, however this line is very difficult to get to without removing the leading edge. Picture 2 show the area with the leading edge removed allowing easier access to this line.

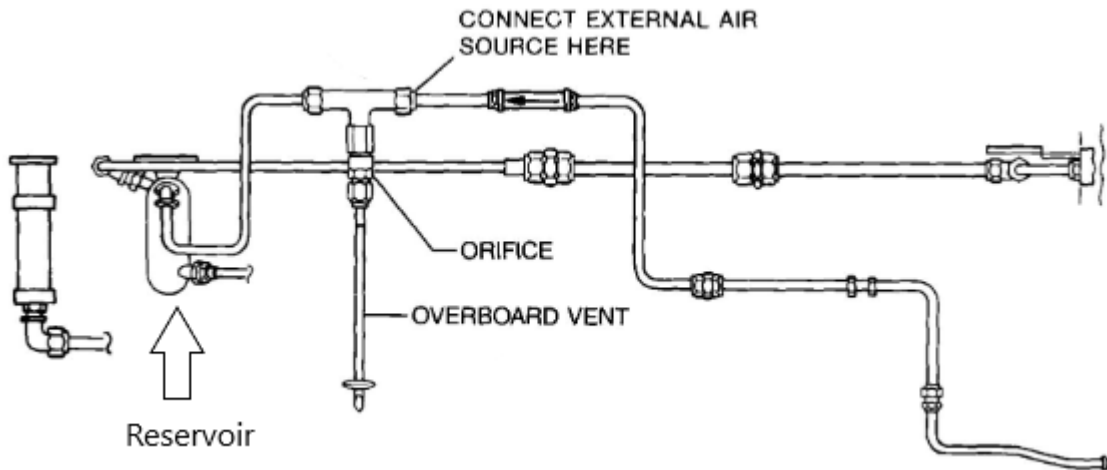
**Left Center Section Leading Edge
King Air C90A/F90-1**

2. Access to the reservoir head pressure line, leading edge removed

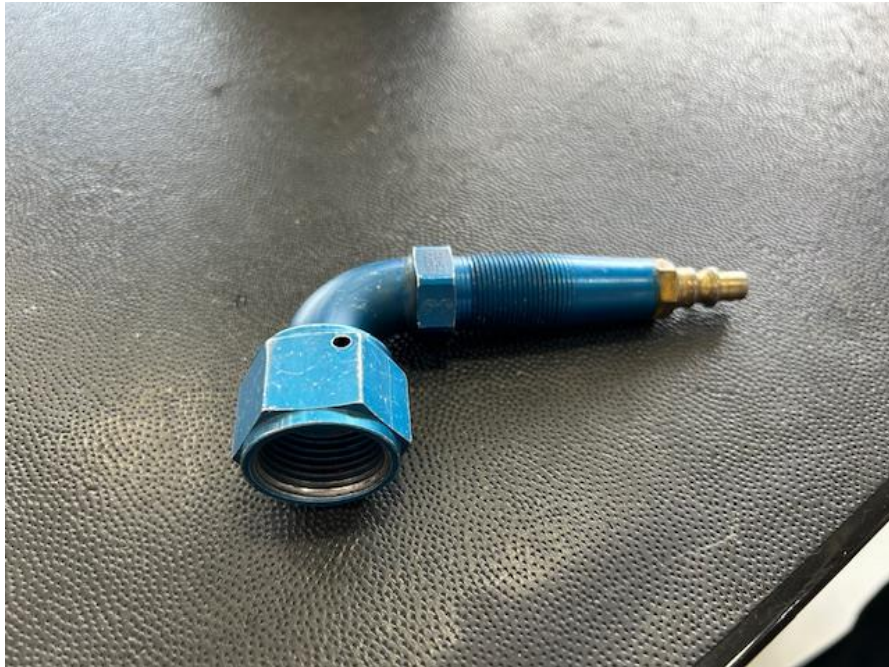
Shop Made Tool

The pictures below show two locations where the shop air can be introduced to the pneumatic system. Most shop air system in hangars are set to 100 psi or so. This pressure is acceptable as it is approximately what the engine's bleed air system produces. The airplane pneumatic regulator brings the pressure down to the proper operating pressures for the systems that use pneumatics and vacuum in the airplane.

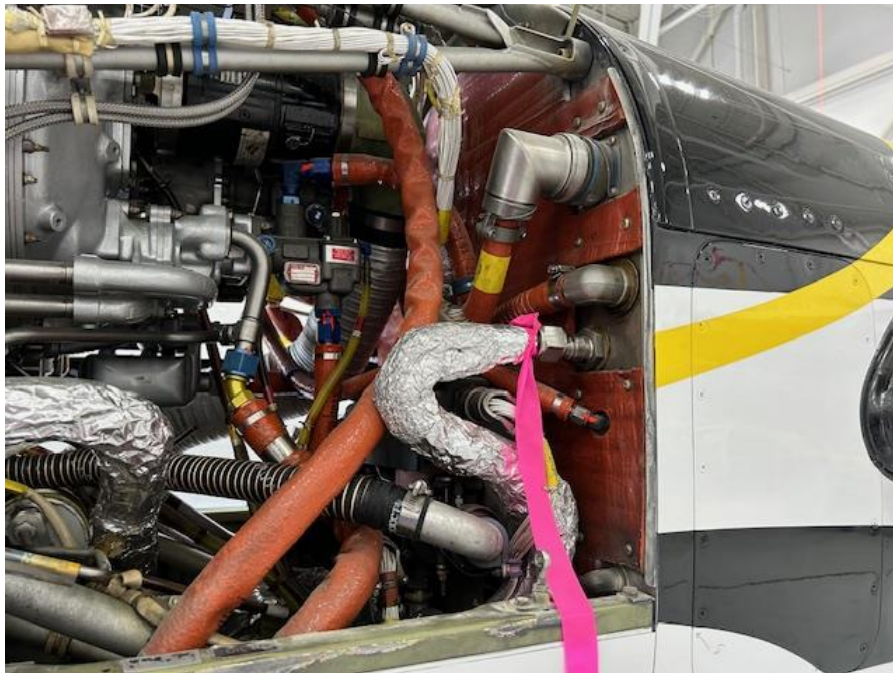
**Line from the Flow Pack to the Firewall Shown by Pink Flag
Models B200/300/B300**

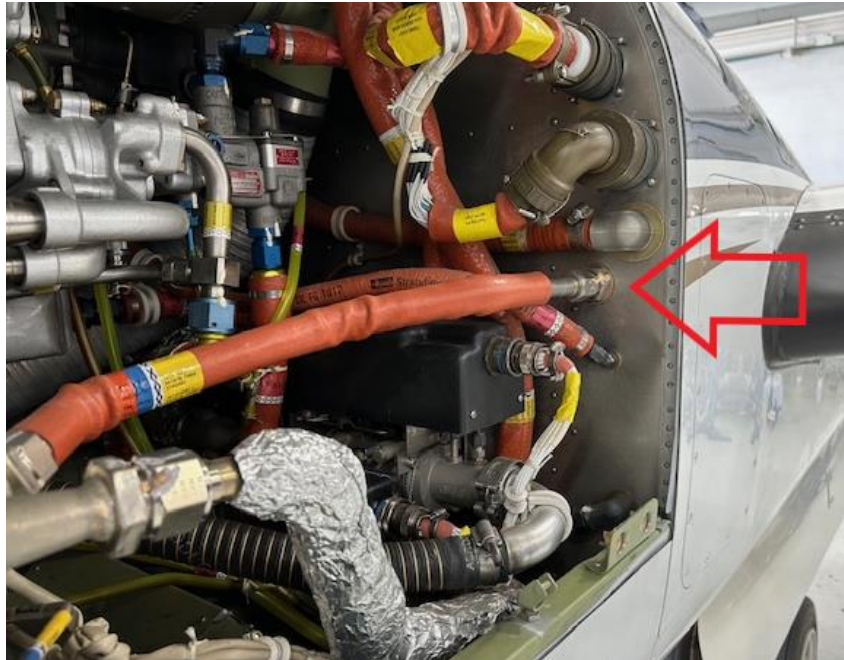
**Line from “Y” from Engine Bleed Air Take-Off to Firewall
Models B200/300/B300**

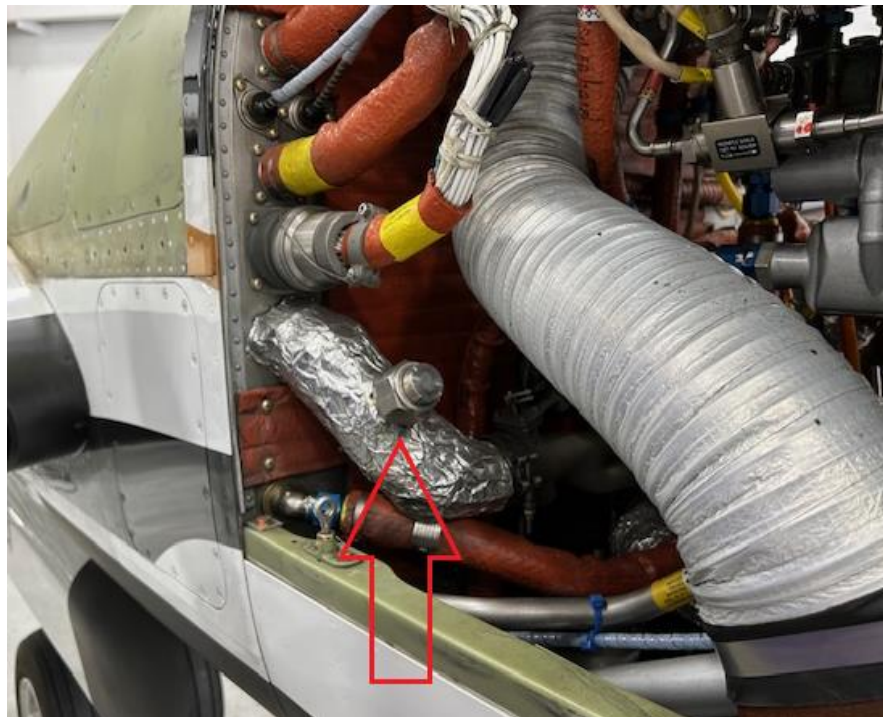
**Line from Flow Pack Pneumatic System Port
Models B200/300/B300**
