**SERVICE BULLETIN**

<sub>N°</sub> 139-539

**DATE:** January 26, 2022

ATA 53 - TRDL BEARING SUPPORT PANEL REINFORCEMENT

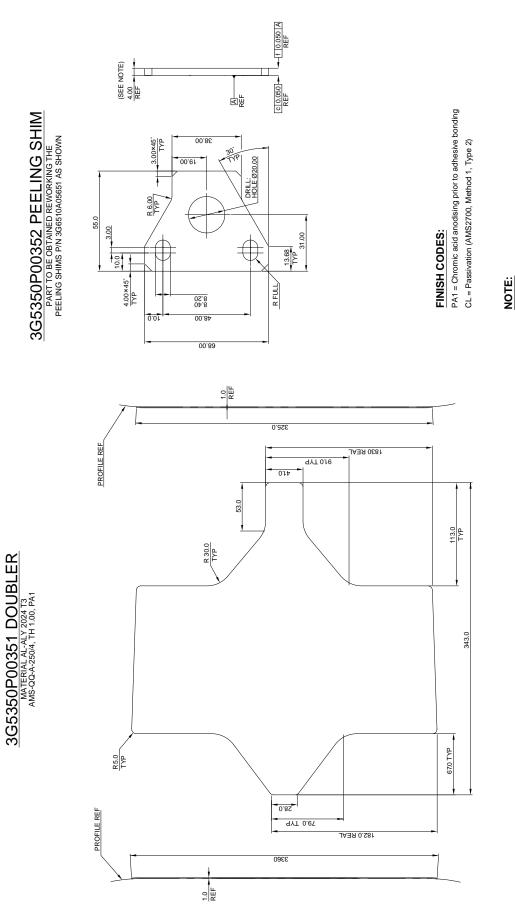
Figure 9

4.00 IS A NOMINAL DIMENSION, PEEL THE SHIM ACCORDING TO THE THICKNESS OF THE ADDED DOUBLER.

Peel the existing shims according to the thickness of the added doublers (see Figure 9).

- 9.15 With reference to Figure 9, manufacture locally the peeling shim P/N 3G5350P00352 reworking the existing peeling shim previously removed.
- 9.16 With reference to Figure 4, reinstall the peeling shim P/N 3G5350P00352 by means of adhesive EA9309.3NA (C021) on the doubler P/N 3G5350P00357.
- 9.17 With reference to Figure 7 Detail H, seal all around the perimeter of the peeling shim P/N 3G5350P00352 by means of sealant MC-780 B-2.
