SERVICE BULLETIN**N° 189-243****DATE:** October 29, 2019**REV. :** A - July 9, 2020

TITLE**ATA 62 - MAIN ROTOR (MR) BLADE TIP INSPECTION****REVISION LOG**

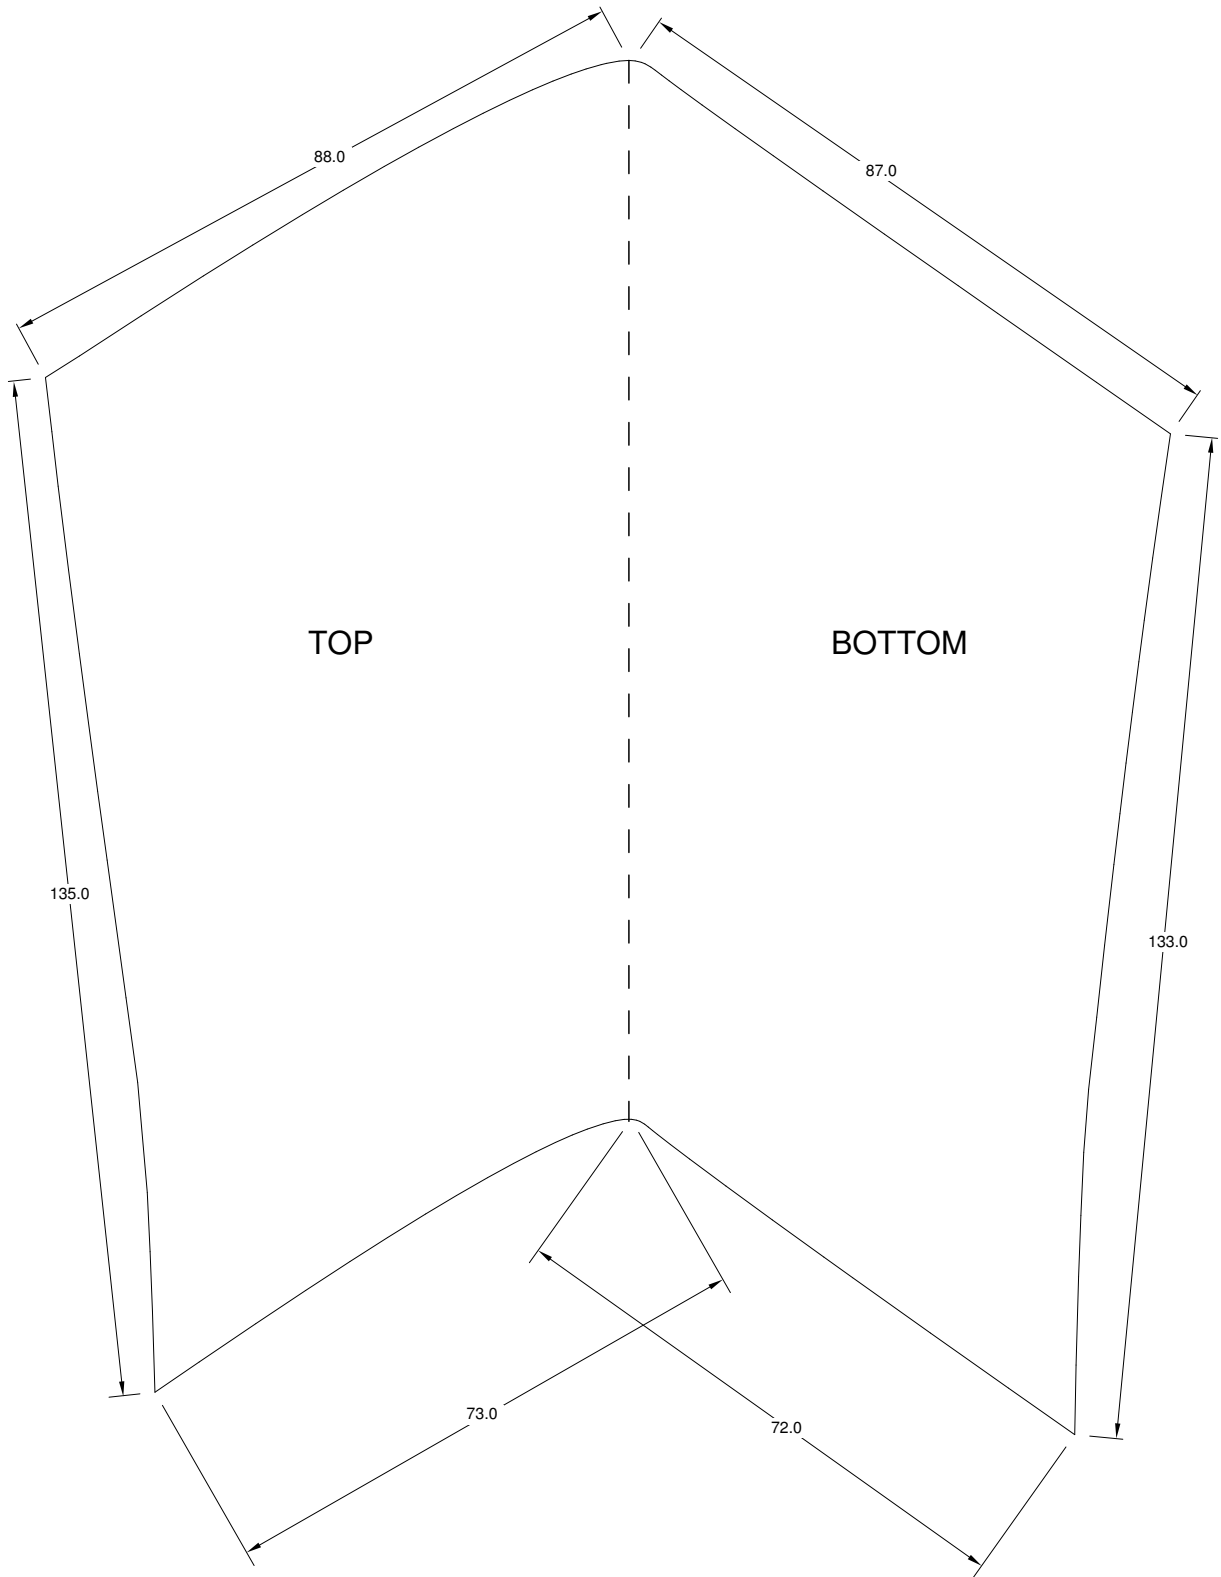
1. In accordance with AMP DM 89-A-00-20-00-00A-120A-A, prepare the helicopter on ground for a safe maintenance. Disconnect the battery, all electrical power sources and/or the external power supply.
2. With reference to Figure 1, Detail A, and Figure 2 and in accordance with applicable steps of AMP DM 89-A-62-11-01-00A-310A-A, perform a visual inspection of the tip cap area of each MR blade.
3. With reference to Figure 2 and in accordance with AMP DM 89-A-62-11-01-01A-663A-B, if the caulking between tip erosion shield and tip swept erosion shield is not in good condition perform the procedure to restore it. Otherwise, skip to Step 4.
4. Return the helicopter to flight configuration and record for compliance with Part I of this Service Bulletin on the helicopter logbook.
5. Send the attached compliance form to the following mail box:
