SERVICE BULLETIN

TITLE: TIME LIMITS - SCHEDULED-UNSCHEDULED MAINTENANCE
- Inspection of the mounting bushings of the horizontal stabilizer

Model:	AS365
Version:	N , N1 , N2 , N3 , F , Fs , K , K2

The purpose of this Service Bulletin is to identify the configuration of the horizontal stabilizer and to do a periodic condition check of the mounting bushings of the horizontal stabilizer PRE MOD 074545.

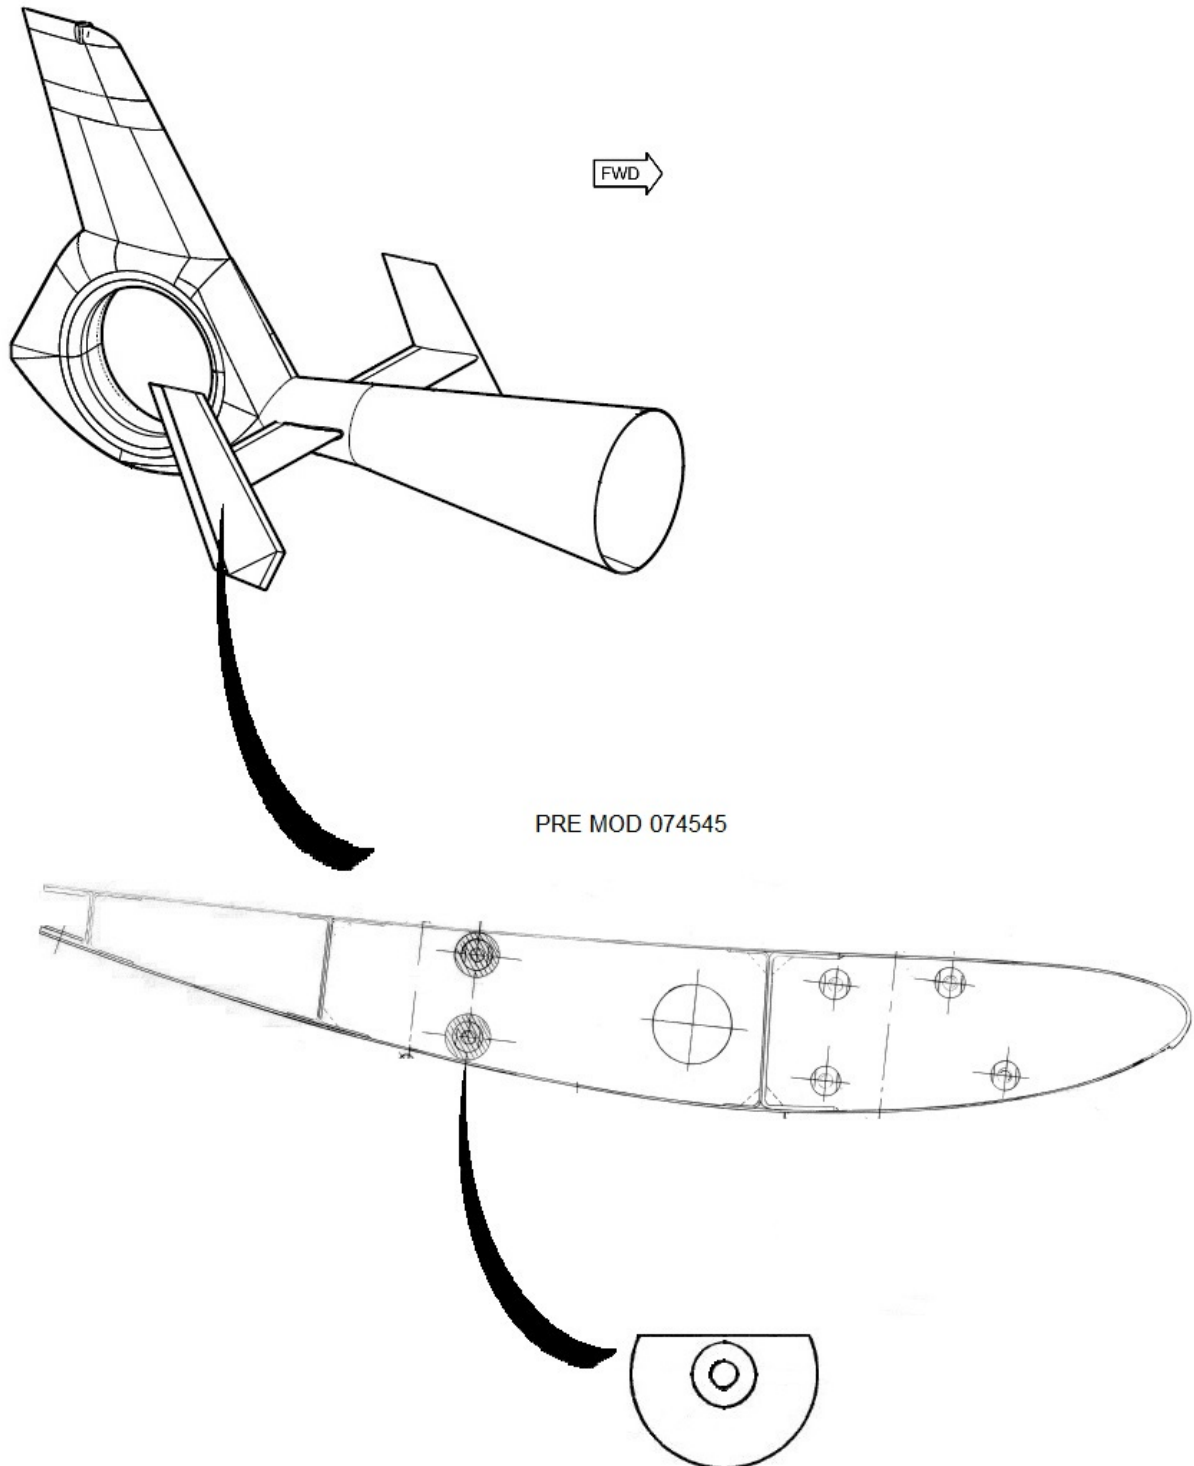
GENERAL ILLUSTRATION

The investigation revealed that the half of the shoulder of the bushing had separated from the internal reinforcement of the horizontal stabilizer, at the rear of the right side spoiler attachment studs. The two rear studs were held in place but the shoulder of bushings inside the horizontal stabilizer were missing.

The four bushings were in place and showed some corrosion.

The presence of corrosion can lead to the failure of the bushings of the internal reinforcement of the horizontal stabilizer.

Consequently, the purpose of this Service Bulletin is to identify the configuration of the horizontal stabilizer and to periodically check the correct condition of the mounting bushings of the horizontal stabilizer PRE MOD 074545.
