SERVICE BULLETIN

N° **139-731**

ATA 00 – FORWARD CABIN ROOF CEILING HARNESS INSPECTION

This Service Bulletin is issued in order to prescribe one-off inspections of the Forward Cabin Roof Ceiling Harnesses and their installation in the area between STA 3120 and 3900 to identify potential chafing conditions.

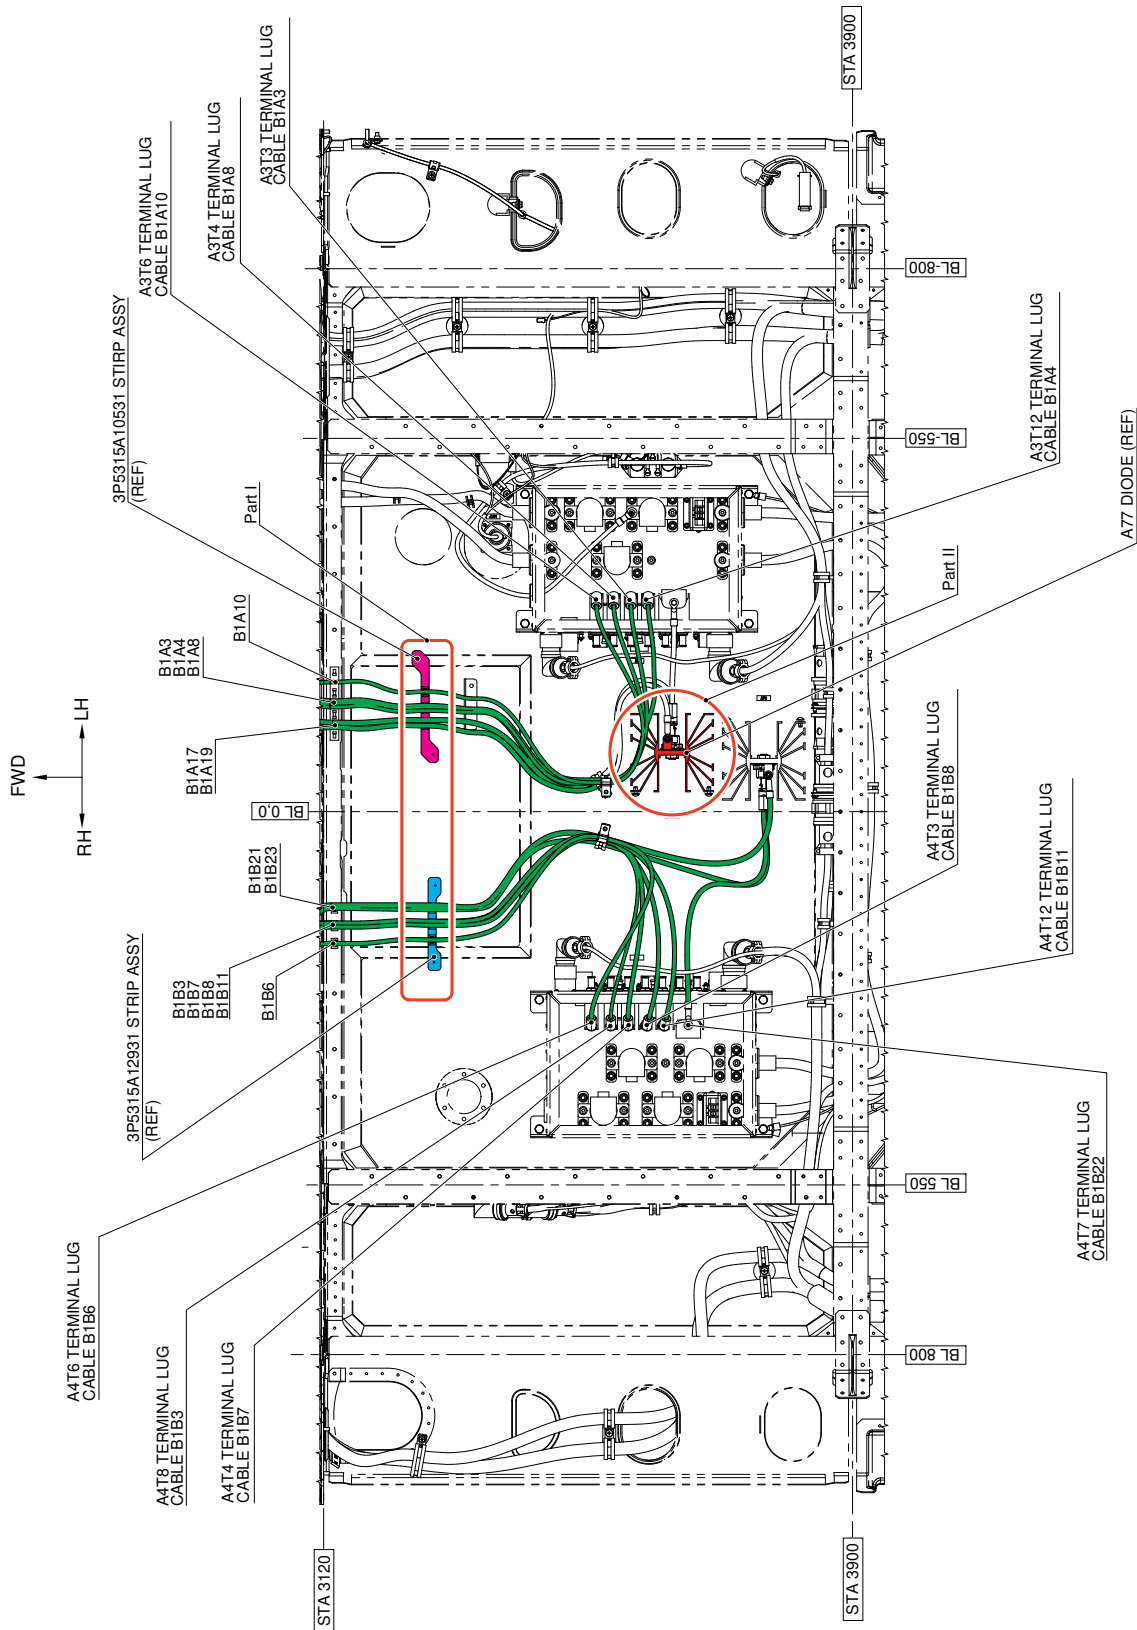
Figure 5

2. In accordance with AMP DM 39-A-06-41-00-00A-010A-A and with reference to Figure 5, Figure 10 and Figure 11, remove all external panels, internal panels and internal liners as required to gain access to the area affected by the installation and perform the diode A77 harness installation inspection in the area between STA 3400 and 3900 as described in the following procedure:

- 2.1 With reference to Figure 5, Figure 10 and Figure 11, perform a visual inspection of the C/As installation next to the Diode A77 P/N 3G2430V00352 according to the following steps:
