SERVICE BULLETIN

N° **189-382**

ATA 71 - FUEL AND D1 DRAINAGE LINES INSPECTION

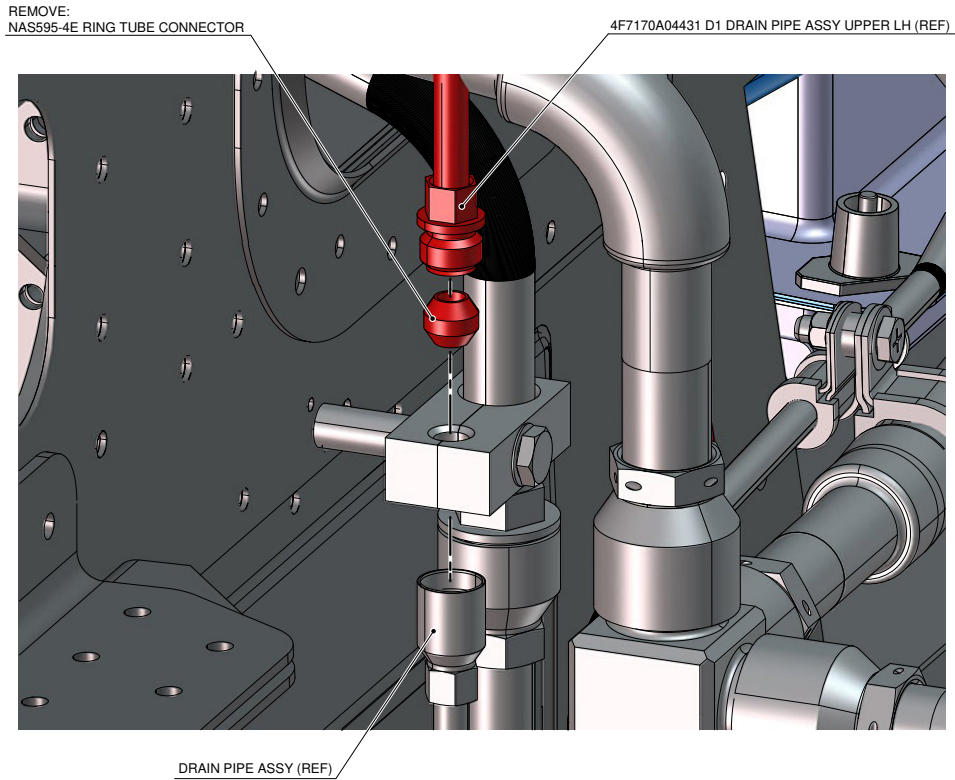
3. With reference to Figure 1 and Figure 2 View B, using a borescope and a bright light source, visually inspect the whole zone of intersection between the “D1 drain pipe assy upper LH” P/N 4F7170A04431 and the fuel pipe assy P/N 8G2820A03234 or P/N 8G2820A03233, for evidence of chafing. In case of no findings, skip to Step 6. Otherwise, perform the following Step.
4. In case of damage on “D1 drain pipe assy upper LH” P/N 4F7170A04431 only, no action is required. Proceed to Step 6.
5. In case of damage on fuel pipe assy P/N 8G2820A03234 or P/N 8G2820A03233, perform the following procedure:
 - 5.1 Measure the depth of the damage found. Use the borescope with measurement feature. Take a picture of the damaged pipe and fill the report in Figure 4. Send pictures and report to Leonardo Helicopters at the following mail box: engineering.support.lhd@leonardo.com.

- 5.2.1 With reference to Figure 2 View C, remove the clamp P/N AS21919WCH04 from the “D1 drain pipe assy upper LH” P/N 4F7170A04431.
 - 5.2.2 With reference to Figure 1 thru 3, remove the “D1 drain pipe assy upper LH” P/N 4F7170A04431 and the ring tube connector P/N NAS595-4E.

3. If not already removed, perform the engine drain D1 retromod removal P/N 8G7170P00311 as described in the following procedure:
 - 3.1 With reference to Figure 2 View C, remove the clamp P/N AS21919WCH04 from the D1 drain pipe assy upper LH P/N 4F7170A04431.
