No. EC155-67-015

SERVICE BULLETIN

ROTOR FLIGHT CONTROLS Replacement of the Old Generation SEMA by the New Generation 2 SEMA

Corresponds to modification 0722B81

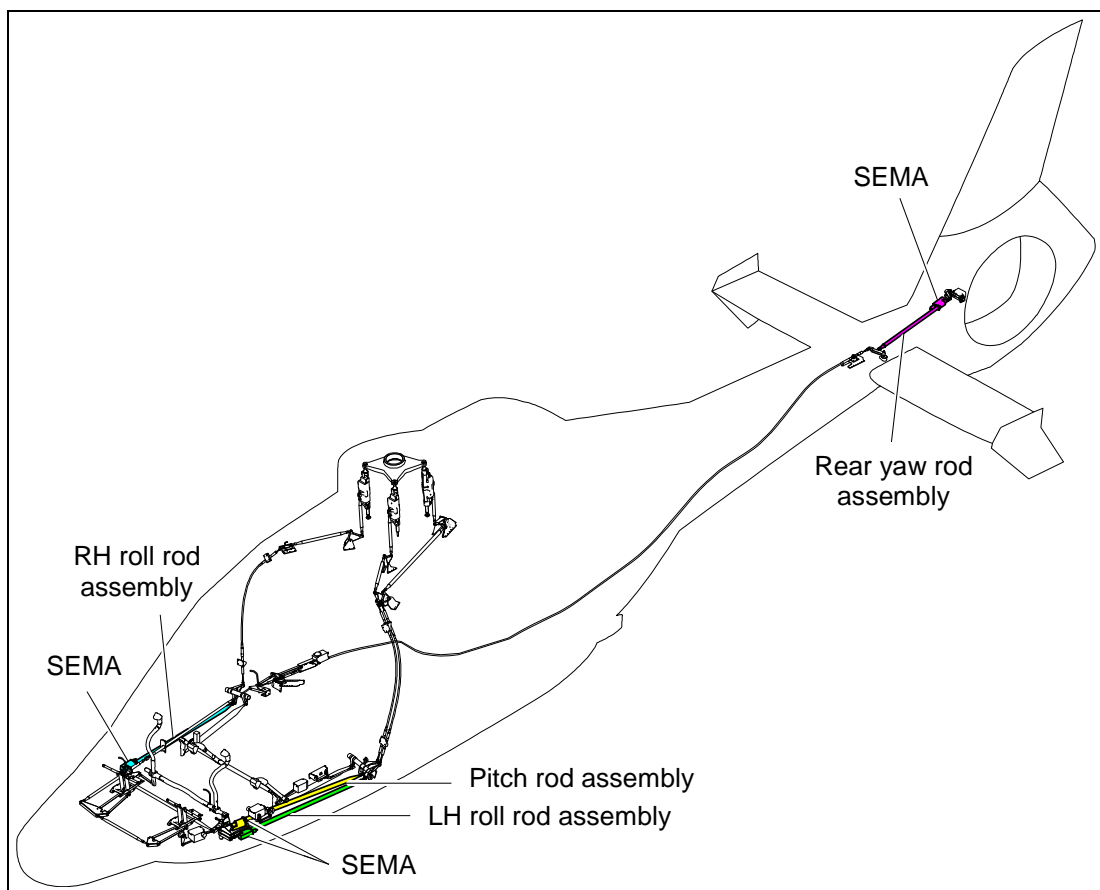
The purpose of this Service Bulletin is to replace the Old Generation (OG) serial actuator SEMA (Smart Electro-Mechanical Actuator) by the New Generation 2 (NG2) SEMA to reduce recurrent maintenance costs, backlash and sealing problems.

This Service Bulletin consists in replacing the OG SEMA and its screws by the NG2 SEMA and its screws.
