Temporary Maintenance Instruction  
TMI109-405 Rev. A

Tail Gearbox –  
Special Inspection

A109E / A109K2 / A109C / A109A/AII /  
A109S/AW109SP Helicopters

2021-08-09

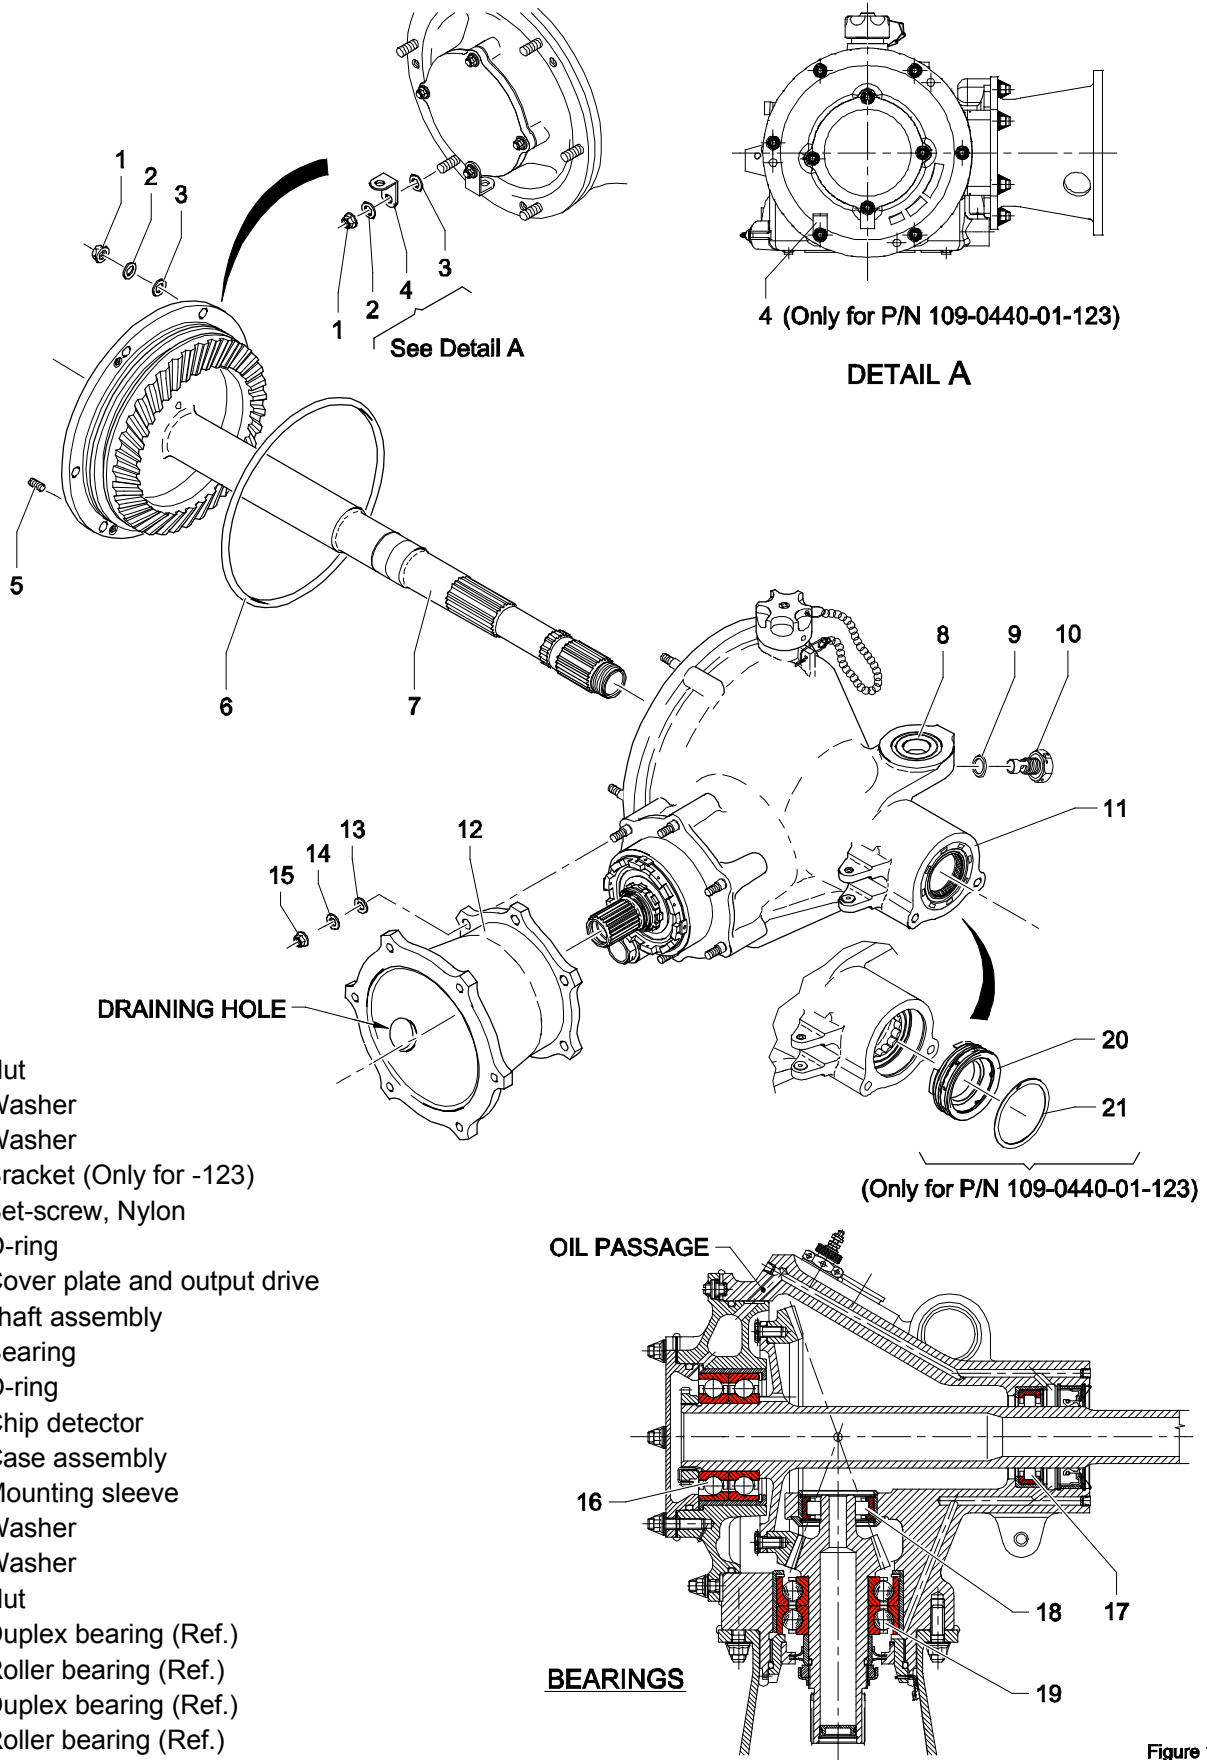
4. Inspect the roller bearing (18, Figure 1) for freedom of rotation and roughness.
5. Inspect the duplex bearing (19) for freedom of rotation and roughness.

9. Visually inspect the roller bearing (17, Figure 1) for wear, damage and for freedom of rotation and roughness.
10. With the shaft assy on a bench, manually rotate the shaft in order to inspect the duplex bearing (16) for freedom of rotation and roughness.

Figure 1 – 90-degrees gearbox assembly.

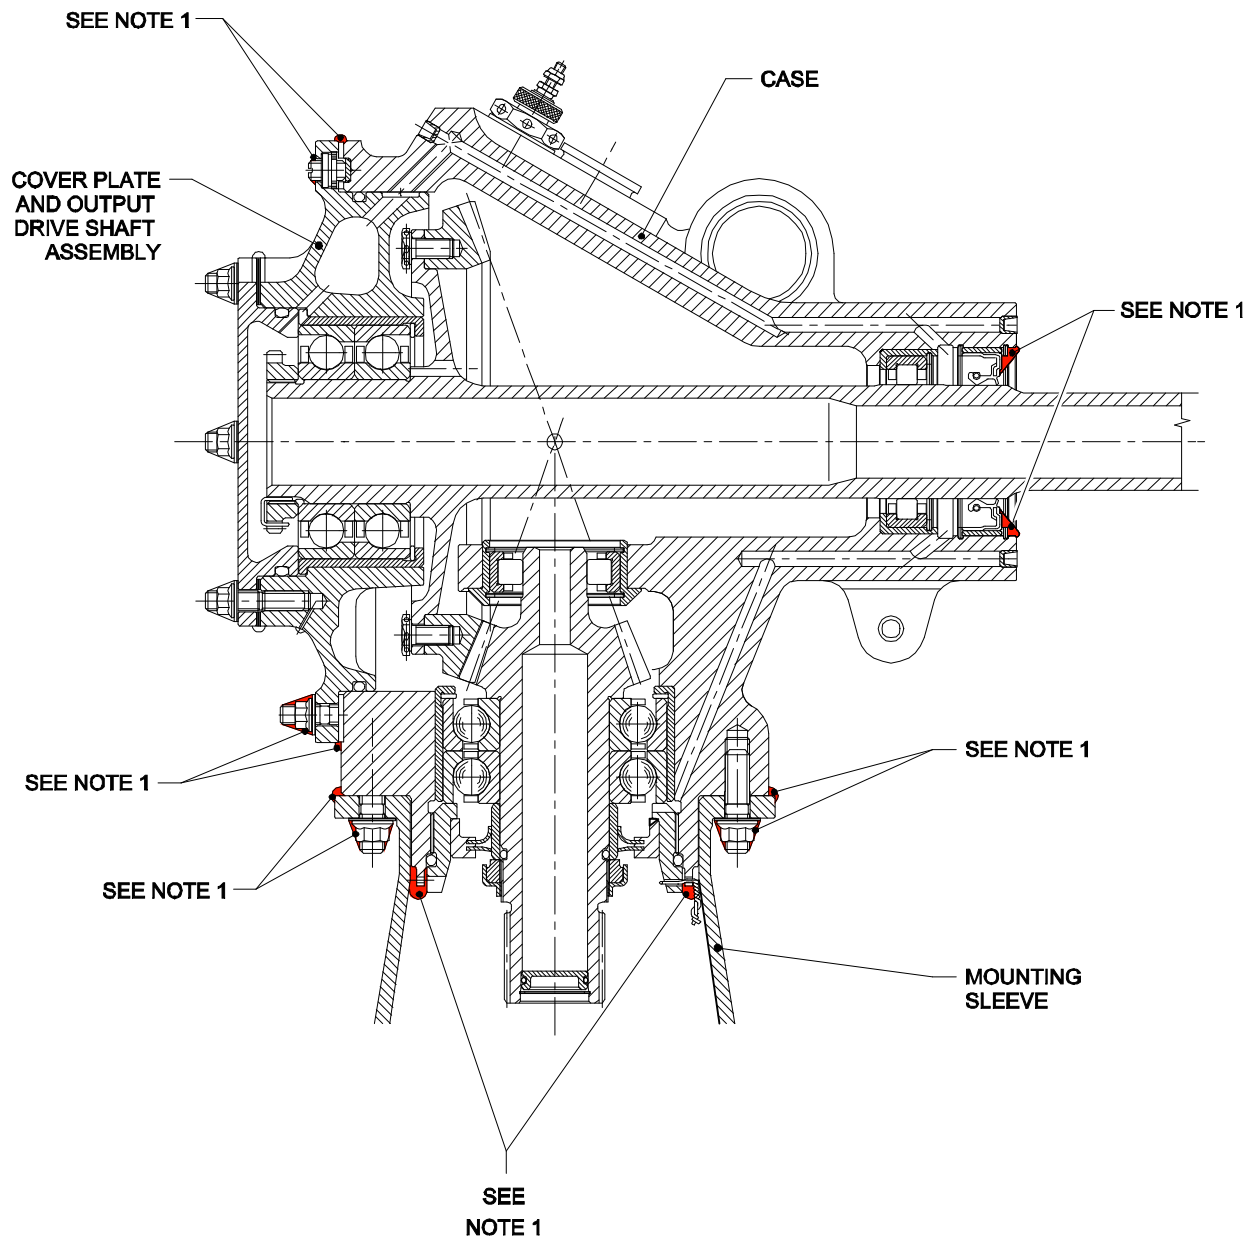
Figure 3 - 90-degrees gearbox - Sealing.

4. Apply sealing compound (Supply Ref. 6) on the mating surfaces of the 90-degrees gearbox as shown in Figure 3.

**NOTE 1 :** Apply sealing compound (Supply Ref. 6) to outer edge of mating surfaces.
