**CT7-2E Maintenance INCREMENTAL CHANGE  
MM 72-00-00, FAULT ISOLATION 002  
NON-FADEC FAULT ISOLATION (CT7-2E1)**

Release Notification Date: 08/08/2024

tk72-00-00-810-810      [Technical Change: Changed the chip detector inspection criteria in Figure 116, Sheet 5.](#)

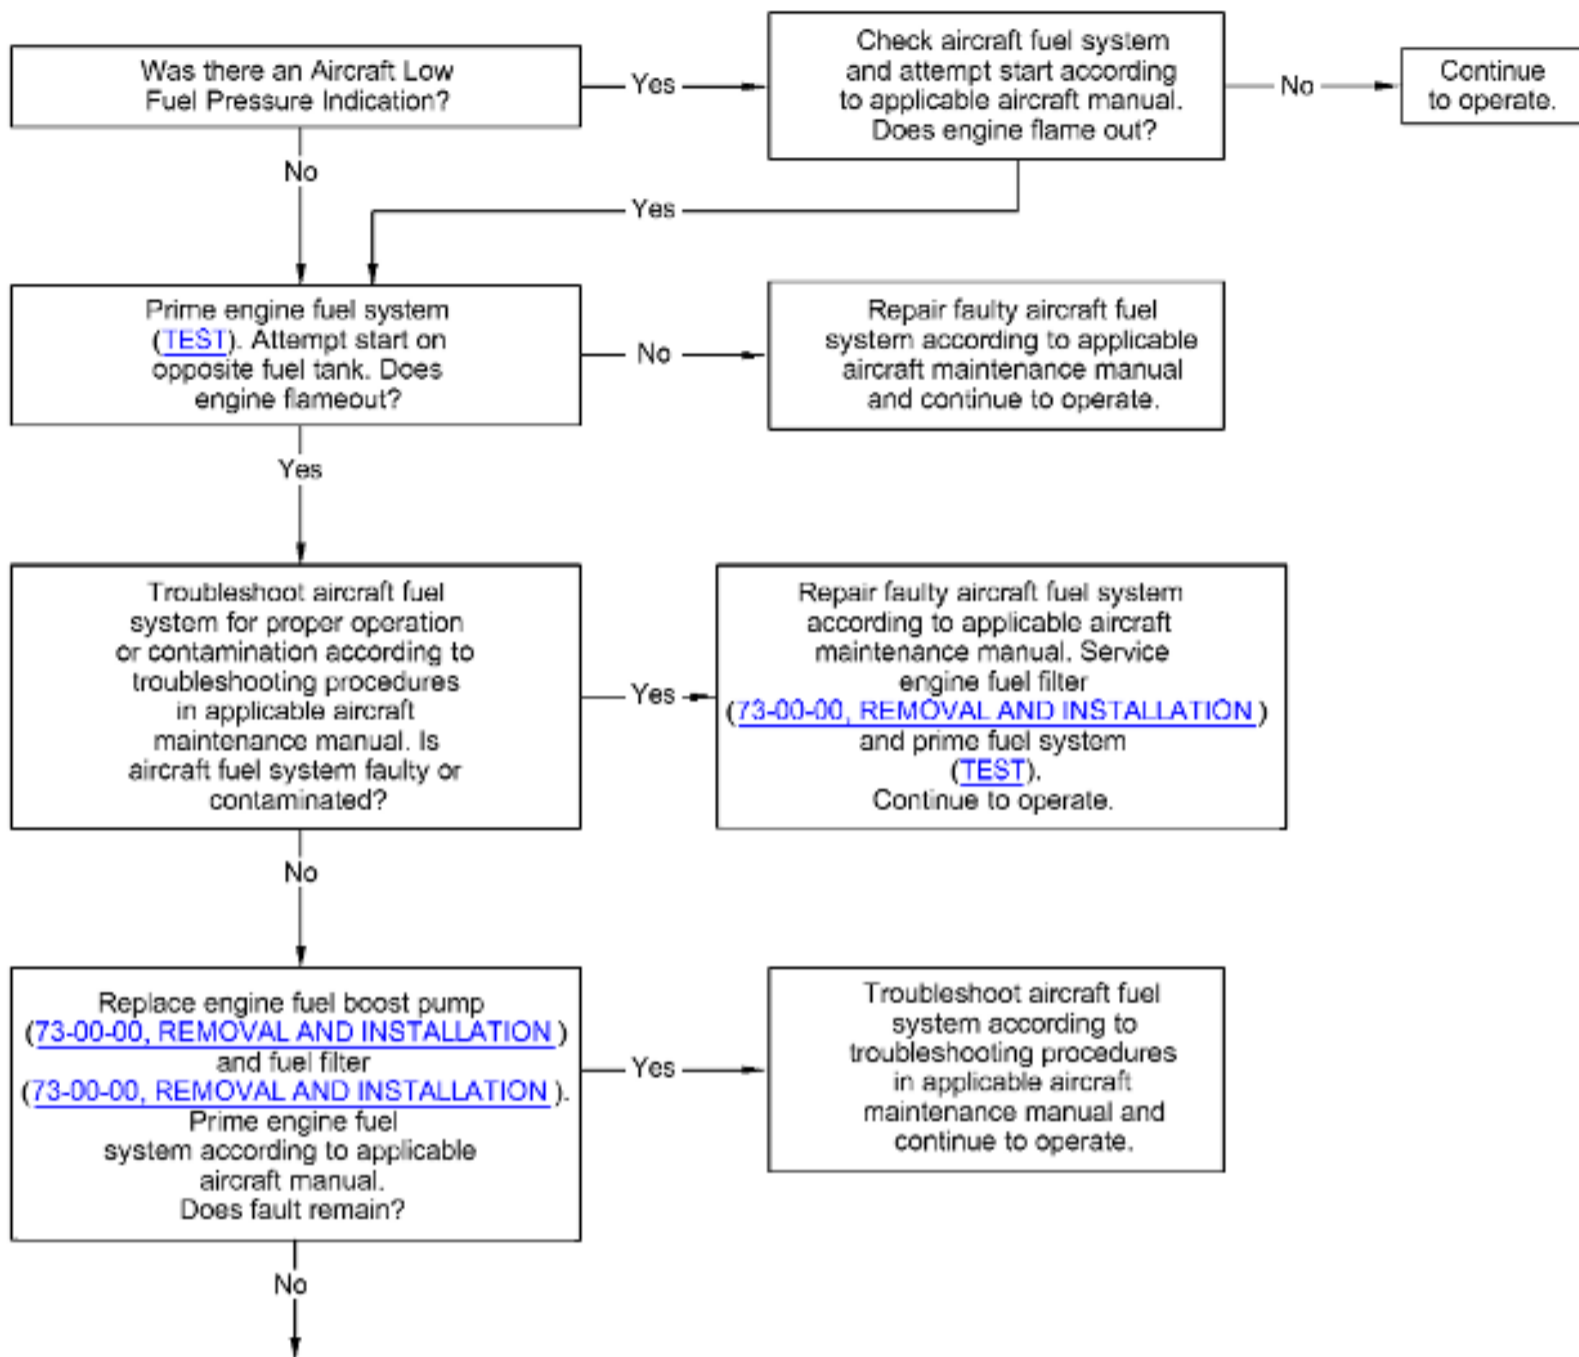
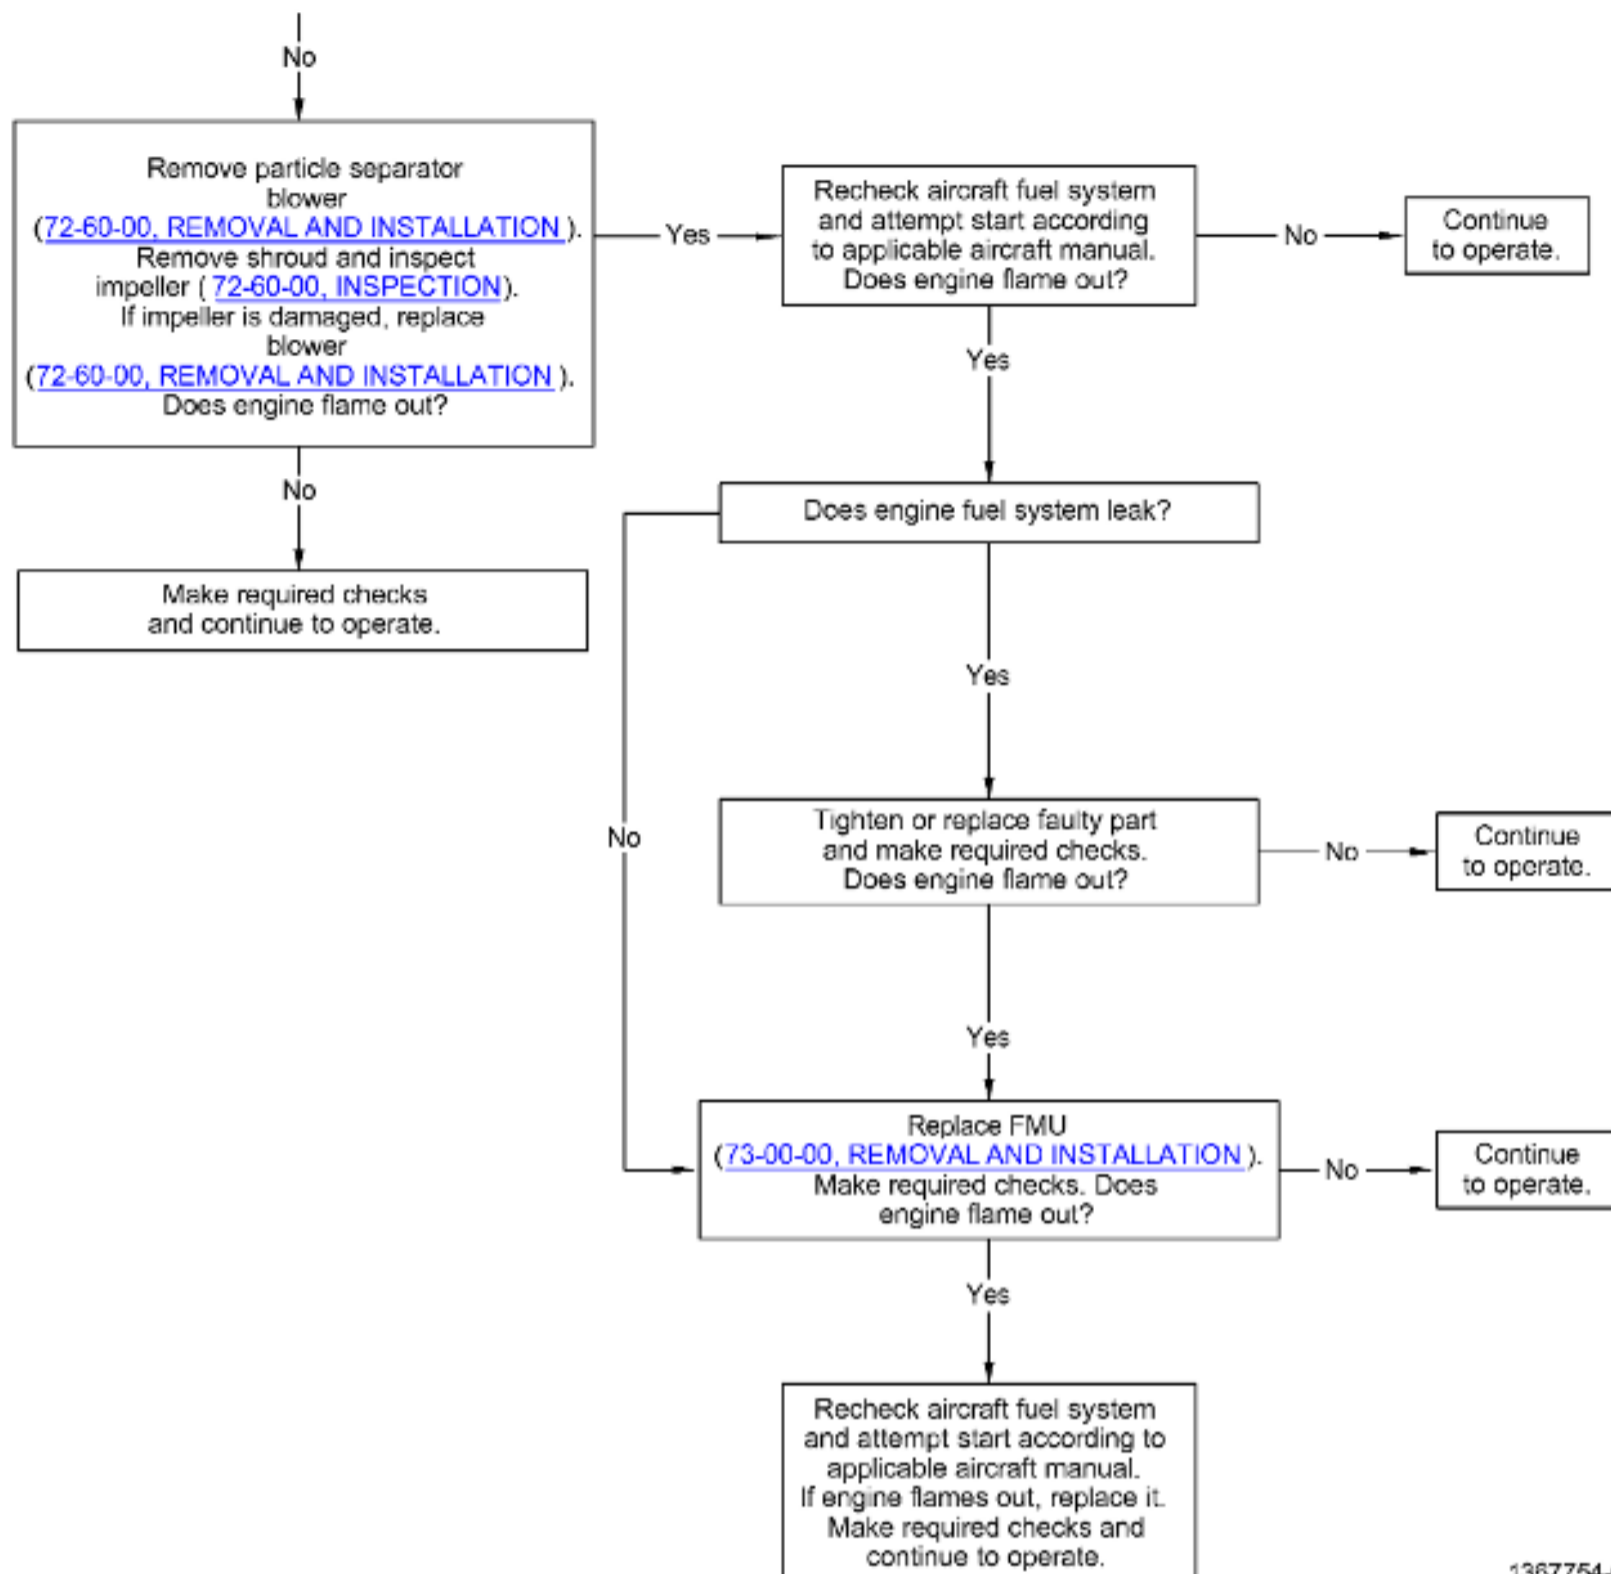
Figure 101 (Sheet 1) Engine Flames Out (Combustion Stops Indicated by a Drop in TGT)

Flameout can be caused by a compressor stall or FOD. See if there are P3 fault codes on the cockpit display caused by P3 sensor failure, tube damage, cracks or blockage.

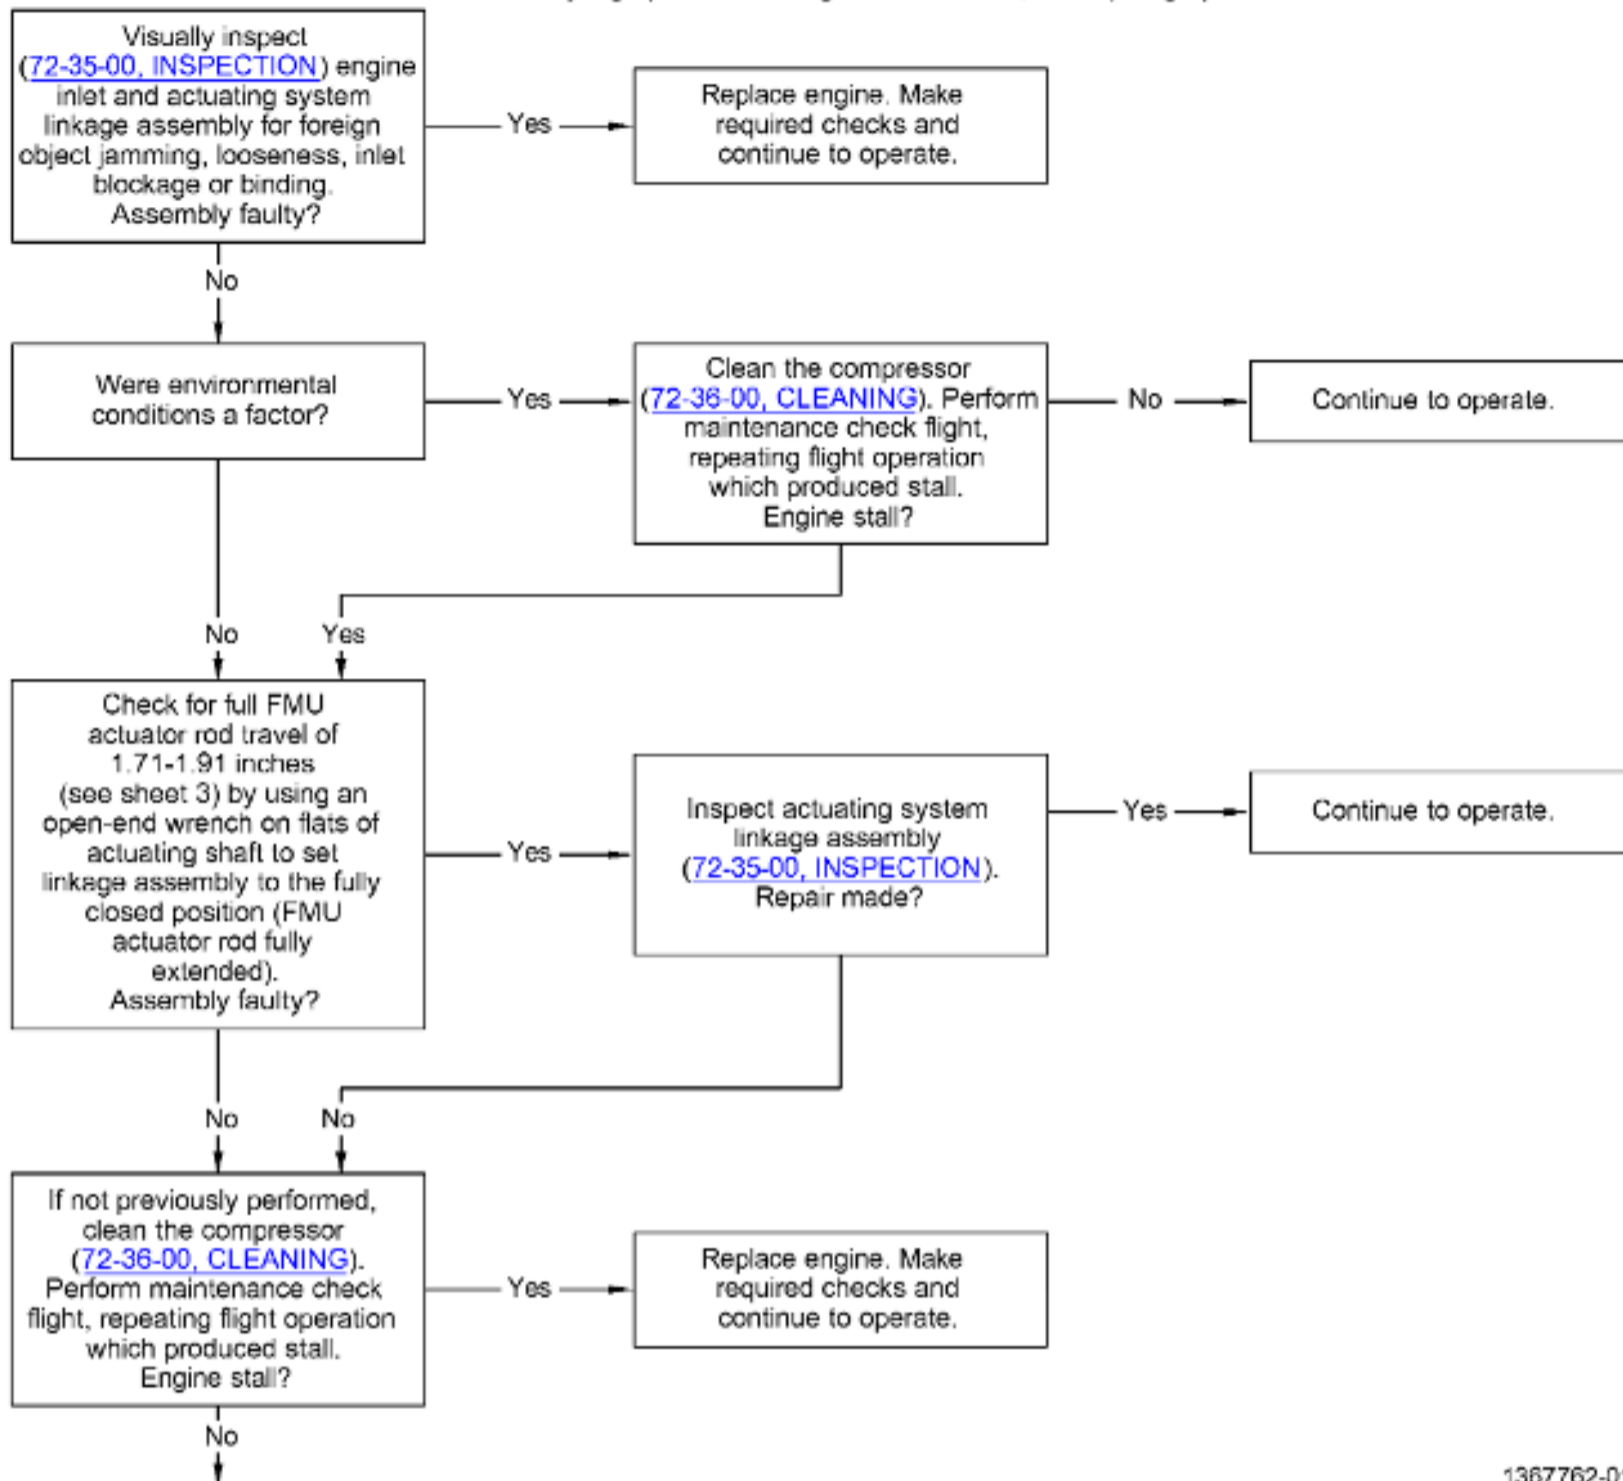
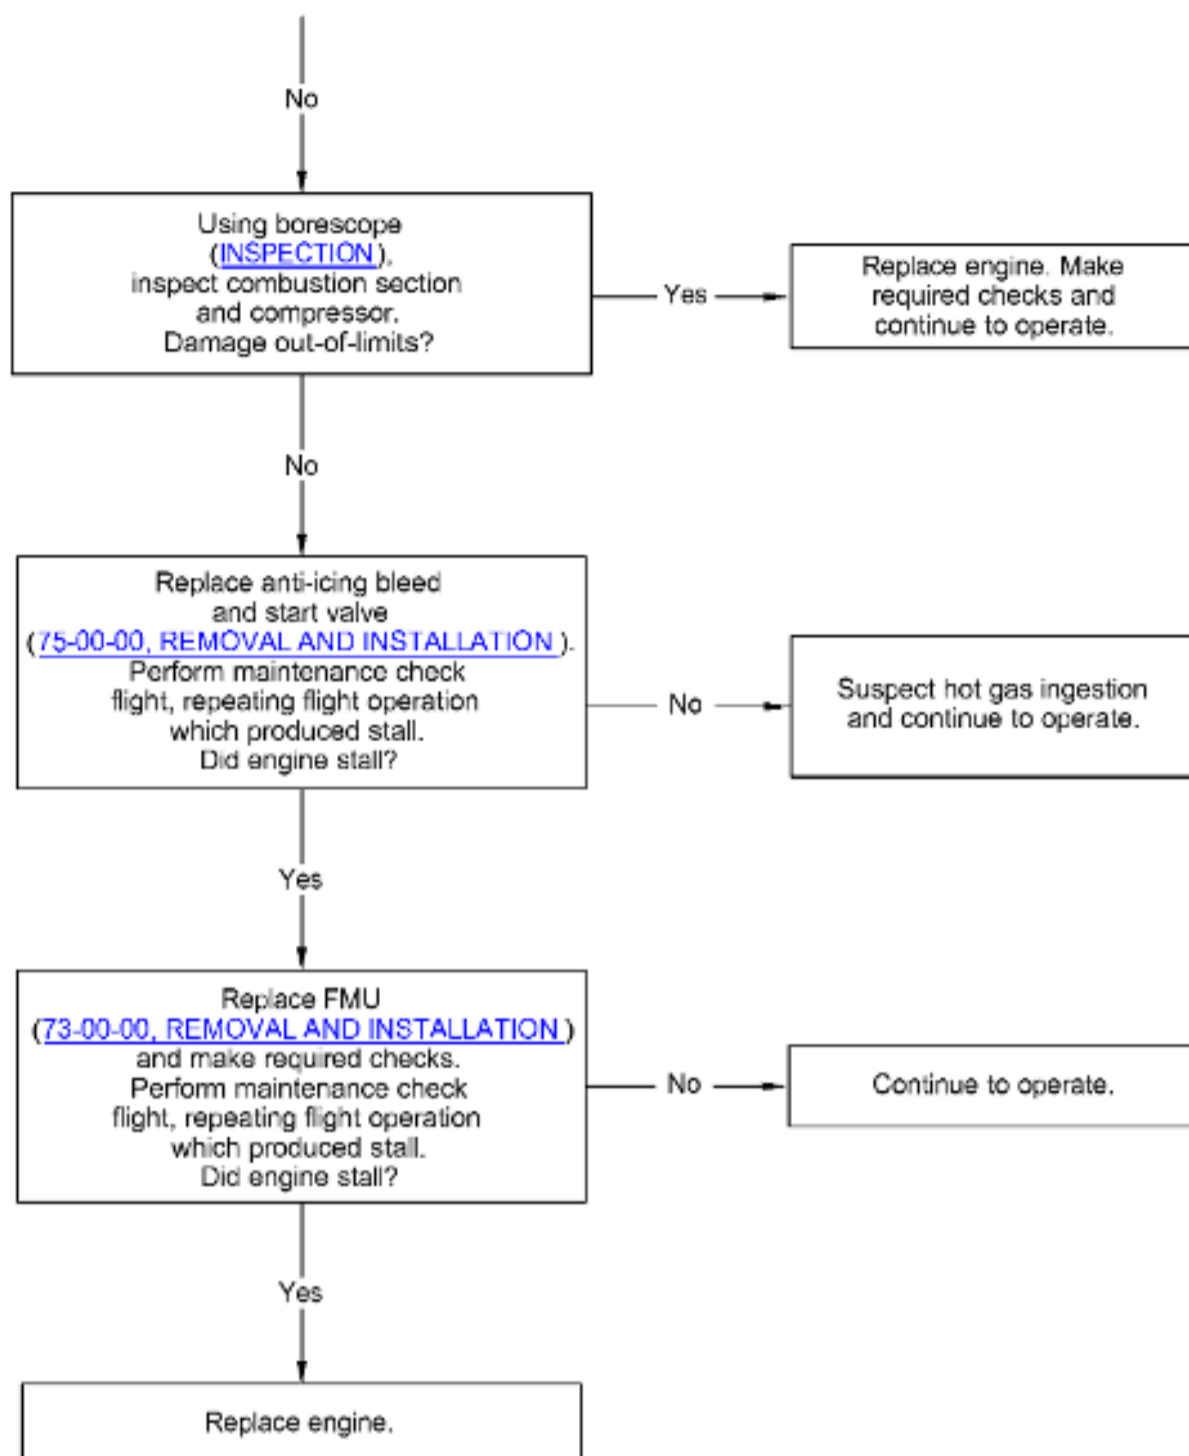
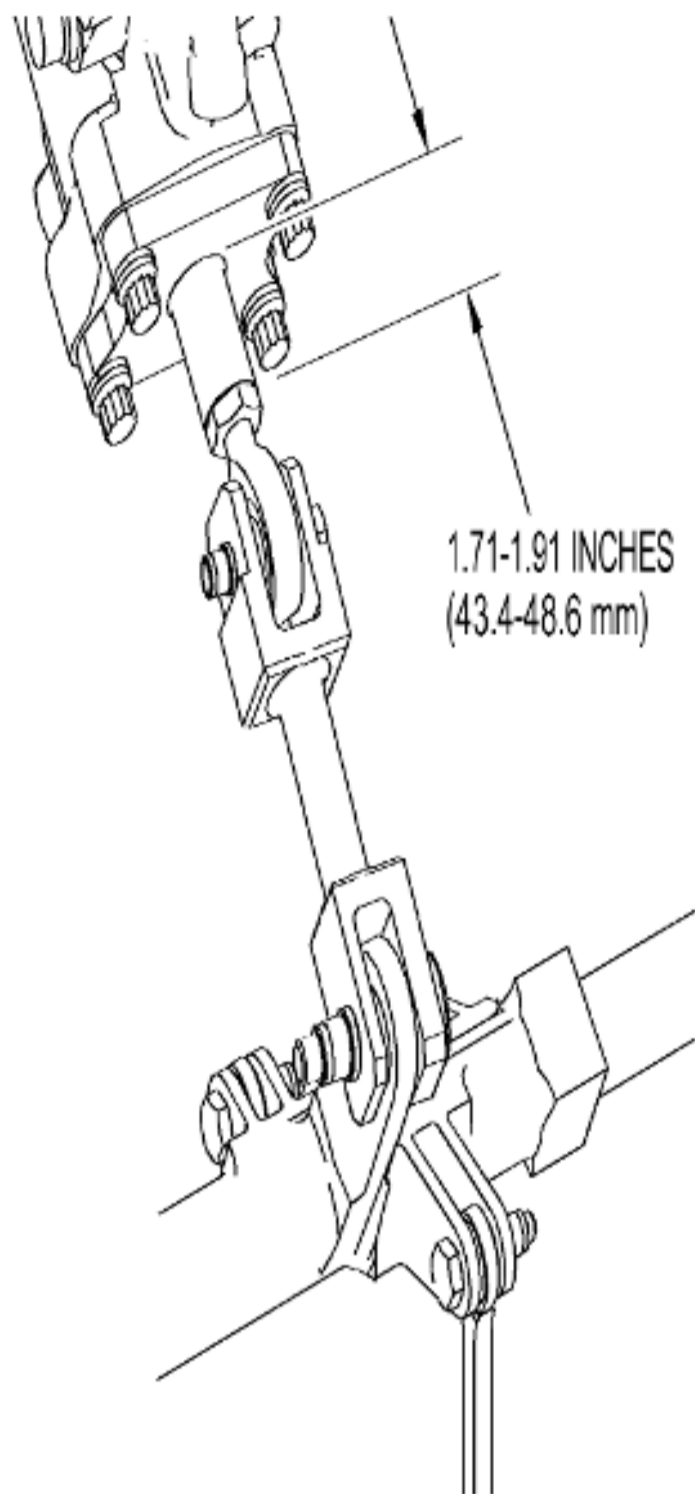
Figure 105 (Sheet 1) Stall Above Ground Idle Speed (Acceleration or Deceleration Above Ground Idle Speed)

A stall is indicated by an audible rumble or bang and may not cause a rise in TGT.  
 • If an unusually high-pitched whining sound is heard, see paragraph 1.D.

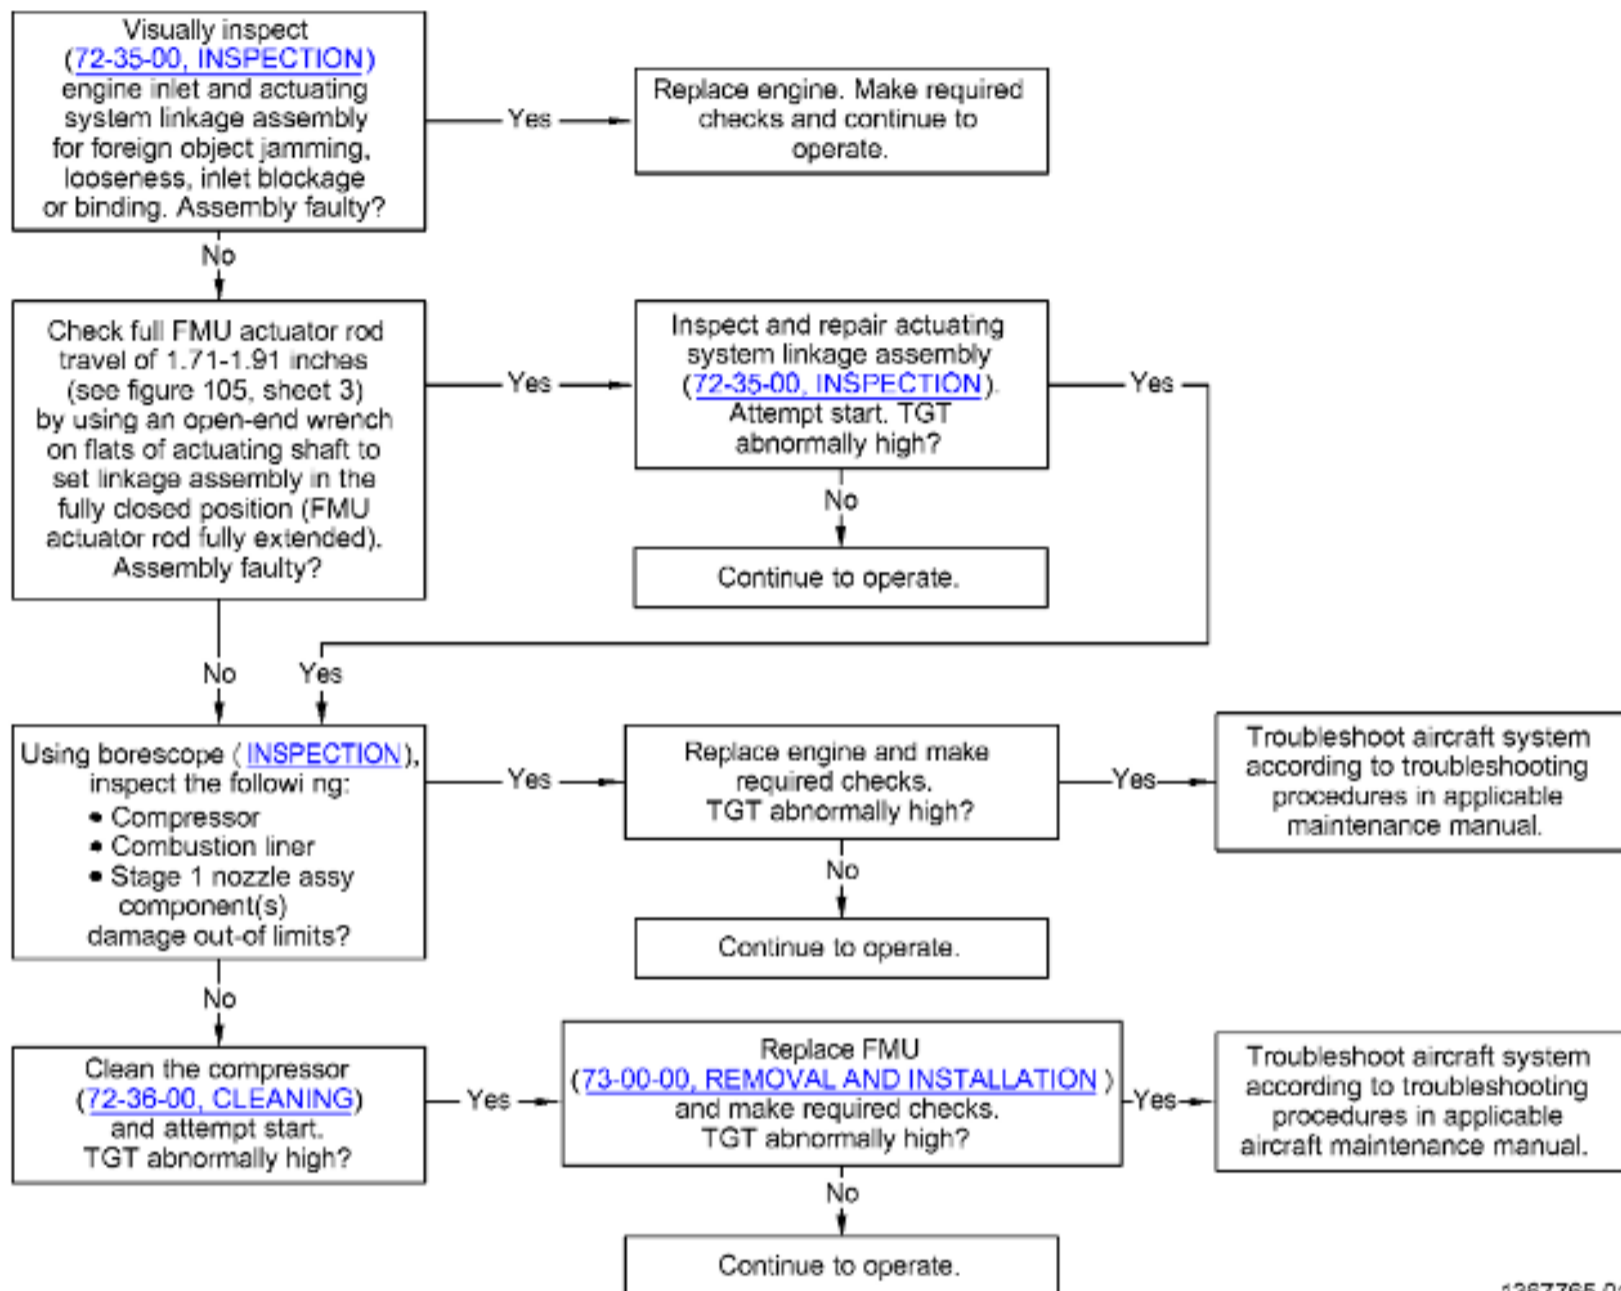
Figure 107 Abnormally High TGT During Start

- Starting system should be able to motor engine to at least 24% Ng (10,728 RPM). Starter must not cut out below 51.6% Ng (23,065 RPM). This can be checked by using cockpit instruments.
- Check for environmental factors and TGT less than 150°C when start was initiated.

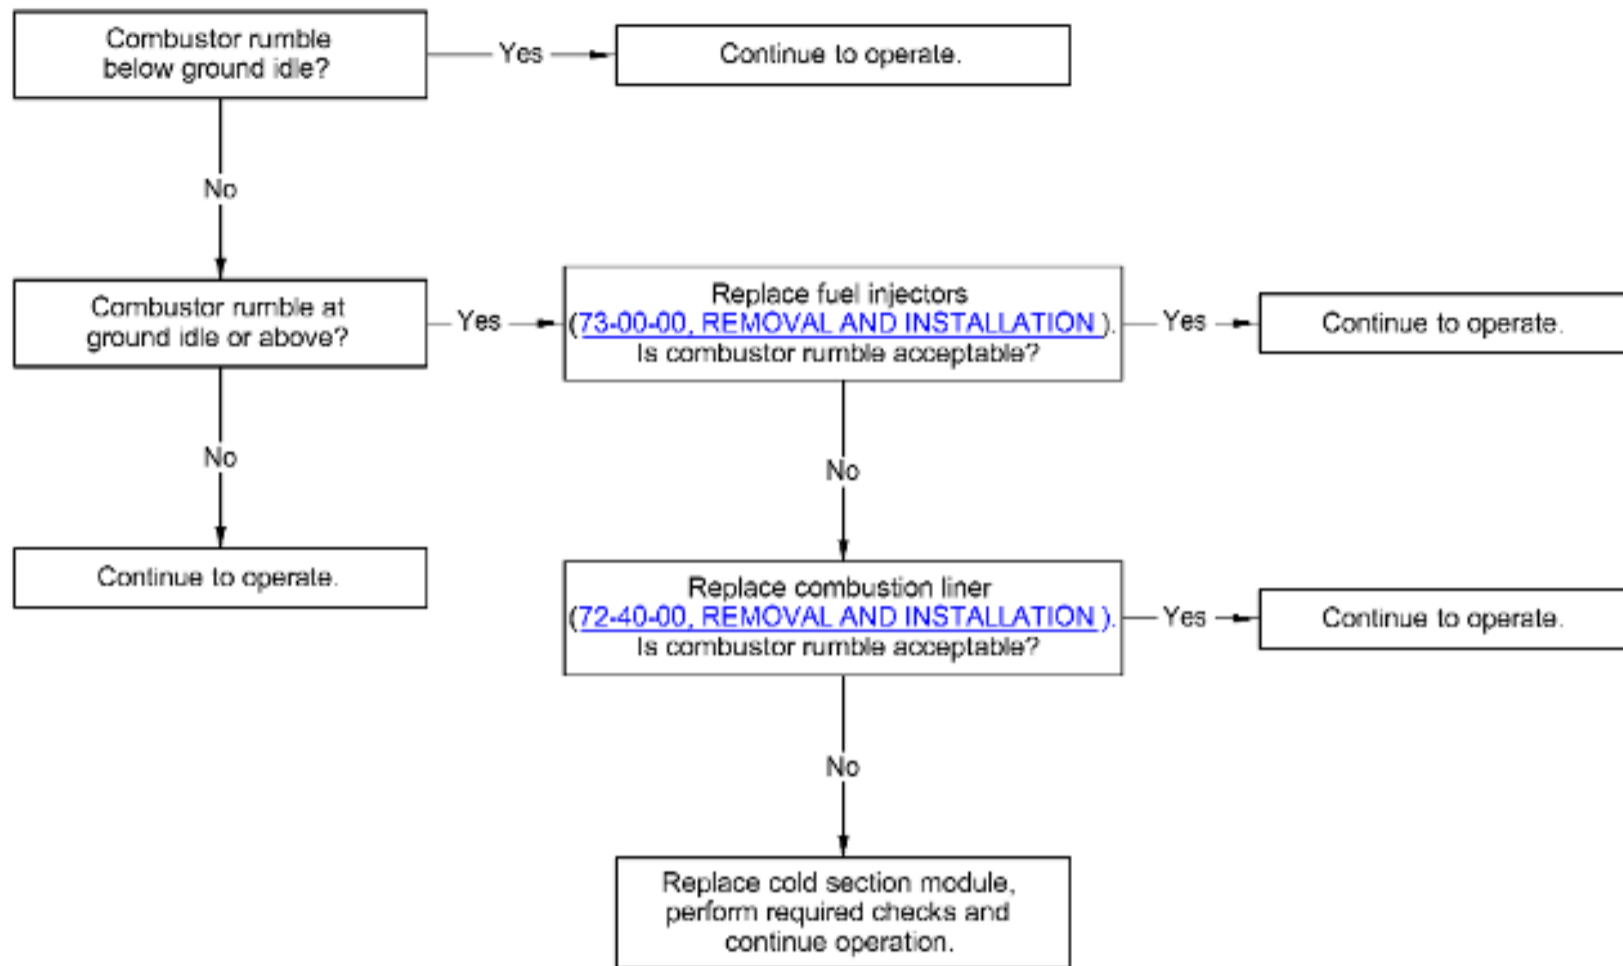
Figure 108 Combustor Rumble During Start

- Combustor rumble is a low frequency noise often described as a howl that may be heard intermittently during engine start .
- Combustor rumble may be more pronounced during cold weather and/or during engine acceleration to ground idle.

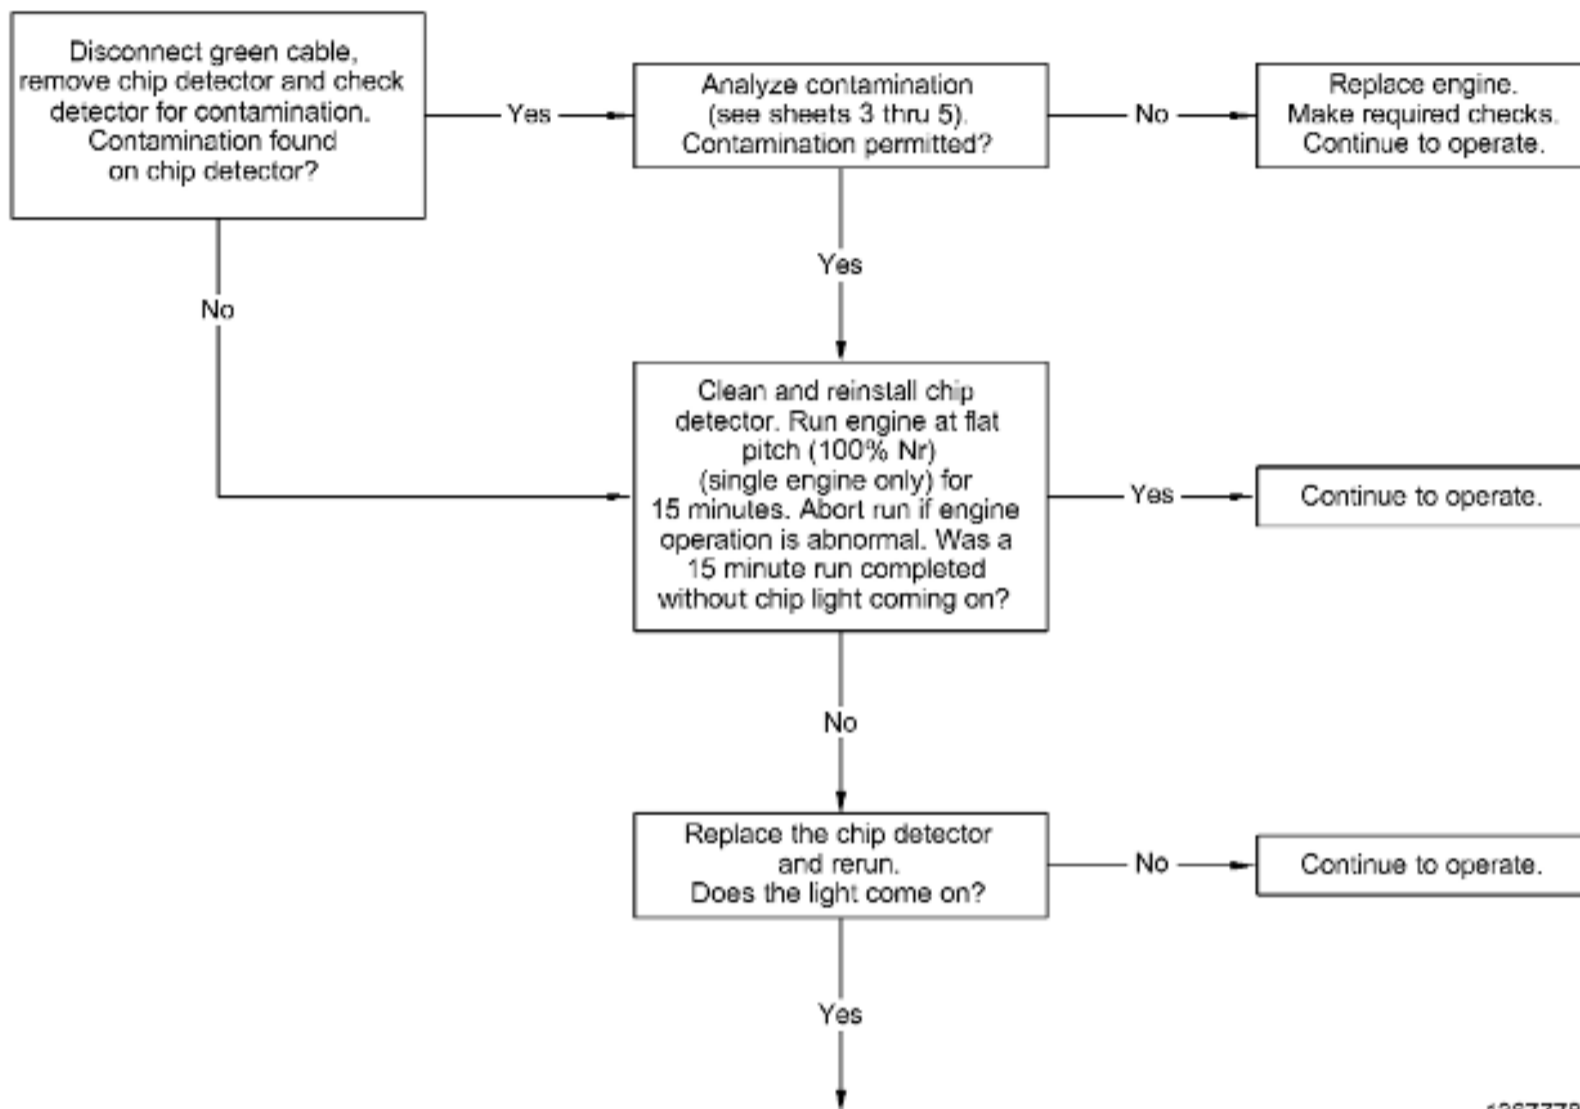
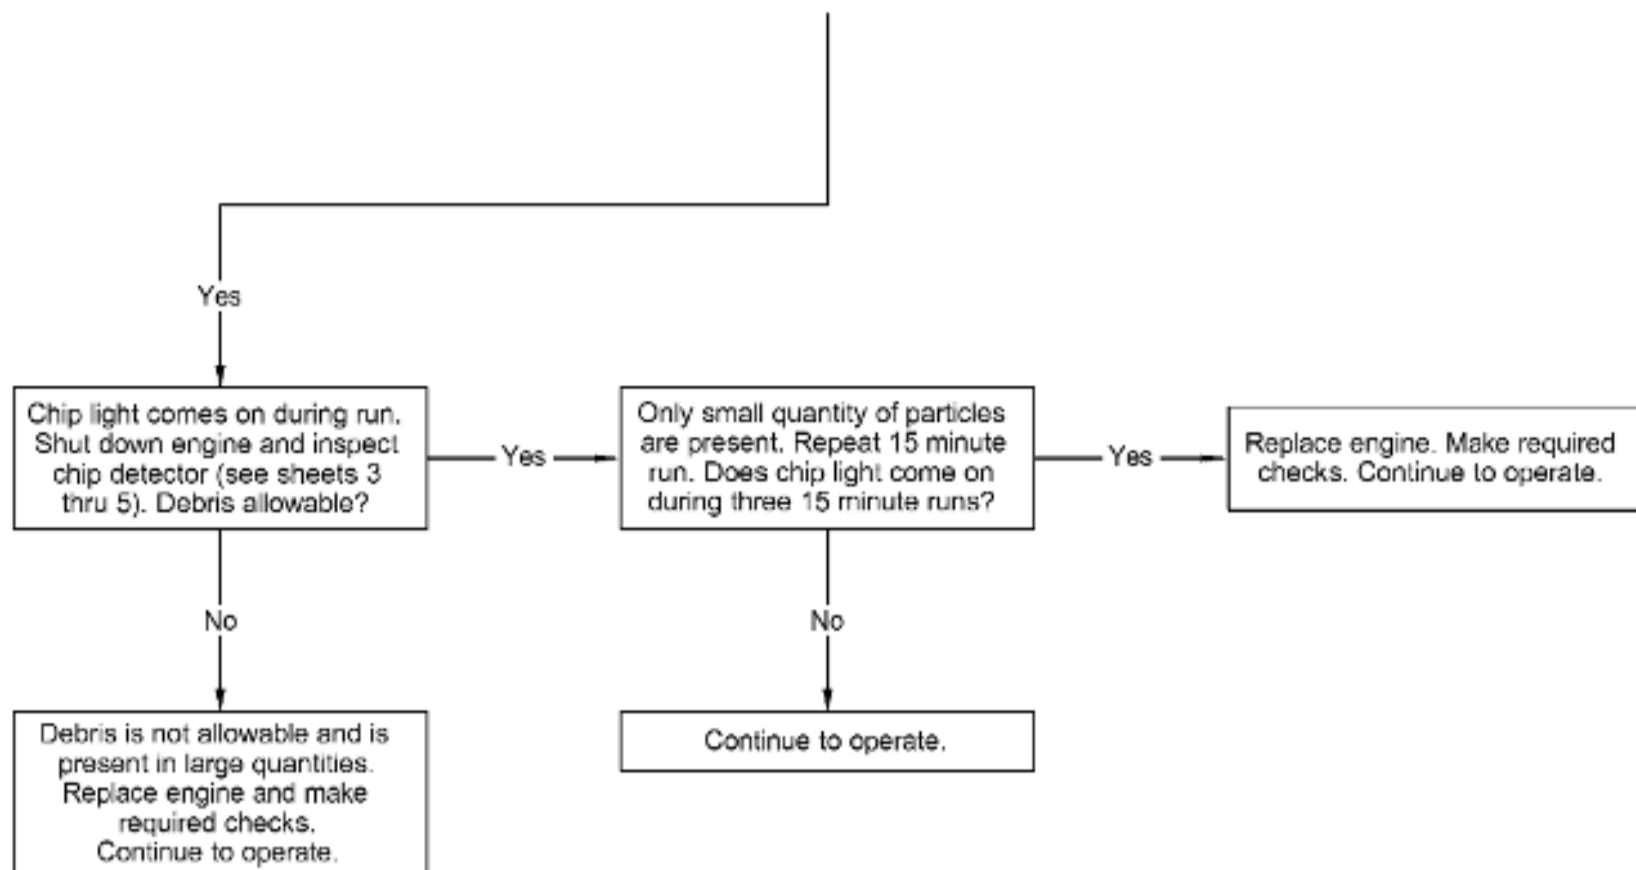
Figure 116 (Sheet 1) Electrical Chip Detector Light On During Engine Operation

- If chip light comes on and if debris is allowed (see sheets 3 and 4), a series of 15 minute ground runs at flat pitch, 100% Nr should be made to clean engine oil system of debris.
- If no chip light comes on during a 15 minute run, continue to operate.
- If chip light comes on, and if debris is allowed but is not present in large quantities, continue making runs until a 15 minute run is made without light coming on.
- If chip detector light comes on for three runs, replace engine. If allowed chips continue to generate and if quantity of debris is increasing, replace engine.

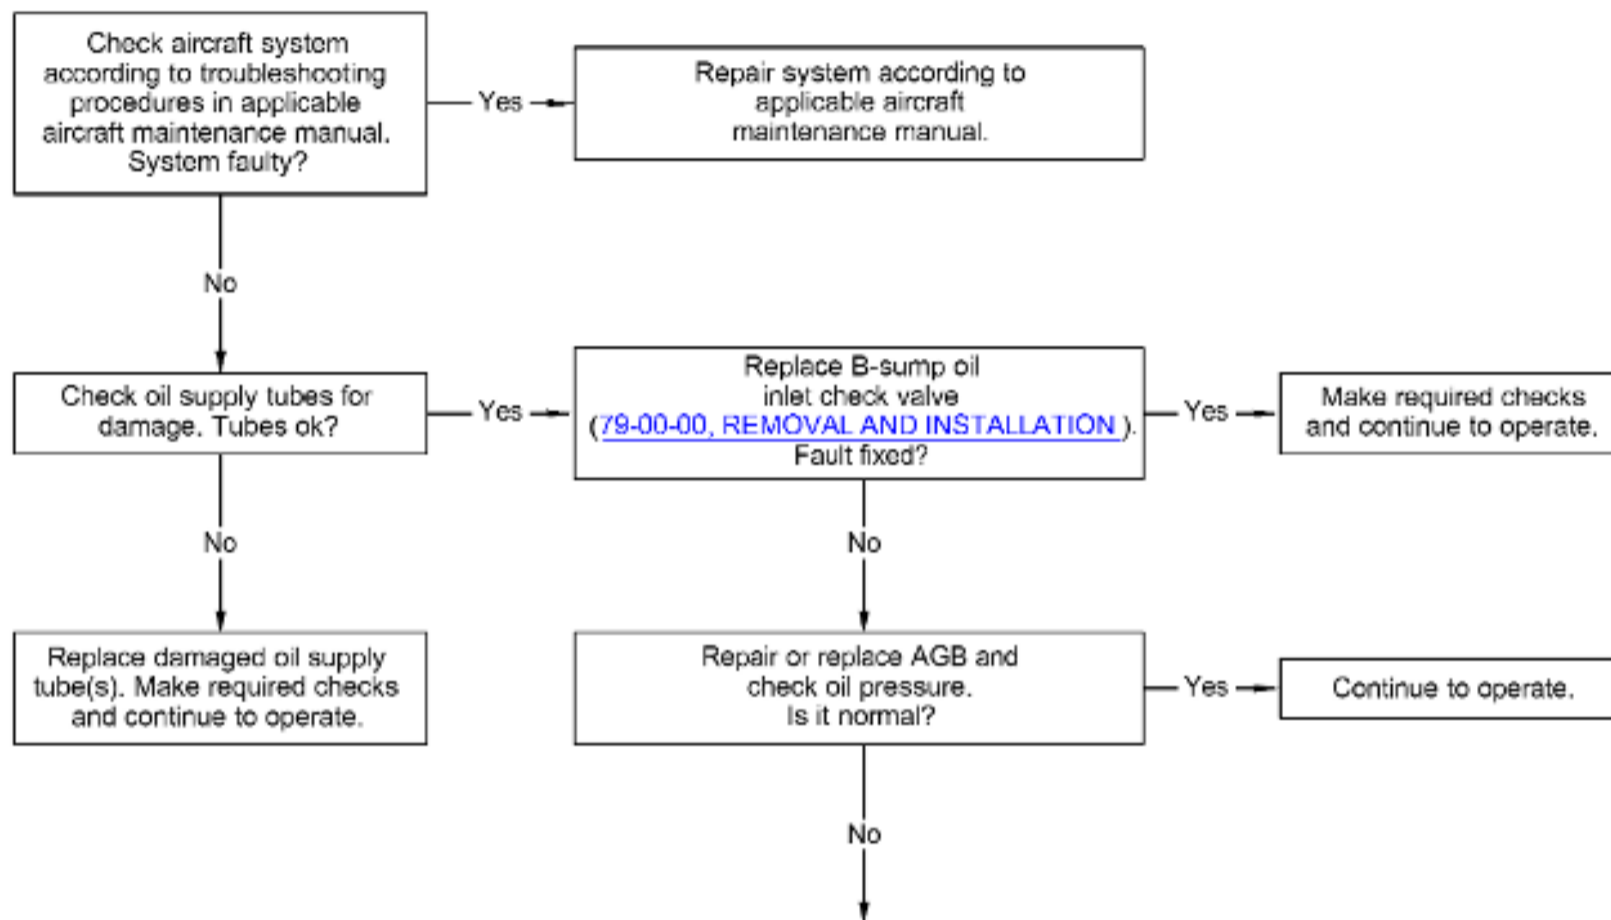
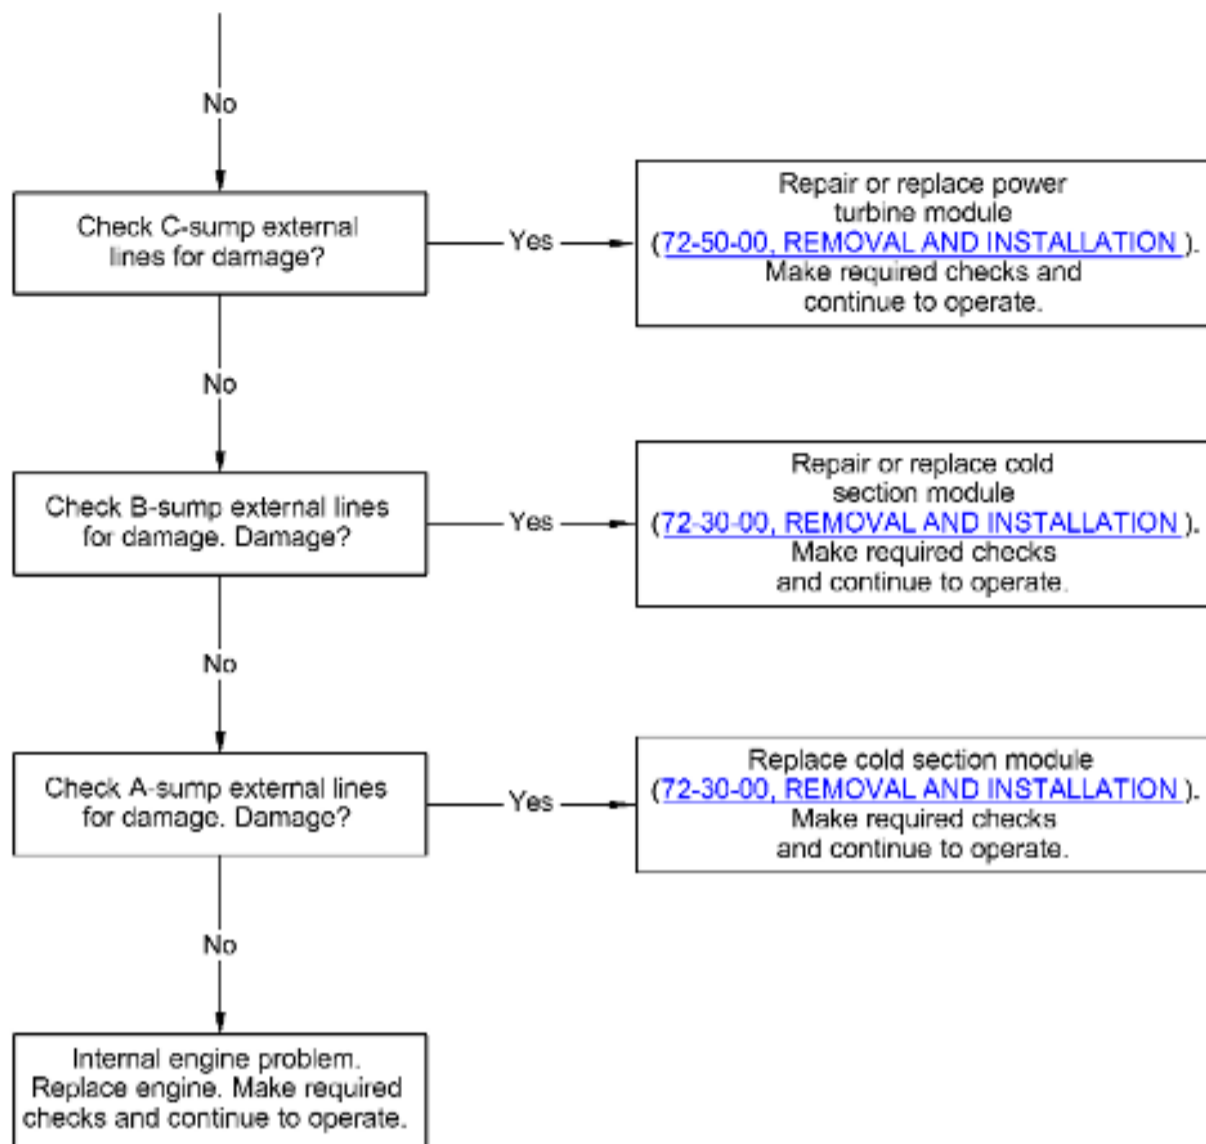
Figure 121 (Sheet 1) High Oil Pressure

- A sudden increase in oil pressure of 10 psig (69kPa) over pressure that is normal for the engine is cause for investigation. It is expected to have an oil spike during cold start. It should return to normal after 5 minutes at idle speed.
- Engine high oil pressure is displayed in the cockpit CWP with X ENG OIL P and MFD with POIL\_HIGH\_MSG when X engine oil pressure is higher 200 psid.
- The oil pressure transducer produces a voltage output proportional to the differential between engine lube pump discharge and B-ump reference pressure. The sensor is mounted on the lube pump drive pad. It is a low-level output device: (100 mV) full scale. The excitation is conditioned 10Vdc provided by the EECU. Continuous remote indications of oil pressure are provided to the aircraft on the Data bus.
