**CT7-2E Maintenance INCREMENTAL CHANGE  
MM 72-00-00, FAULT ISOLATION 002  
NON-FADEC FAULT ISOLATION (CT7-2E1)**

Release Notification Date: 08/08/2024

tk72-00-00-810-810      [Technical Change: Changed the chip detector inspection criteria in Figure 116, Sheet 5.](#)

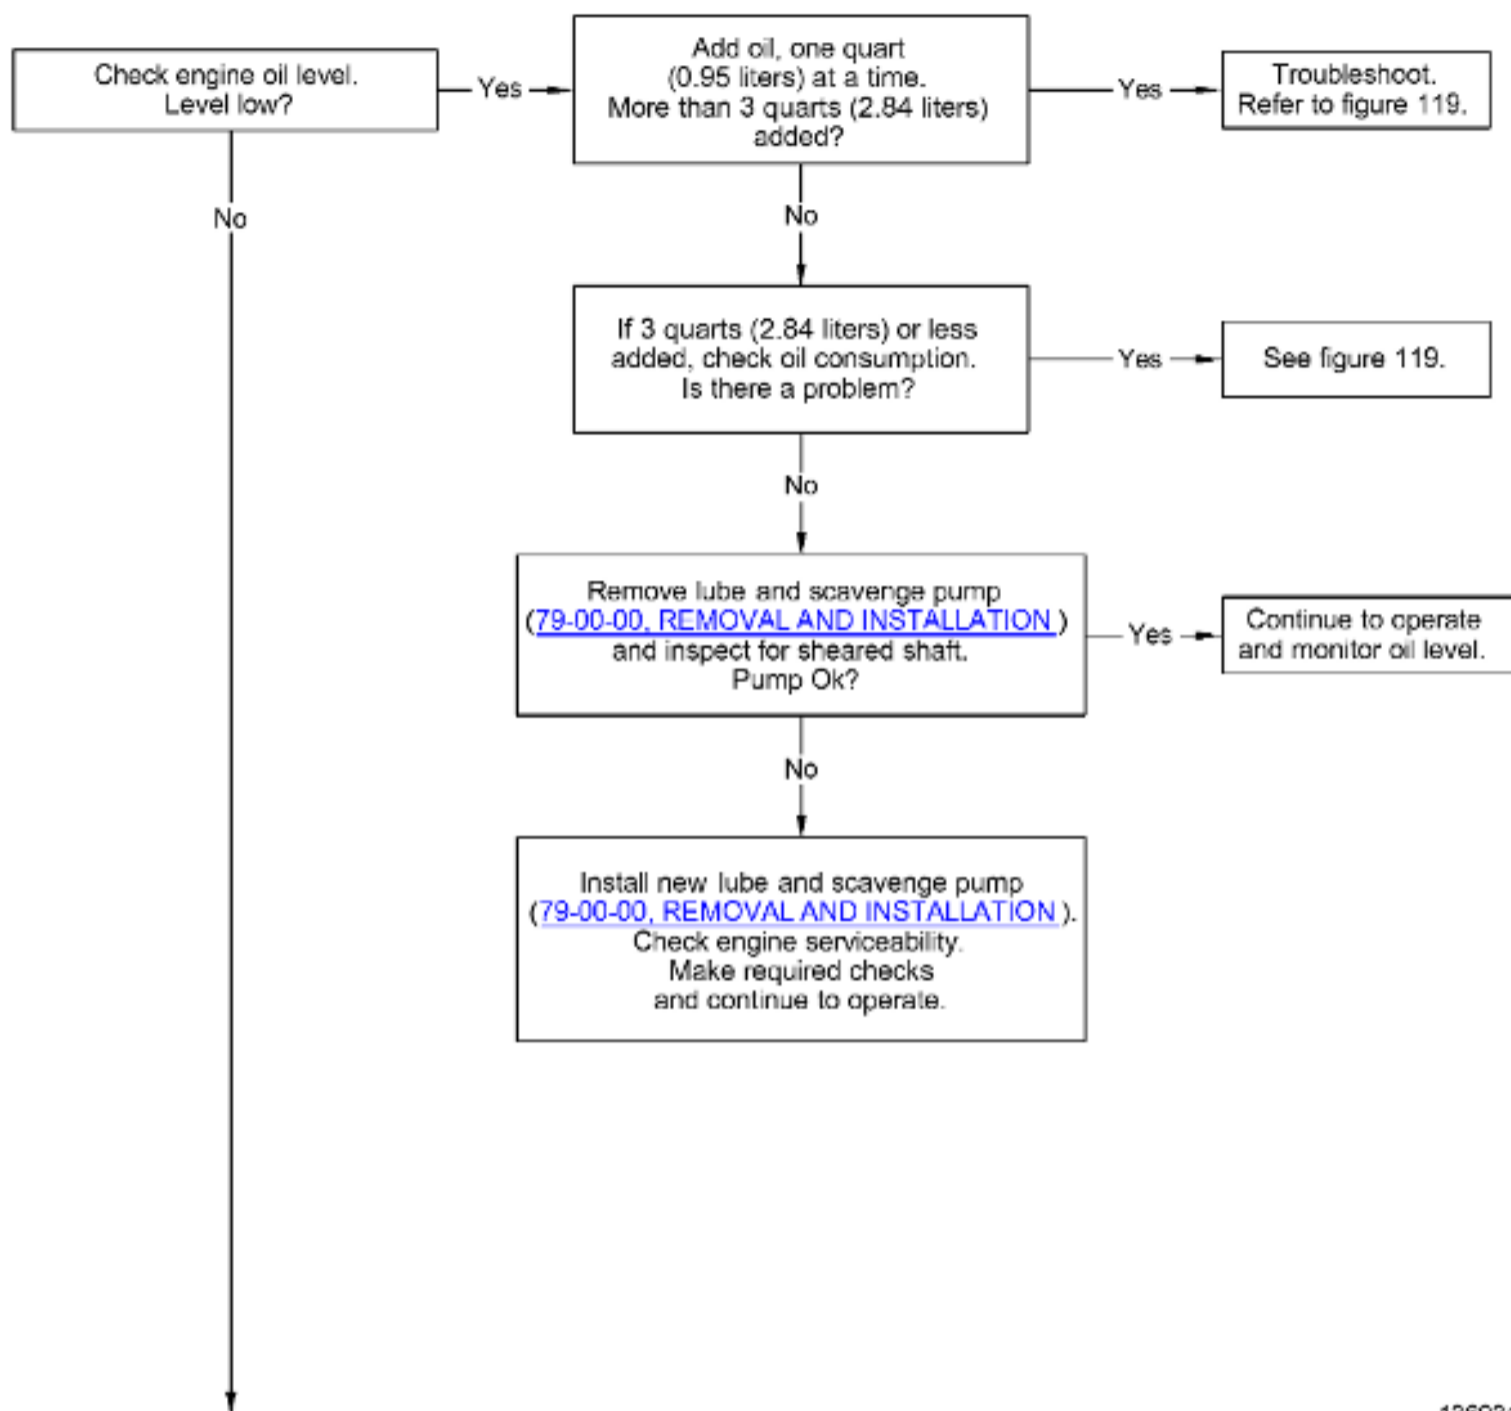
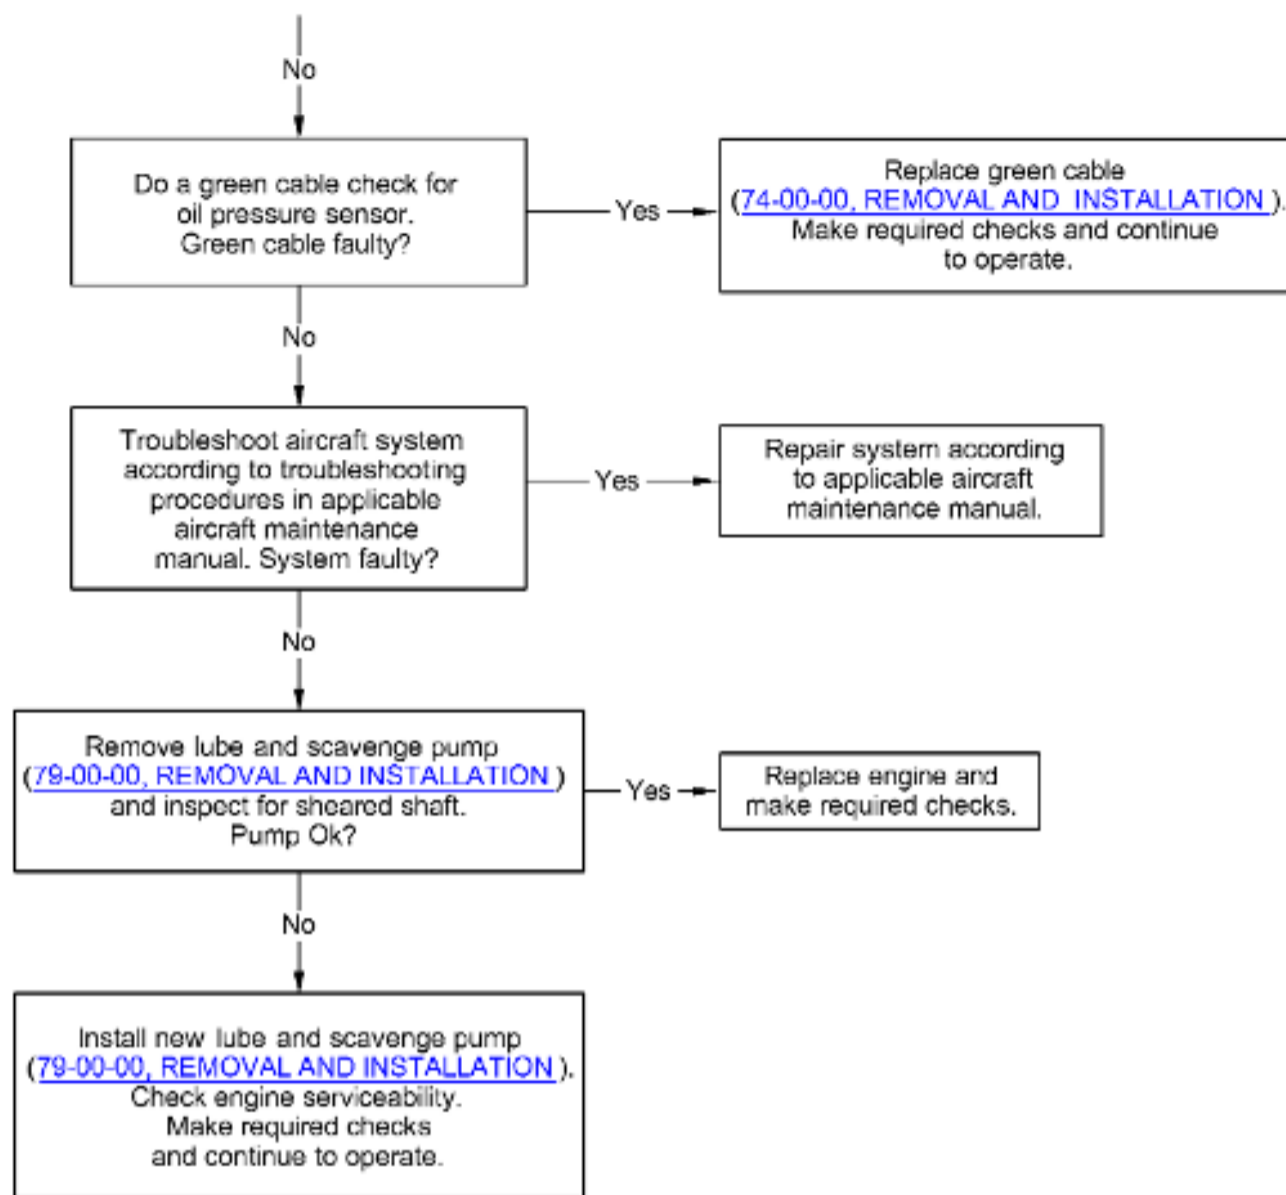
Figure 122 (Sheet 1) No Oil Pressure

**CAUTION**  
 IF ENGINE RUNS FOR MORE THAN 1 MINUTE WITH NO OIL PRESSURE  
 AND IF AIRCRAFT INDICATING SYSTEM IS OK, REPLACE ENGINE.

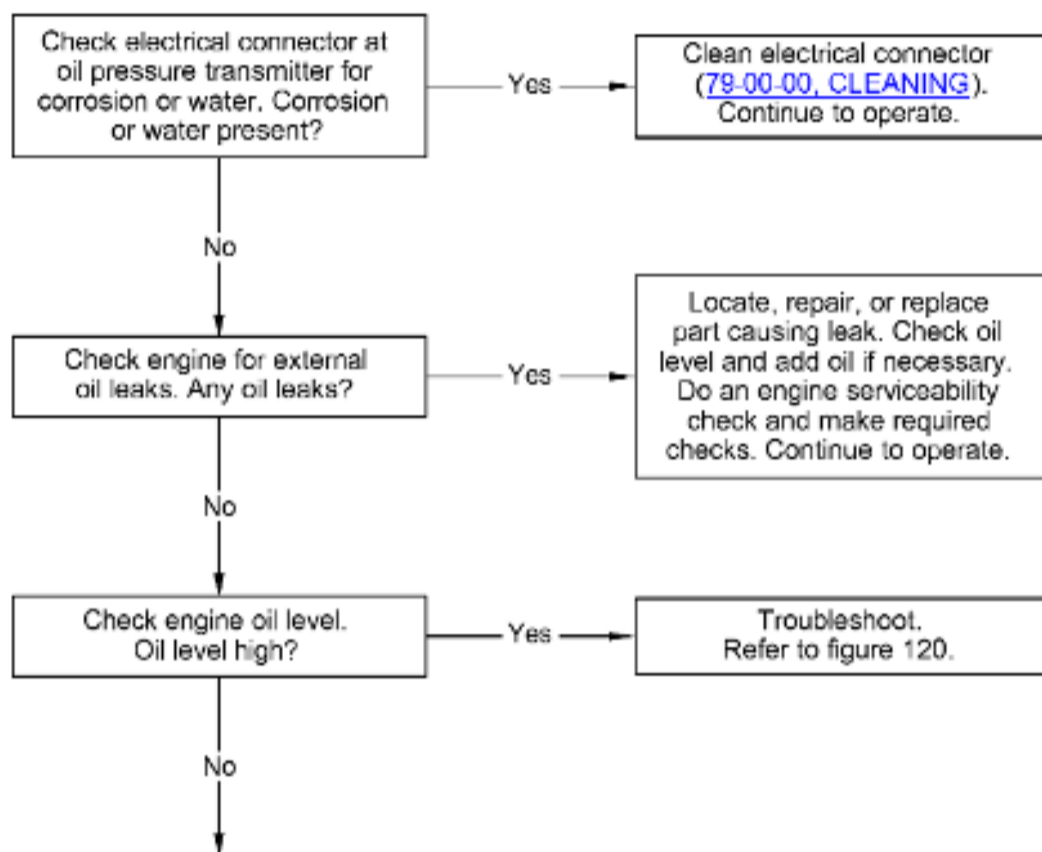
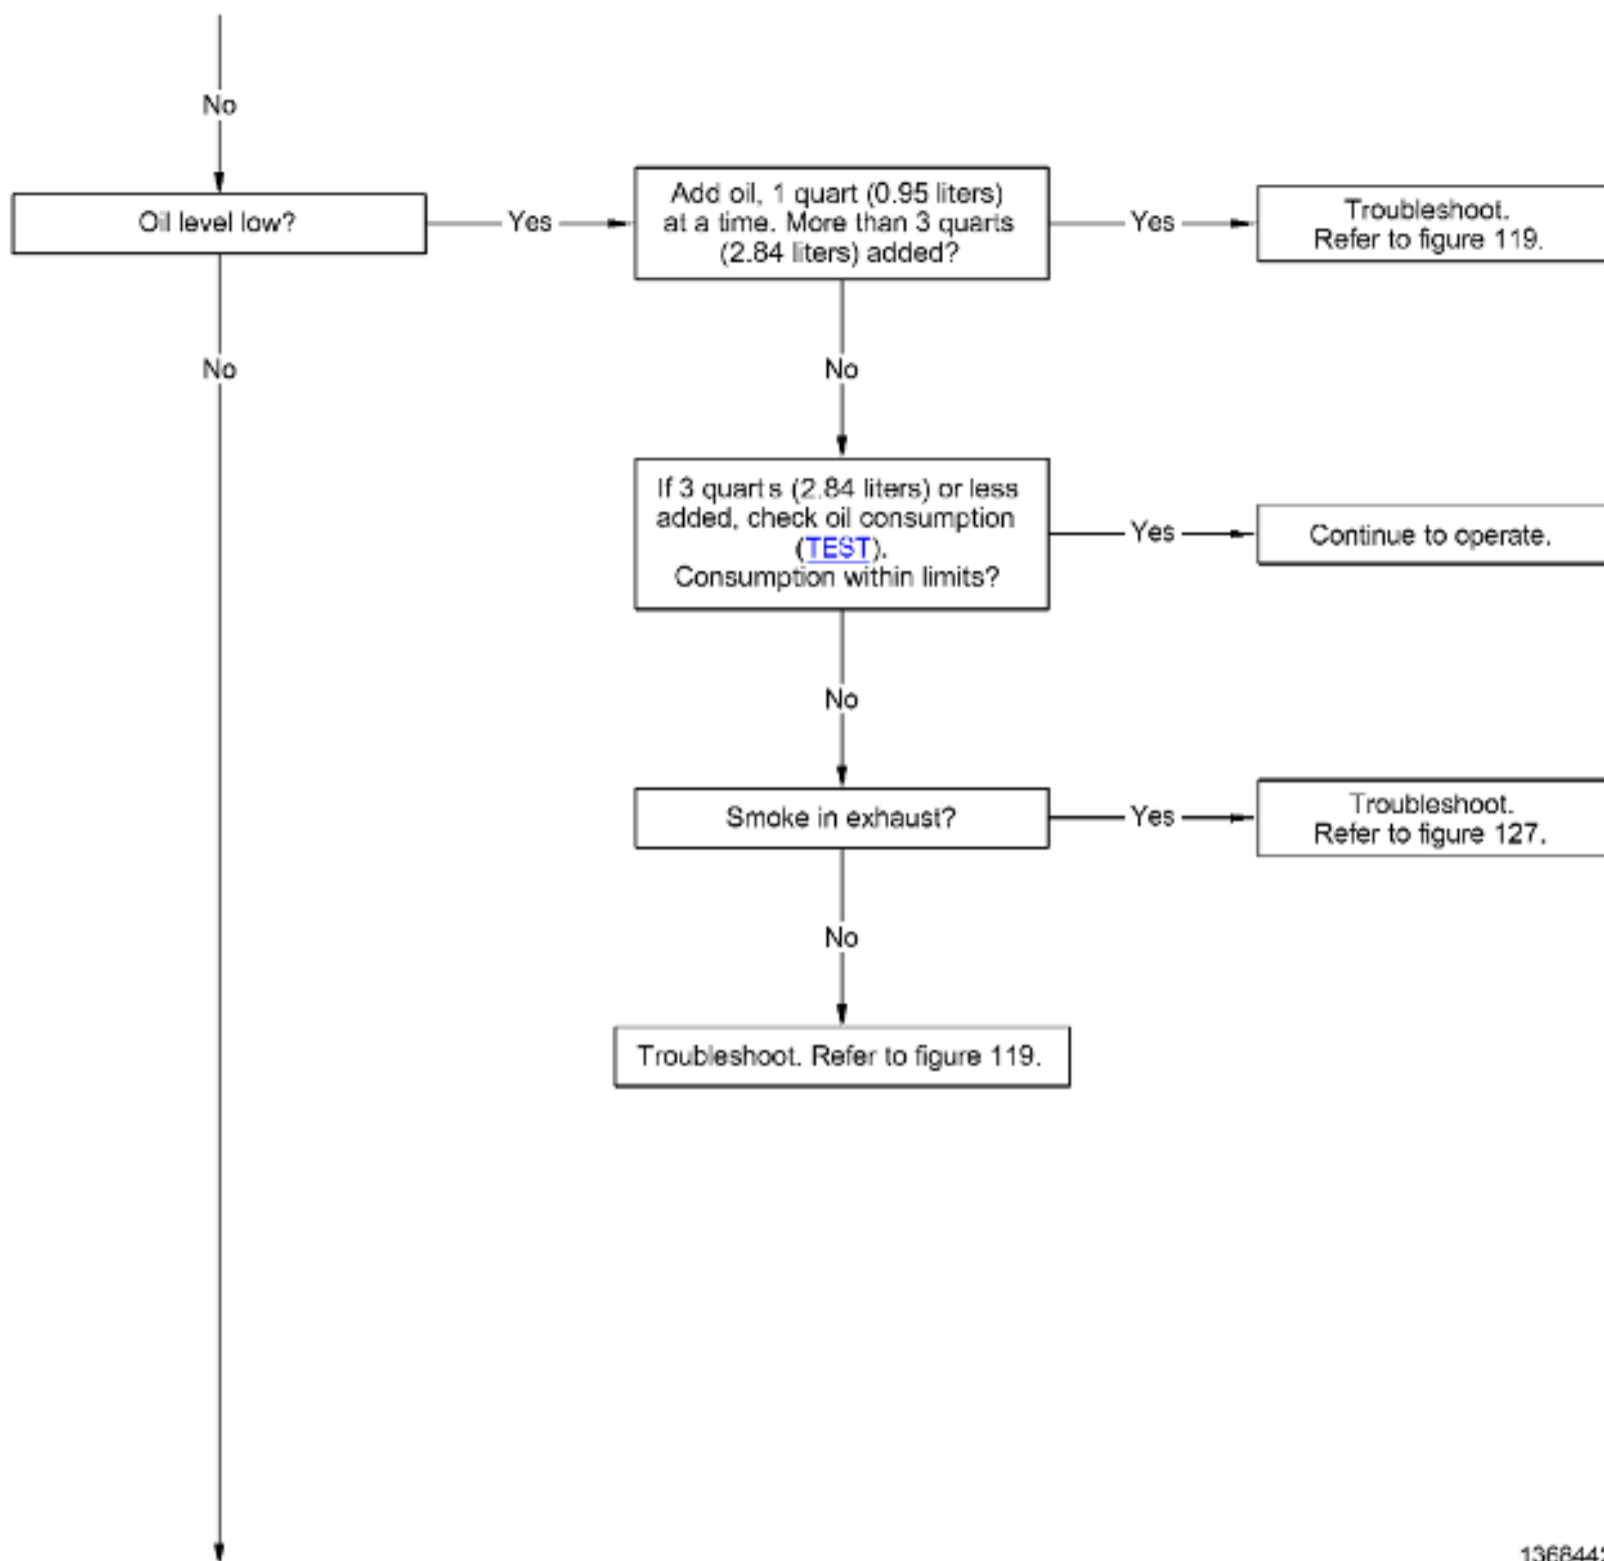
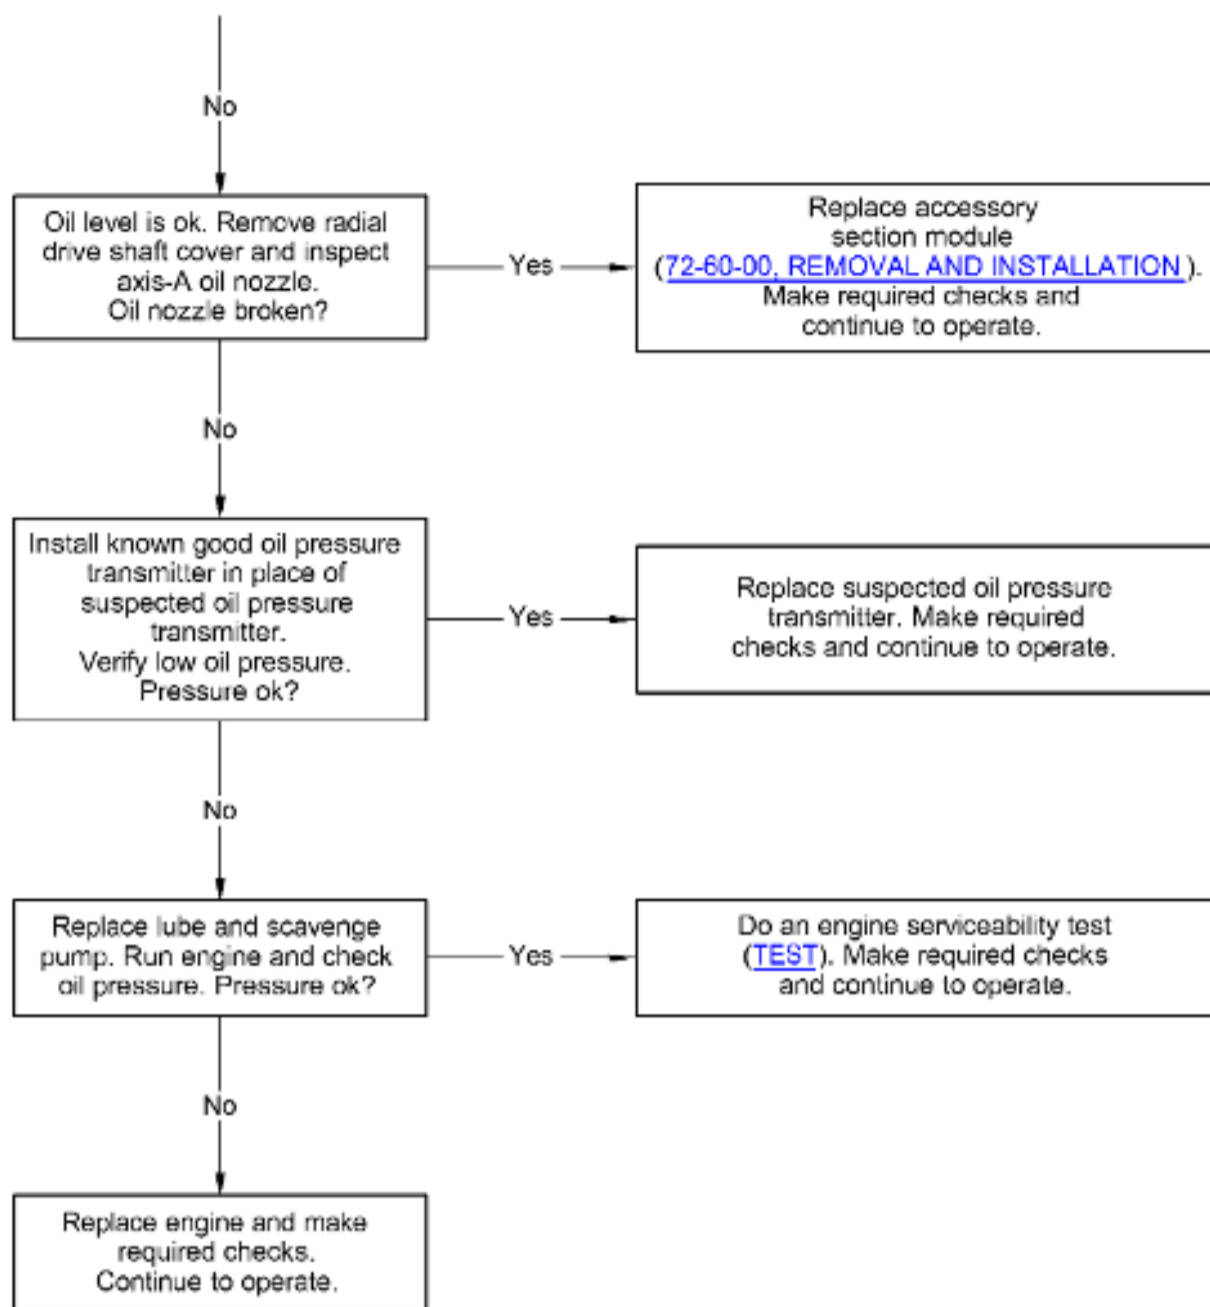
Figure 124 (Sheet 1) Oil Pressure Below Limits

IF ENGINE RUNS MORE THAN 1 MINUTE WITH OIL PRESSURE BELOW MINIMUM, REFER TO (TEST),  
 AND IF AIRCRAFT INDICATING SYSTEM IS OK, REPLACE ENGINE.

Engine oil low pressure is displayed in the cockpit CWP with X ENG OIL P and MFD with ENGX LOW OIL PRESSURE when low oil pressure switch indicating low pressure, including engine shutdown.

The low oil pressure switch is a gearbox-mounted component that senses the differential between engine lube pump discharge and B-sump reference pressure and is activated at 21+/-1 psi d. The switch assembly incorporates an integral relief valve, which actuates under cold oil conditions to limit maximum positive oil pressure. The oil pressure transducer produces a voltage output proportional to the differential between engine lube pump discharge and B-sump reference pressure. The sensor is mounted on the lube pump drive pad. It is a low-level output device: (100 mV) full scale. The excitation is conditioned 10Vdc provided by the EECU. Continuous remote indications of oil pressure are provided to the aircraft on the Data bus. Cross checking between the oil pressure switch and the oil pressure transducer serves to distinguish transducer failure from actual low-pressure events. The oil pressure switch and transducer are wired to different EECU channels and therefore can continue to provide a low lube pressure signal after any single failure.

A change of  $\pm 5$  psig ( $\pm 34$  kPa) is cause for investigation. Oil pressure will change during transient conditions. These changes should stop about 1 minute after to return to steady state Ng conditions.

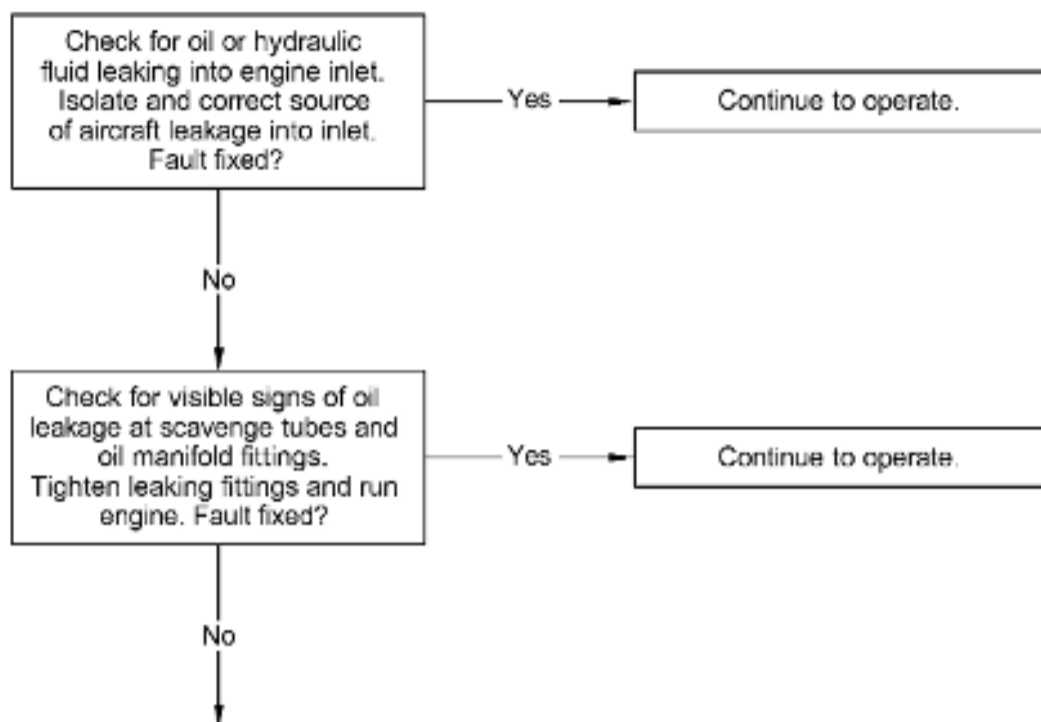
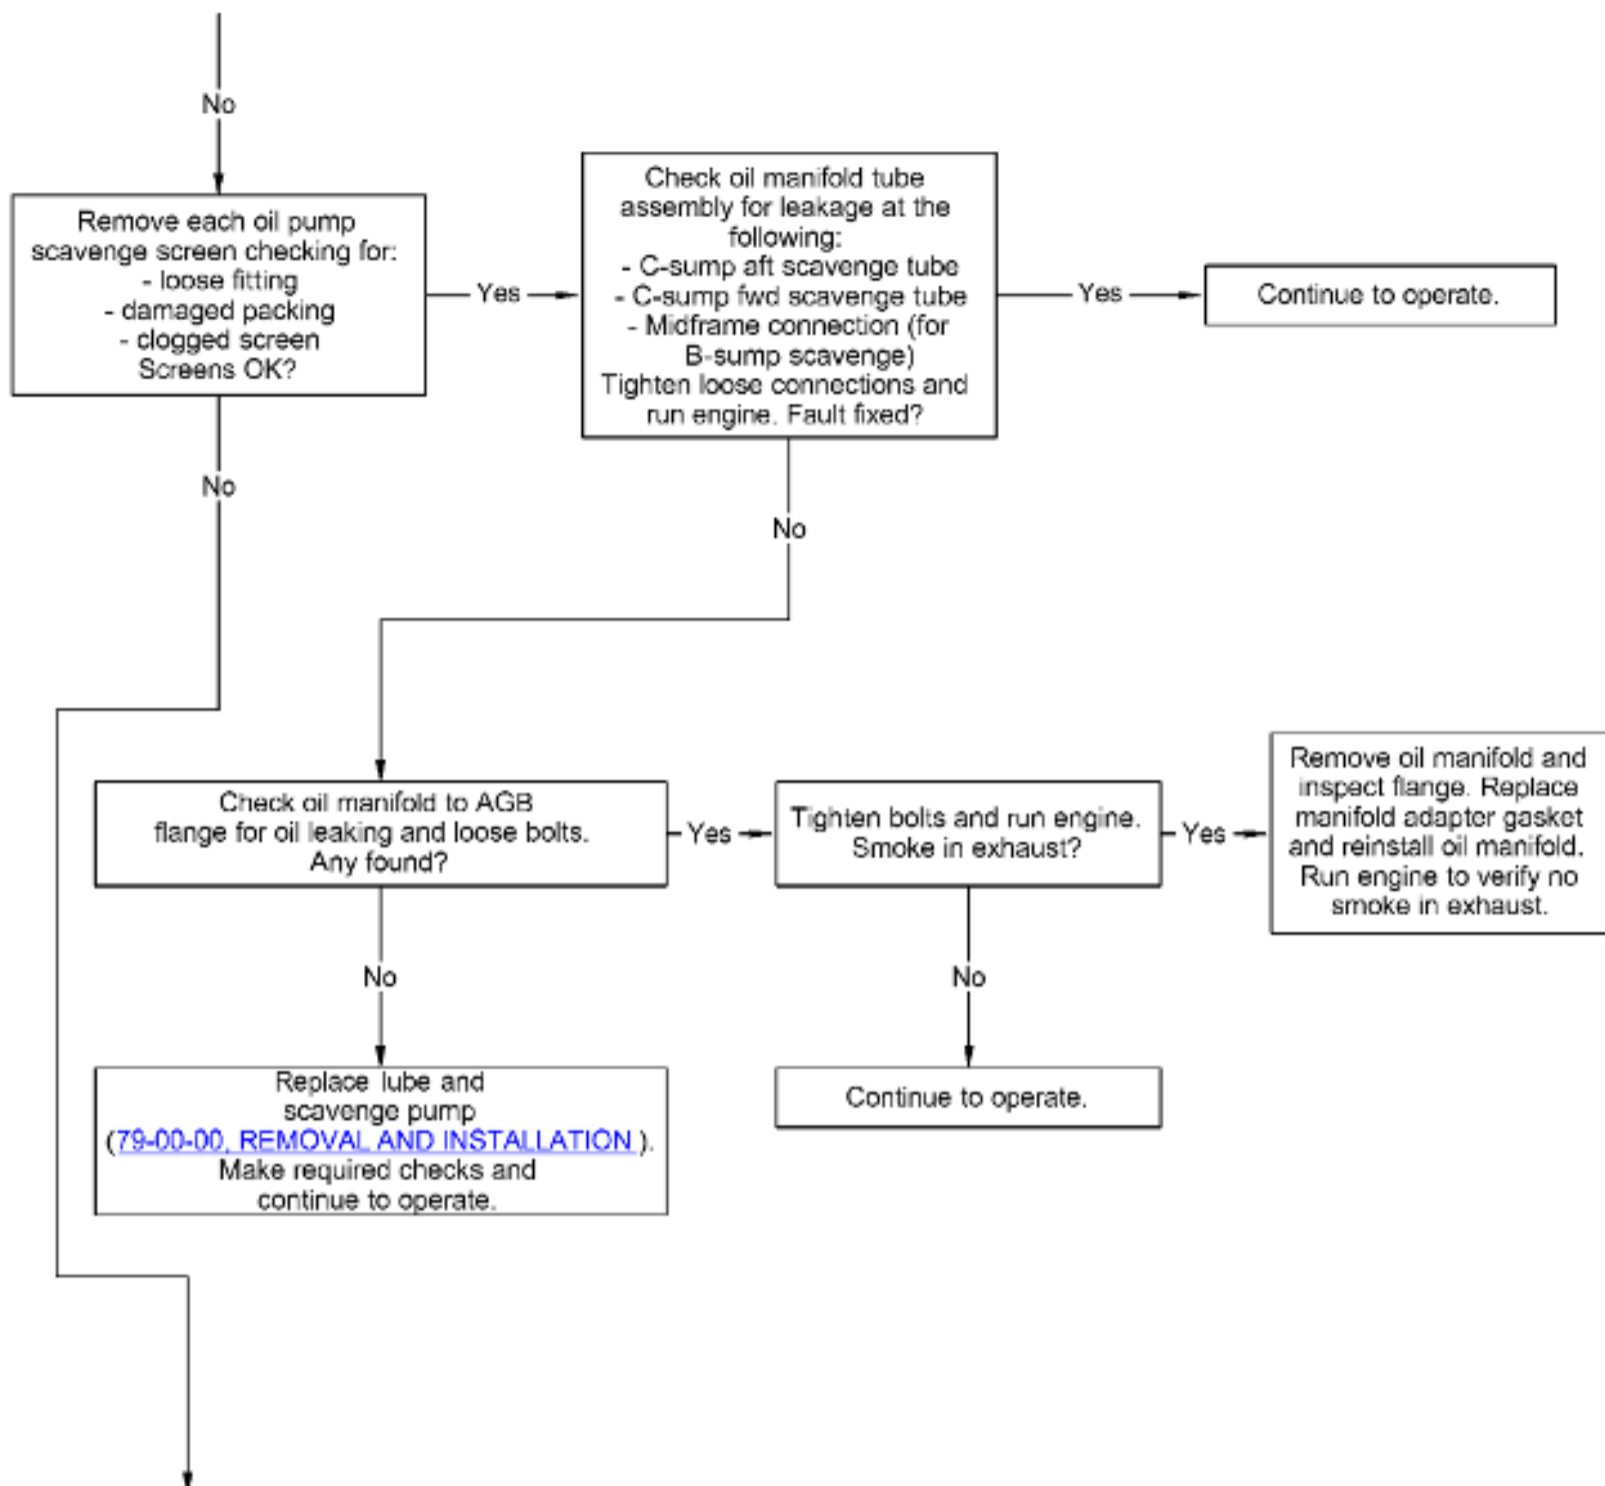
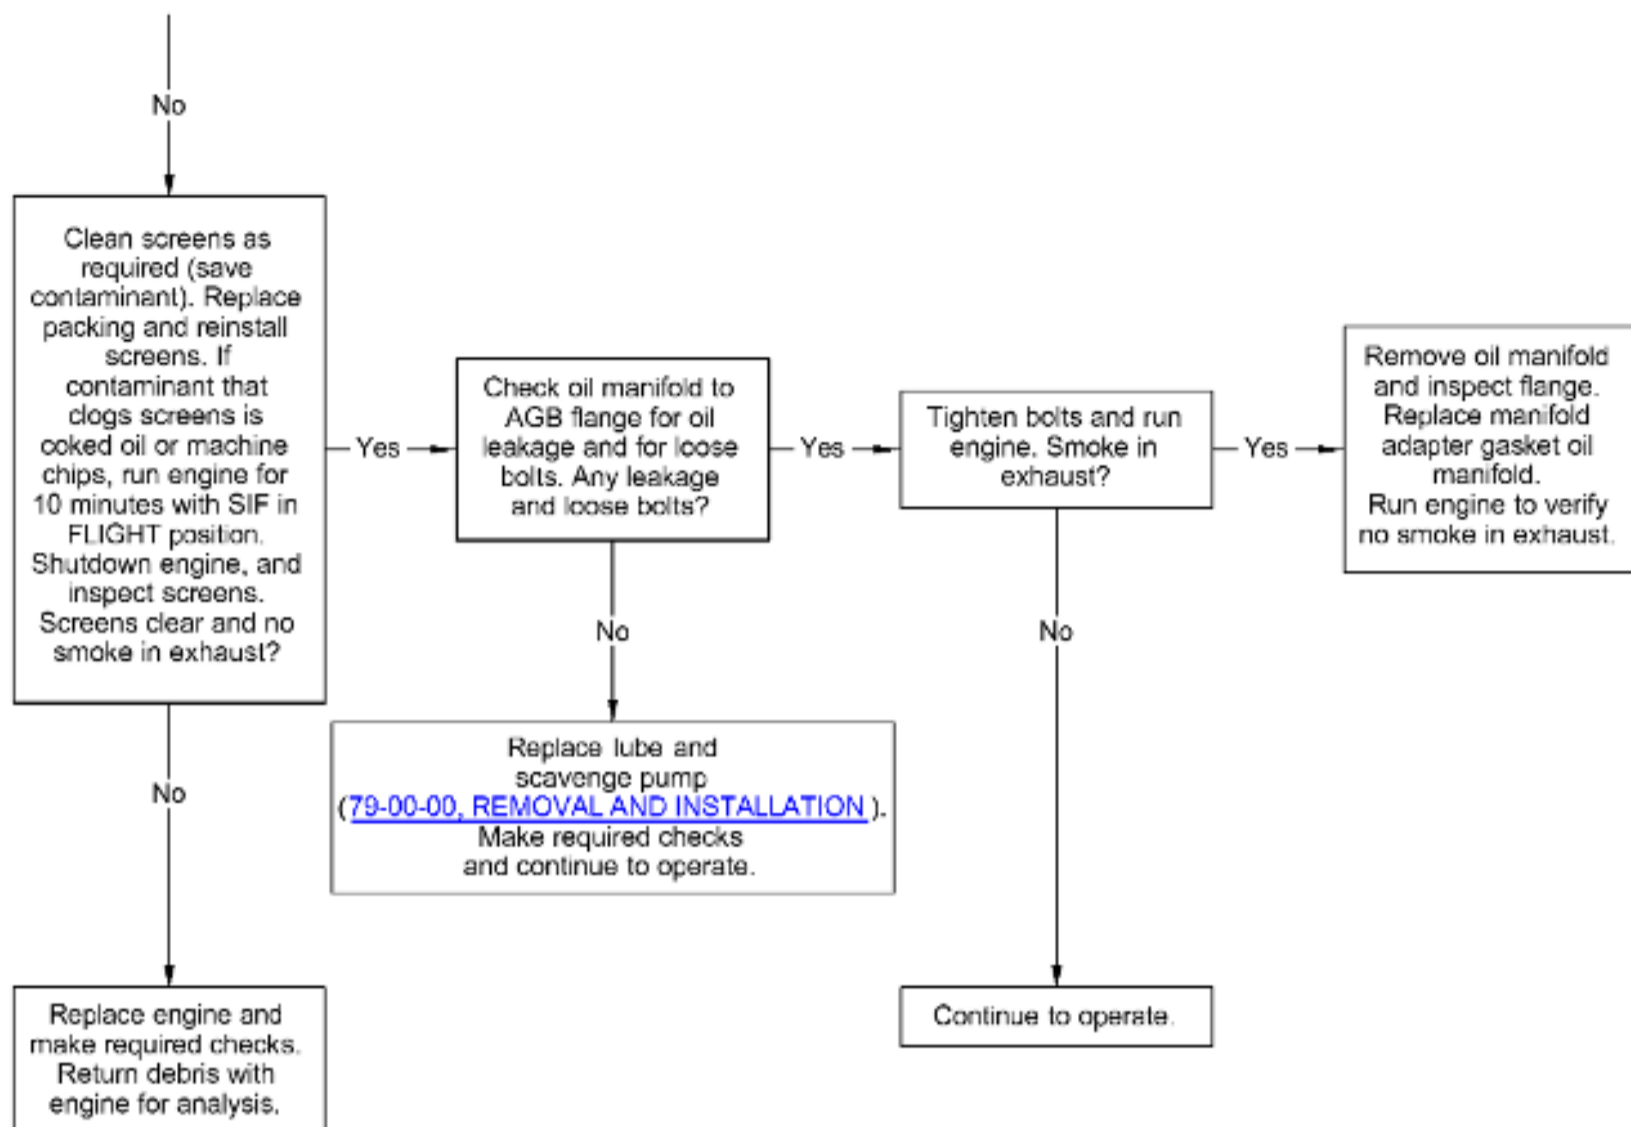
Figure 127 (Sheet 1) Smoke in Exhaust

White mist coming out of tailpipe before engine light off is fuel mist.  
Smoke may be visible during the start cycle, especially at low ambient temperatures.  
During locked rotor operation, exhaust smoke may be present.

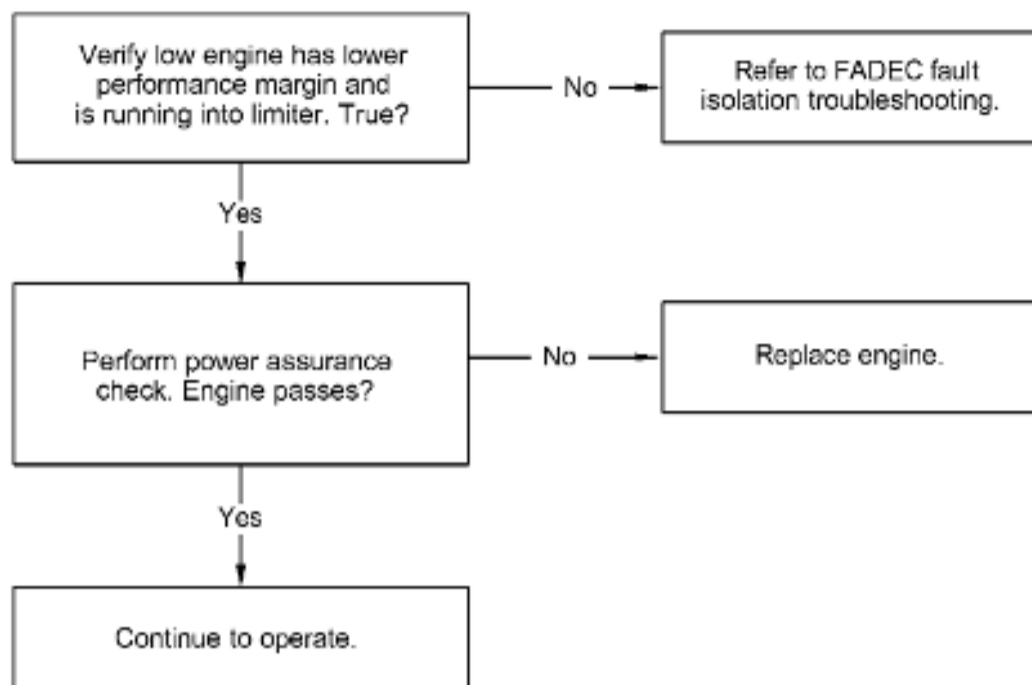
Figure 129 Torque Split

For engines that show >5% torque difference while running on torque load share.

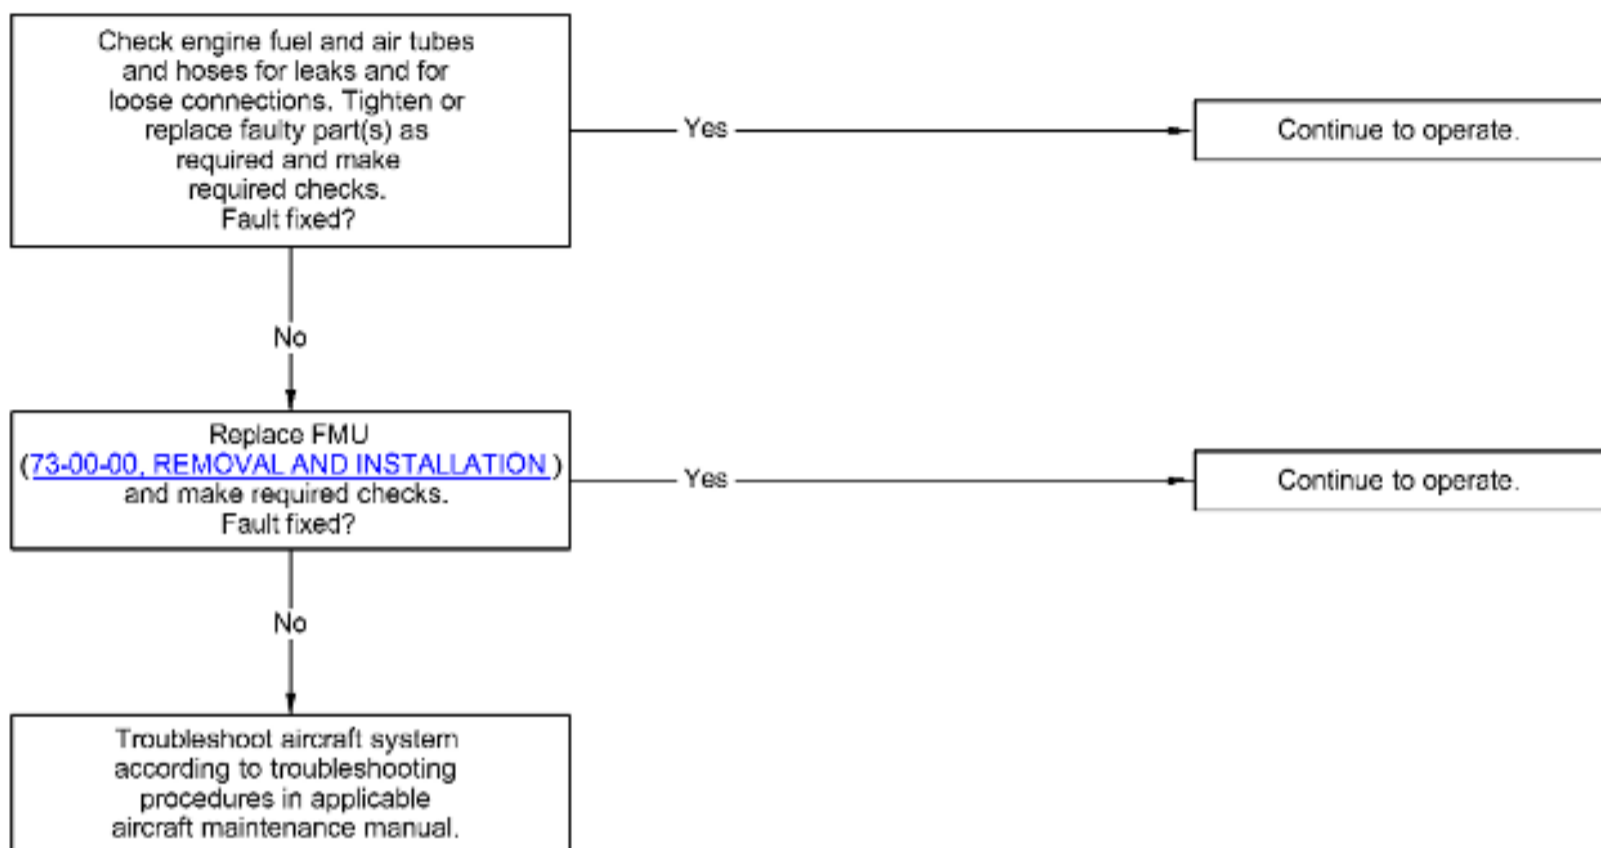
Figure 130 Unstable Operation at Flight on Ground (Ng, TGT, Torque and Np Fluctuate Greater Than 5% With Engine at Flight)

**NOTE**  
 If fuel filter impending bypass light is on, refer to figure 115. If aircraft fuel inlet pressure is low, refer to aircraft system and applicable aircraft maintenance manual.
