SERVICE BULLETIN

N° **139-783**

ATA 32 – MLG SHOCK ABSORBER INSPECTION

INSPECTION OF SHOCK ABSORBER PISTON ROD EYE END

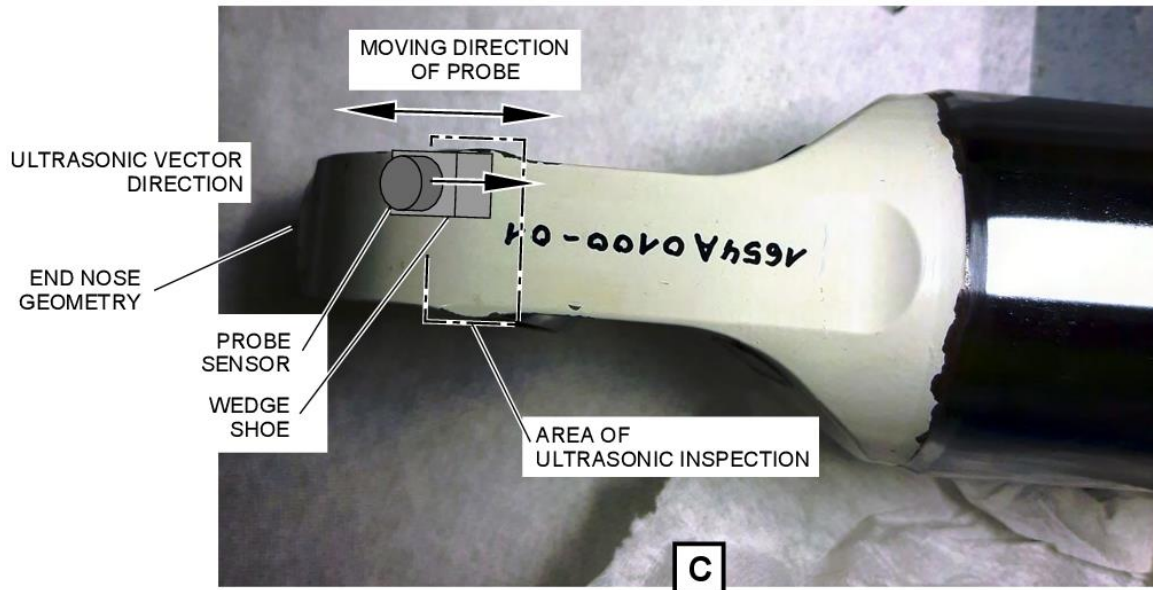
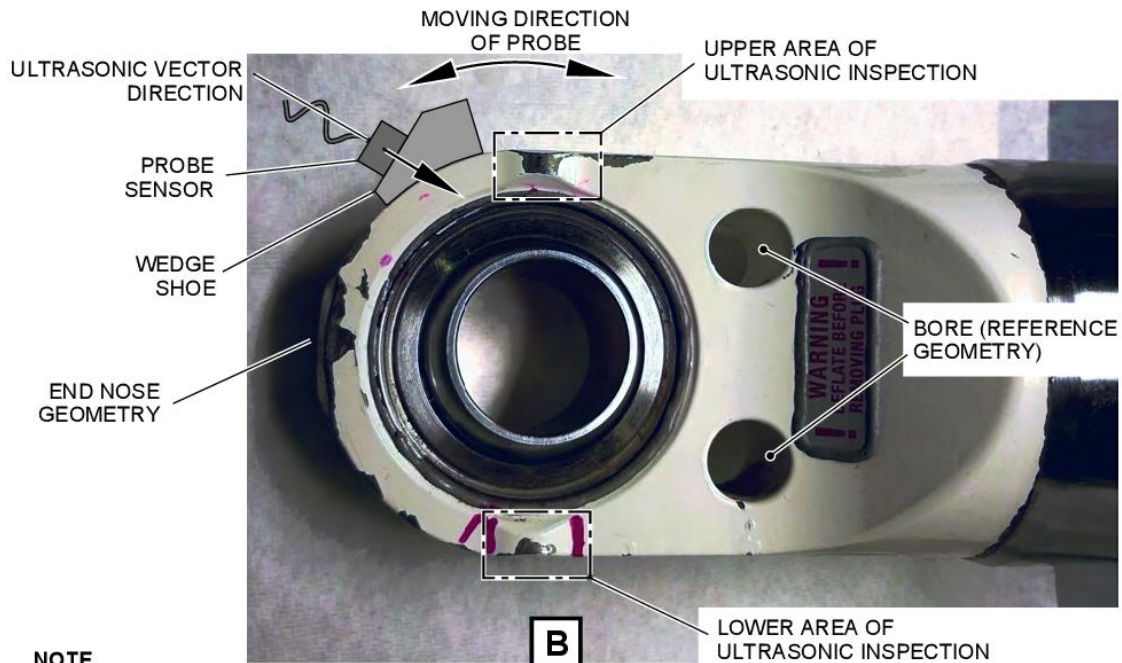
Ultrasonic inspection of the piston rod eye end shall be performed in the installed condition. Picture above show the piston rod separated from the landing gear for clarification of the accomplishment procedure only.
