WORKSHEET

SERVICE ORDER : 9 0 0 2 5 5 6 6 WORKSHEET NUMBER : 2022/31763/007-14

AIRCRAFT REGISTRATION : 9M-BGH		AIRCRAFT SERIAL NUMBER : 31763		AIRFRAME HOURS : 300:40		LANDINGS : 838	
#1 ENGINE SERIAL NO.: PCE-KB1931	#1 ENGINE HOURS : 300:40	#2 ENGINE SERIAL NO.: PCE-KB1885	#2 ENGINE HOURS : 300:40	APU SERIAL NO.: N/A		APU HOURS : N/A	
CRITICAL MAINTENANCE TASK REQUIREMENT				YES	NO	RAISED BY : SYAQIRA	RAISED DATE : 17-11-2022

TITLE**ATA 25 – LIFERAFT RESERVOIR INSPECTION AND REPLACEMENT****REVISION LOG**

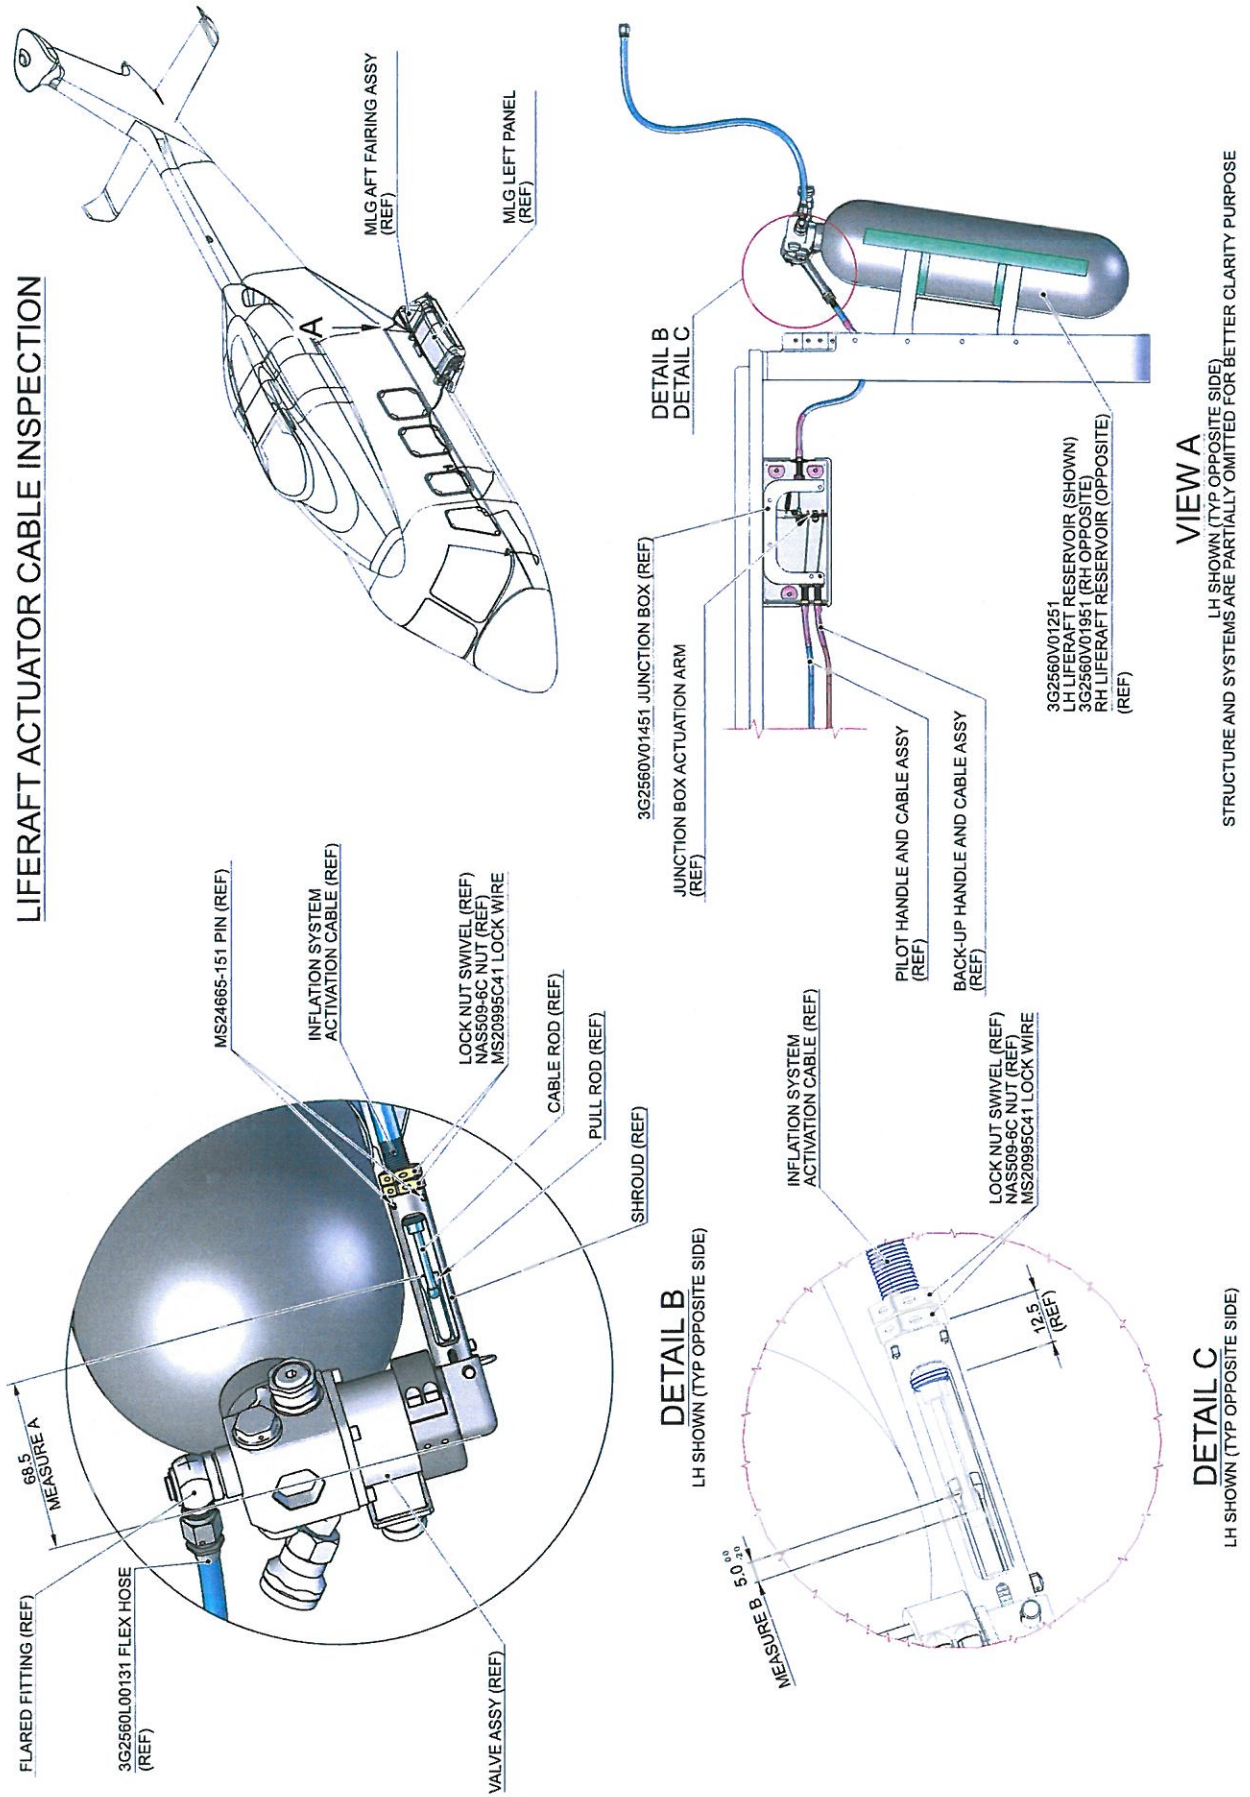
LIFERAFT ACTUATOR CABLE INSPECTION

1. In accordance with AMP DM 39-A-00-20-00-00A-120A-A, prepare the helicopter on ground for a safe maintenance, if required. Disconnect the battery, all electrical power sources and/or the external power supply.
2. In accordance with AMP DM 39-A-06-41-00-00A-010A-A and with reference to Figure 1, gain access to the affected area.
3. With reference to Figure 1 Detail B, disconnect the flex hose P/N 3G2560L00131 from the bottle valve.
4. With reference to Figure 2 Detail A, install the diffuser cap P/N 601.2382.
5. With reference to Figures 1 and 2, perform the valve pull rod inspection as described in the following procedure:
 - 5.1 With reference to Figure 1 Detail B and Figure 2 Detail B, perform the measurement of the actuation cable between the face of the pull rod and the back of the valve cap and compare it with the maximum allowed of 68.5 mm (see measure A).

1. In accordance with AMP DM 39-A-00-20-00-00A-120A-A, prepare the helicopter on ground for a safe maintenance, if required. Disconnect the battery, all electrical power sources and/or the external power supply.
2. In accordance with AMP DM 39-A-06-41-00-00A-010A-A and with reference to Figure 1, gain access to the affected area.

3. With reference to Figure 1 Detail B, disconnect the flex hose P/N 3G2560L00131 from the bottle valve.
4. With reference to Figure 2 Detail A, install the diffuser cap P/N 601.2382.

5. With reference to Figure 1, perform the life raft actuator cable inspection as described in the following procedure:
 - 5.1 With reference to Figure 1 View A and Detail C, with the junction box actuation arm in its rest position (90° with respect to the helicopter longitudinal axis), verify the presence of a $5.0^{+0.0}_{-2.0}$ mm clearance between the sphere at the end of the cable and the activation system in accordance with the measurement range shown (see measure B).

7. With reference to Figure 1 Detail B, connect the flex hose P/N 3G2560L00131 to the bottle valve. Tighten the nut of the hose to the standard torque value.

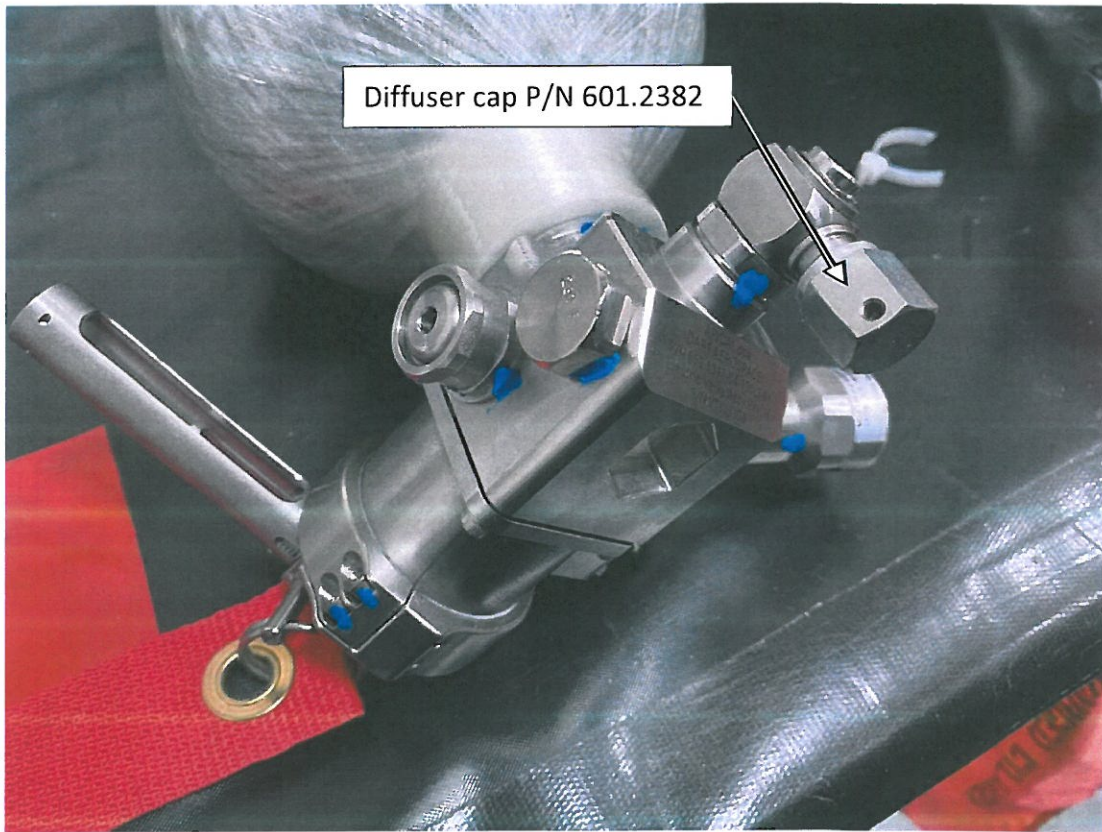
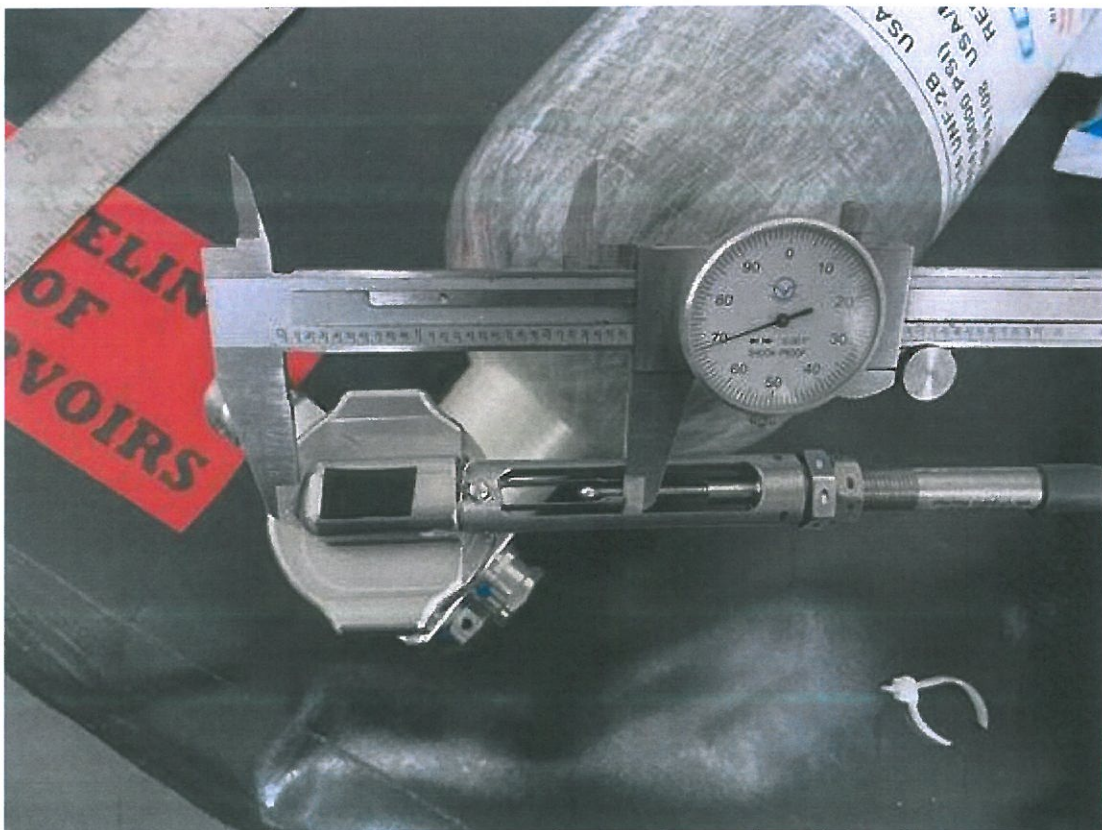
DETAIL A

DETAIL B

6. With reference to Figure 2 Detail A remove the diffuser cap P/N 601.2382 from the bottle valve.
7. With reference to Figure 1 Detail B, connect the flex hose P/N 3G2560L00131 to the bottle

- 5.2 If the measurement value exceeds the allowed limit, perform the life raft activation cable adjustment in accordance with Annex A.
6. With reference to Figure 2 Detail A, remove the diffuser cap P/N 601.2382 from the valve.

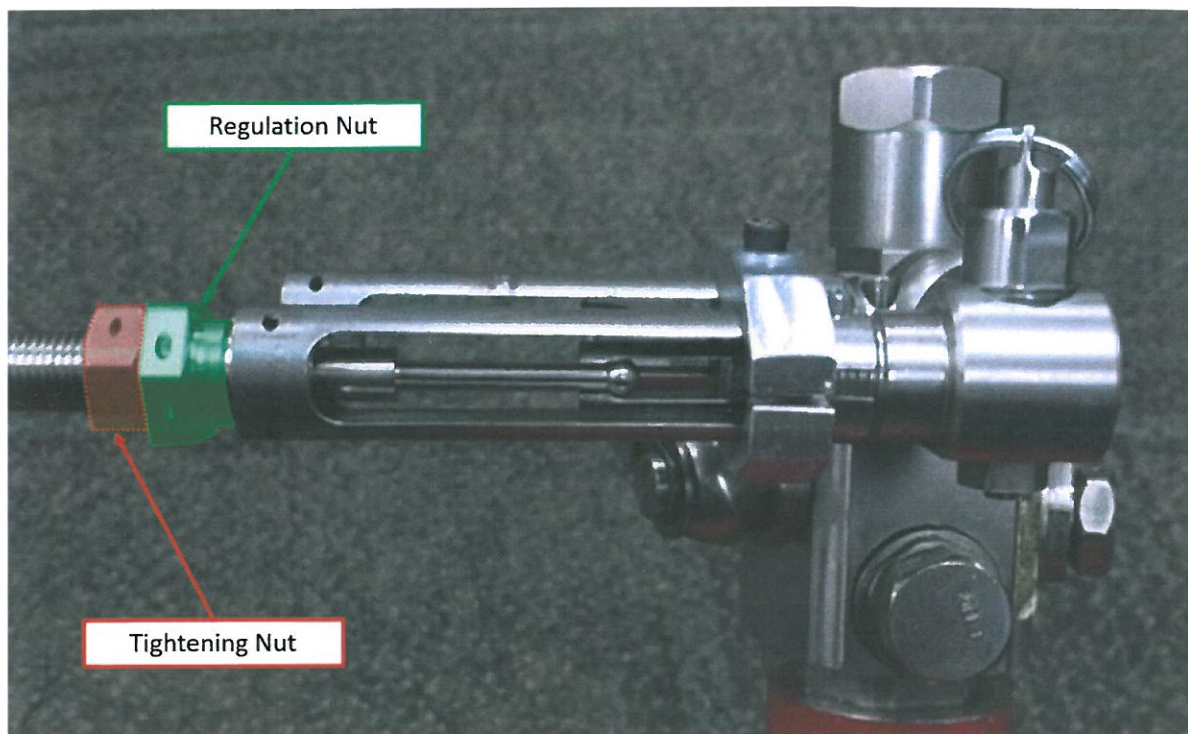
Figure A1 – Activation cable zone

1 END OF ACTIVATION CABLE ZONE LOCK NUTS

- 1.1 Unscrew the 9/16" tightening nut.
- 1.2 Adjust the cable length acting on the 5/8" regulation nut.
 - TO INCREASE THE GAP: unscrew the regulation nut;
 - TO DECREASE THE GAP: screw the regulation nut.
- 1.3 Screw the 9/16" tightening nut in order to block the regulation nut.

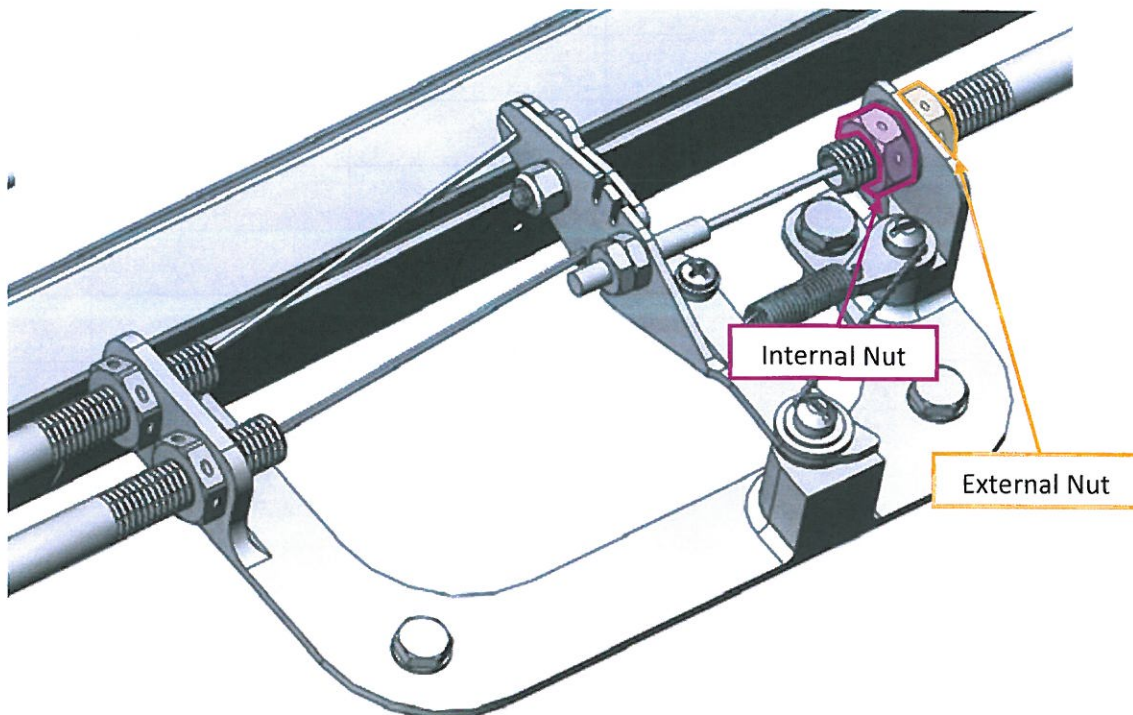
Figure A2 – Junction box zone

2 JUNCTION BOX ZONE LOCK NUTS

2.3 Once the correct gap is achieved, make sure that both the internal and the external nuts are in contact with the structure and tightened at the standard torque value.

2.4 Safety the external nut and the internal nut with stainless steel (302/304) medium strong safety wire.

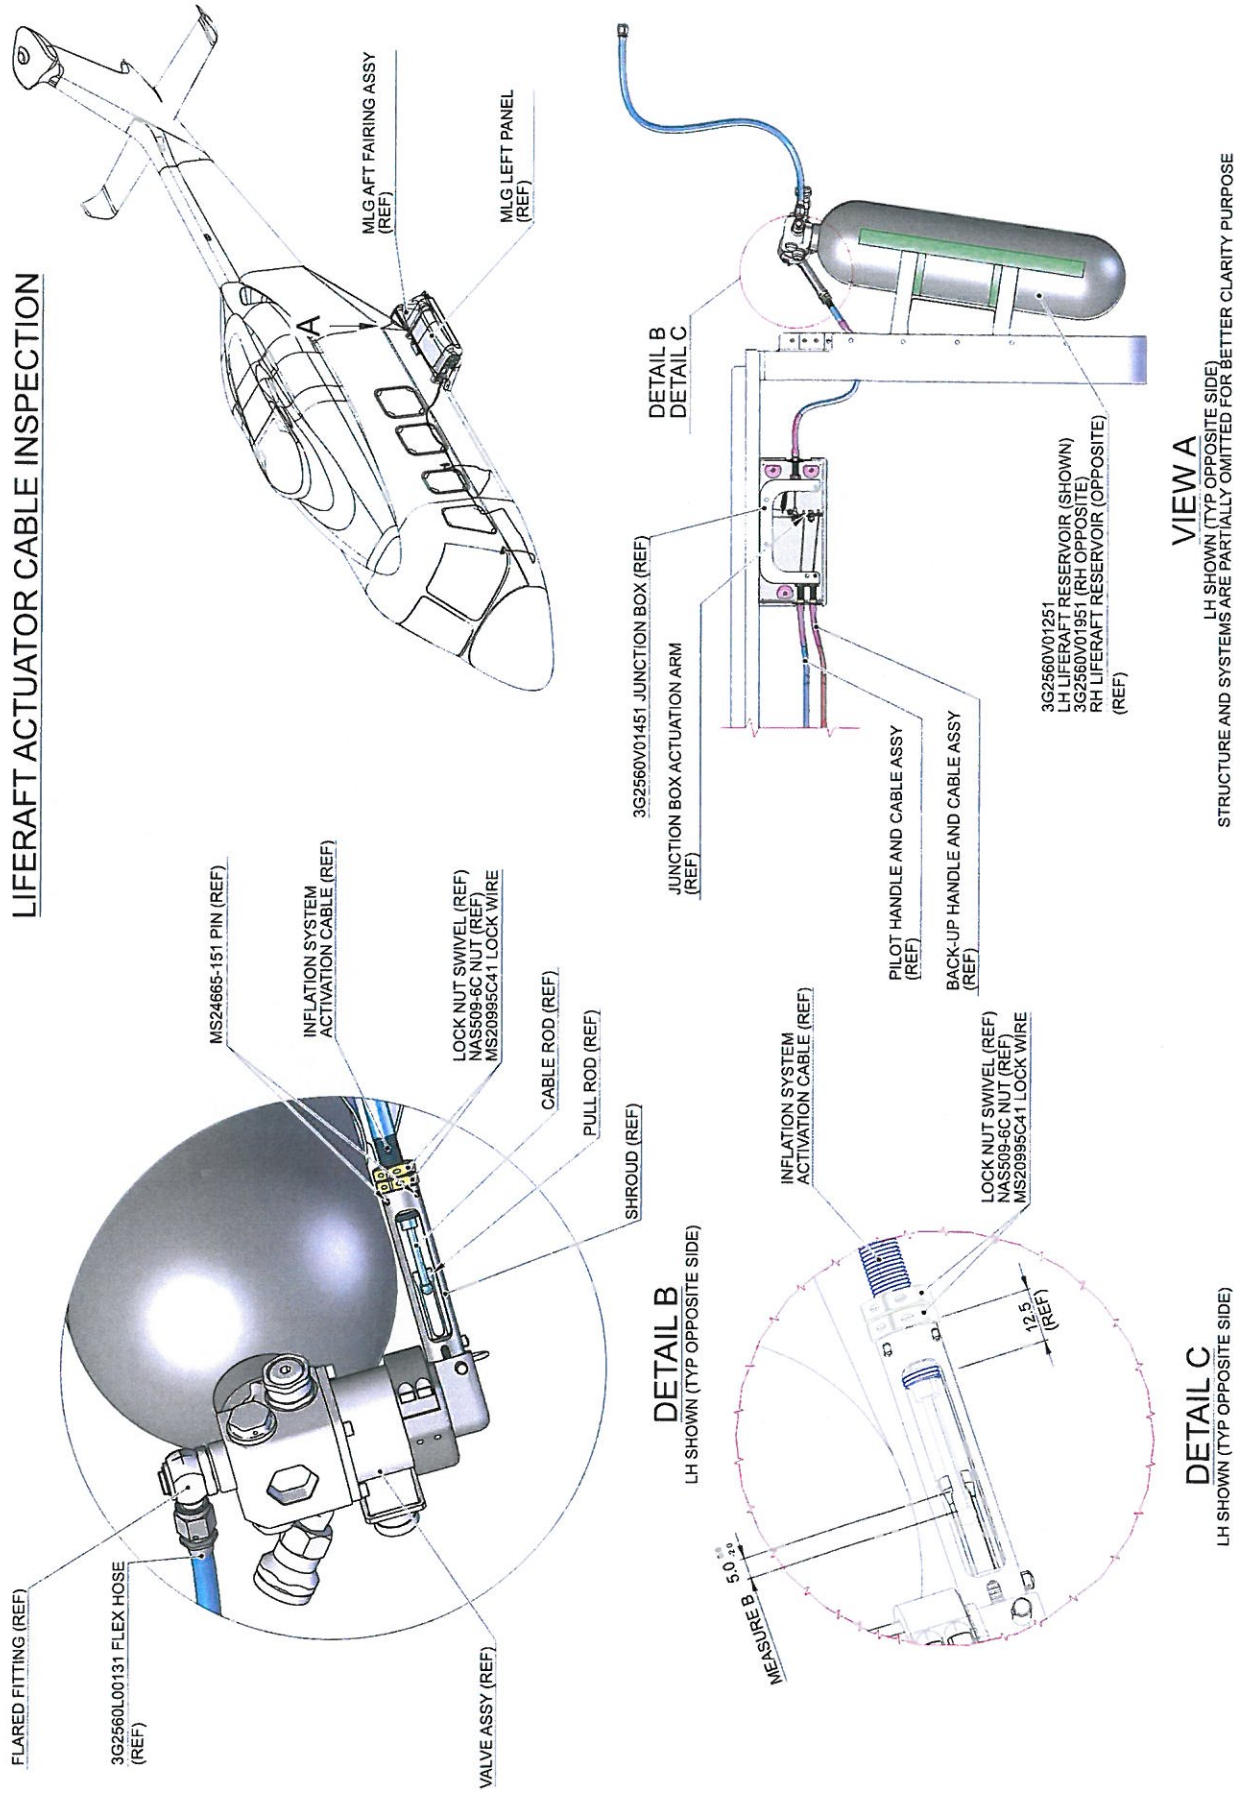
LIFERAFT ACTUATOR CABLE INSPECTION

3. Install a serviceable LH/RH life raft reservoir P/N 3G2560V01251/3G2560V01951 to replace the part removed at previous step 2, in accordance with the relevant AMP DM:
 - 39-E-25-62-01-00A-720A-K - Left bottle assembly - Install procedure;
 - 39-E-25-62-02-00A-720A-K - Right bottle assembly - Install procedure.
4. Perform the life raft actuator cable inspection in accordance with the following procedure:
 - 4.1 With reference to Figure 1 Detail B, disconnect the flex hose P/N 3G2560L00131 from the bottle valve.
 - 4.2 With reference to Figure 2, install the diffuser cap P/N 601.2382.
 - 4.3 With reference to Figure 1, perform the life raft actuator cable inspection as described in the following procedure:

- 4.3.1 With reference to Figure 1 View A and Detail C, with the junction box actuation arm in its rest position (90° with respect to the helicopter longitudinal axis), verify the presence of a $5.0^{+0.0}_{-2.0}$ mm clearance between the sphere at the end of the cable and the activation system in accordance with the measurement range shown (see measure B).

- 4.5 With reference to Figure 1 Detail B, connect the flex hose P/N 3G2560L00131 to the bottle valve. Tighten the nut of the hose to the standard torque value.

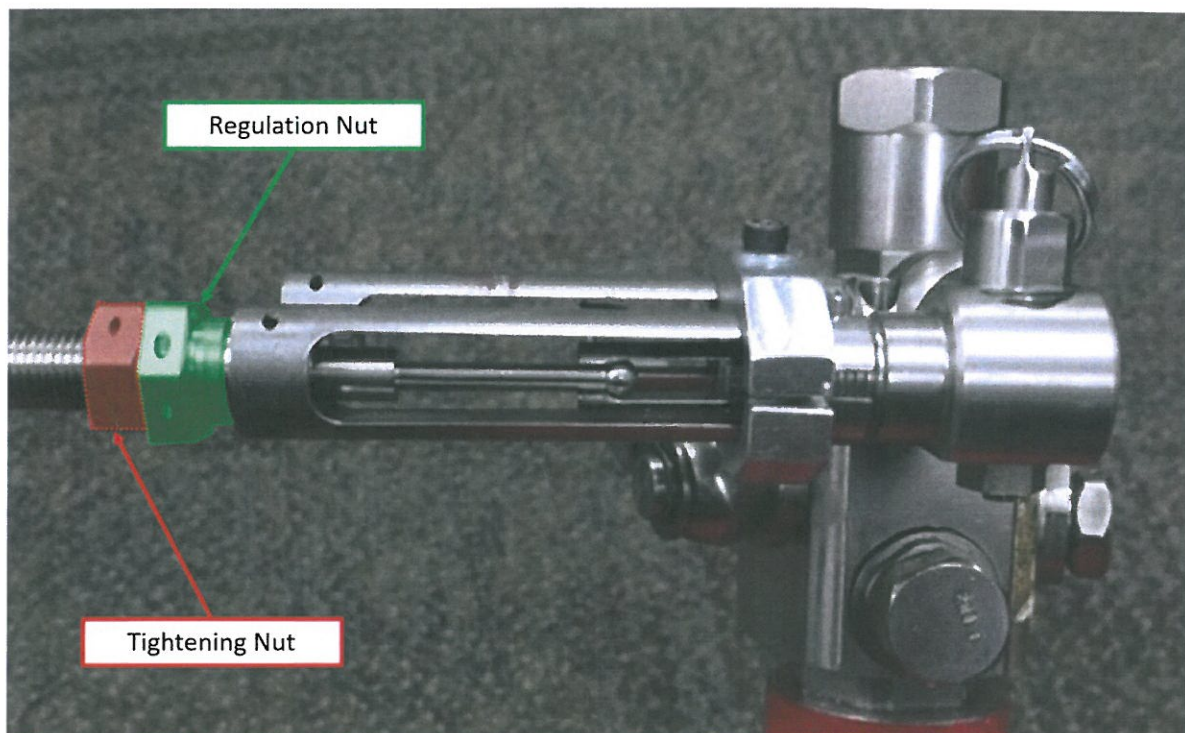
Figure A1 – Activation cable zone

1 END OF ACTIVATION CABLE ZONE LOCK NUTS

- 1.1 Unscrew the 9/16" tightening nut.
- 1.2 Adjust the cable length acting on the 5/8" regulation nut.
 - TO INCREASE THE GAP: unscrew the regulation nut;
 - TO DECREASE THE GAP: screw the regulation nut.
- 1.3 Screw the 9/16" tightening nut in order to block the regulation nut.

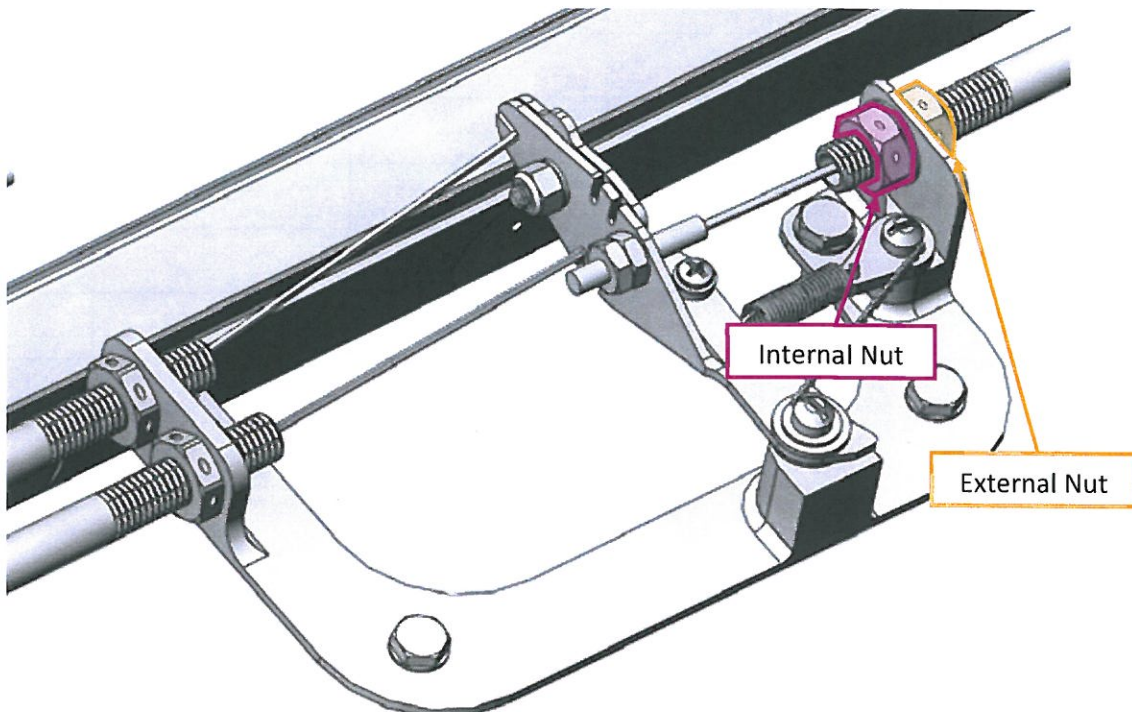
Figure A2 – Junction box zone

2 JUNCTION BOX ZONE LOCK NUTS

Both lock nuts are 9/16".

- 2.1 Remove safety-wire from the nuts.
- 2.2 Adjust the gap as follows:
 - TO INCREASE THE GAP:
 - Unscrew External Nut;
 - Screw Internal Nut.
 - TO DECREASE THE GAP:
 - Unscrew Internal Nut;
 - Screw External Nut.
- 2.3 Once the correct gap is achieved, make sure that both the internal and the external nuts are in contact with the structure and tightened at the standard torque value.
- 2.4 Safety the external nut and the internal nut with stainless steel (302/304) medium strong safety wire.
