CIVIL AVIATION GUIDANCE MATERIAL – 1410

# PAVEMENT DISTRESS MANUAL

CIVIL AVIATION AUTHORITY OF MALAYSIA

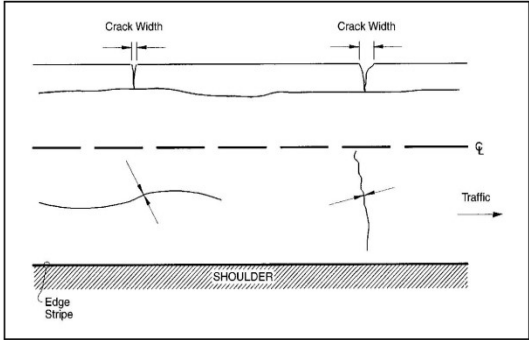
<p><b>Figure 1a: Measuring Crack Width on Asphalt Pavement</b></p>

<p><b>How to measure the severity: -</b> Measured in the gap of the cracks in millimetres and area affected in meters.</p>		Low	Medium	High	<b>CRACK WIDTH</b>	Less than 6mm	6mm to 19mm	More than 19mm	<b>CRACK PATTERN</b>	Fine, longitudinal hairline crack run parallel with none/few interconnecting cracks. Not spalled	Well defined of pattern interconnecting crack which securely held. Lightly spalled	Pieces are well defined (loosen) and spalled at edges. Potential FOD

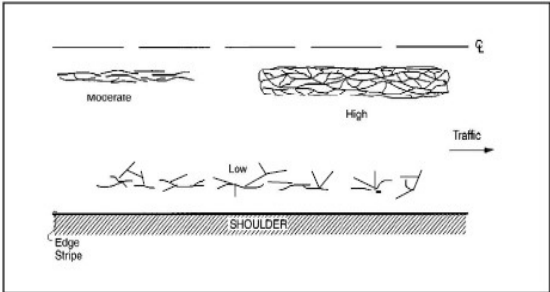
<p><b>Figure 1b: Alligator Crack Patterns of Differing Severity</b></p>
	Low	Medium	High											
<b>CRACK WIDTH</b>	Less than 6mm	6mm to 19mm	More than 19mm											
<b>CRACK PATTERN</b>	Fine, longitudinal hairline crack run parallel with none/few interconnecting cracks. Not spalled	Well defined of pattern interconnecting crack which securely held. Lightly spalled	Pieces are well defined (loosen) and spalled at edges. Potential FOD

PAVEMENT DISTRESSES	DESCRIPTION	ILLUSTRATION												
<p>Alligator Cracking</p>	<p>Alligator cracking may be considered a combination of fatigue and block cracking. It is a series of interconnected cracks of various stages of development. Alligator cracking develops into a many-sided pattern that resembles chicken wire or alligator skin. It can occur anywhere in the road lane. Alligator cracking must have a quantifiable area.</p> <p><b>Severity Levels</b></p>

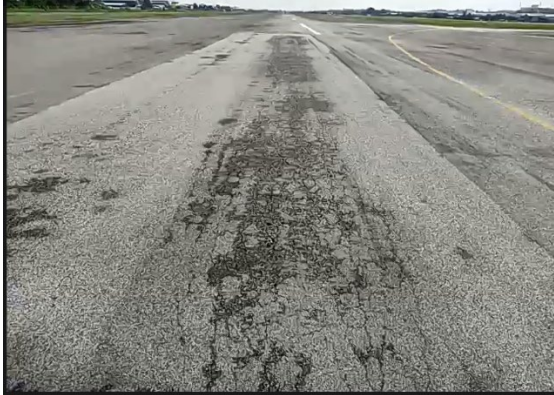
<p><b>Figure 1c: Alligator Crack with Medium Severity</b></p>

PAVEMENT DISTRESSES	DESCRIPTION	ILLUSTRATION
	<p><b>Recommended action to be taken: -</b></p> <p>Low - Take note of the distress existence</p> <p>Medium - Close monitoring and arrange for repair works if it occurs on the wheel path</p> <p>High - Arrange for repair works</p>

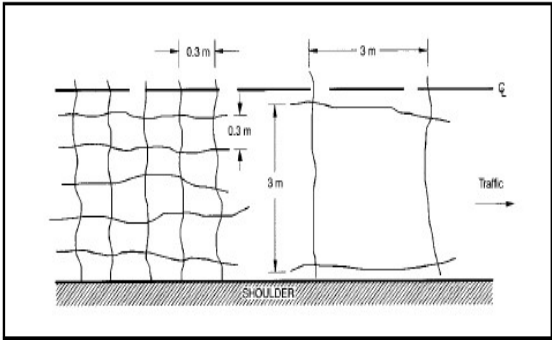
<p><b>Figure 3a: Block Cracking</b></p>

PAVEMENT DISTRESSES	DESCRIPTION	ILLUSTRATION												
<p>Block Cracking</p>	<p>Pattern of cracks that divide the pavement into approximately rectangular pieces. Rectangular blocks range in size from approximately 0.3m x 0.3m to 3m x 3m.</p> <p><b>Severity Levels</b></p>

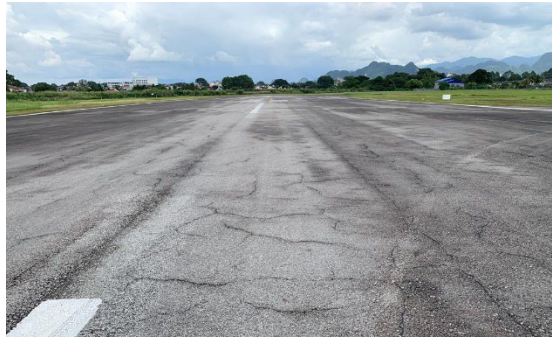
<p><b>Figure 3b: Block Cracking with Medium Severity</b></p>
	Low	Medium	High											
<b>CRACK WIDTH</b>	Less than 6mm	6mm to 19mm	More than 19mm											
<b>CRACK PATTERN</b>	Non or lightly spalled cracks or filled cracks with sealant material in good condition	Filled or non filled cracks with potential or minor FOD	Blocks are well defined by severely spalled cracks causing definite FOD

<p><b>How to measure the severity: -</b> Measured in the gap of the cracks in millimetres and area affected in meters.</p> <p><b>Recommended action to be taken: -</b></p> <p>Low - Take note of the distress existence</p> <p>Medium - Close monitoring</p> <p>High - Arrange for repair works</p>		Low	Medium	High	<b>CRACK WIDTH</b>	Less than 6mm	6mm to 19mm	More than 19mm	<b>CRACK PATTERN</b>	Non or lightly spalled cracks or filled cracks with sealant material in good condition	Filled or non filled cracks with potential or minor FOD	Blocks are well defined by severely spalled cracks causing definite FOD

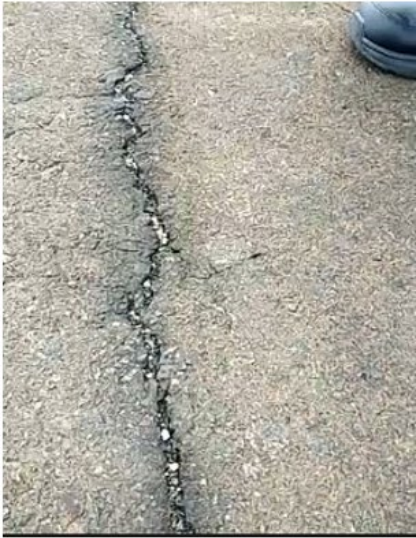
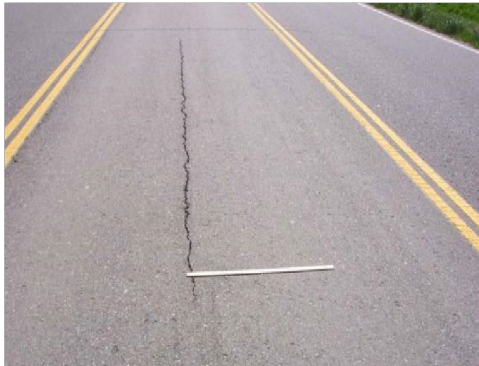
<p><b>Figure 6a: Longitudinal Cracking</b></p>
	Low	Medium	High											
<b>CRACK WIDTH</b>	Less than 6mm	6mm to 19mm	More than 19mm											
<b>CRACK PATTERN</b>	Light spalling with less or no potential FOD	Moderate spalled with FOD potential	Multiple spalling and pieces are loosen or missing causing definite FOD

PAVEMENT DISTRESSES	DESCRIPTION	ILLUSTRATION												
<p>Longitudinal/Transverse Cracking</p>	<p>Longitudinal cracking occurs predominantly parallel to the pavement centreline. It can occur anywhere within the lane. Longitudinal cracks occurring in the wheel path may be significant.</p> <p>Transverse cracking occurs predominantly perpendicular to the pavement centreline. It can occur anywhere within the lane.</p> <p><b>Severity Levels</b></p>

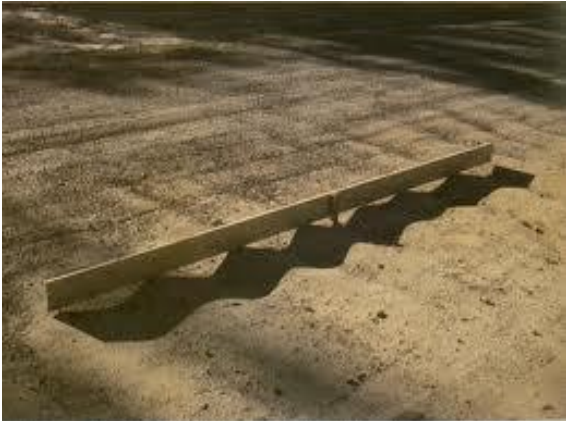
<p><b>Figure 4: Corrugation</b></p>
		Low	Medium	High																	
DEPTH OF THE VALLEYS	RWY & High-Speed TWY	Less than 6mm	6mm to 13mm	More than 13mm																	
	Other areas	Less than 13mm	13mm to 25mm	More than 25mm																	
PATTERN		Minor pattern and do not significantly affect ride quality	Noticeable and significantly affect ride quality	Easily notice and severely affect ride quality

<p><b>How to measure the severity: -</b> Measured the depth of the valleys by using a 3m straightedge, place perpendicular to the corrugations.</p> <p><b>Recommended action to be taken: -</b></p> <p>Low            - Take note of the distress existence</p>			Low	Medium	High	DEPTH OF THE VALLEYS	RWY & High-Speed TWY	Less than 6mm	6mm to 13mm	More than 13mm	Other areas	Less than 13mm	13mm to 25mm	More than 25mm	PATTERN		Minor pattern and do not significantly affect ride quality	Noticeable and significantly affect ride quality	Easily notice and severely affect ride quality

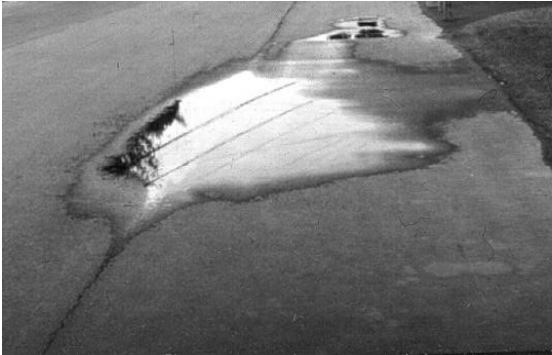
<p><b>Figure 5: Water ponding due to Depression</b></p>
		Low	Medium	High																				
DEPTH OF THE DEPRESSIONS	RWY & High-Speed TWY	3mm to 13mm	13mm to 25mm	More than 25mm																				
	Other areas	13mm to 25mm	25mm to 51mm	More than 51mm																				
PATTERN		Observed or located by the stain areas, lightly affect rice quality and may cause hydroplaning potential on runway	Can be observed, moderately affect rice quality and may cause hydroplaning potential on runway	Can be observed, severely affect rice quality and cause definite hydroplaning potential on runway

PAVEMENT DISTRESSES	DESCRIPTION				ILLUSTRATION																			
Depression	<p>Localized pavement surface areas having elevations slightly lower than the surrounding pavement. Creates water ponding and stains caused by the ponding water.</p> <p><b>Severity Levels</b></p>

PAVEMENT DISTRESSES	DESCRIPTION	ILLUSTRATION
	<p><b>How to measure the severity: -</b> Measured the depth of the depressions by using a 3m straightedge, place across the depression area, measure the maximum depth of the depression and area affected in meters.</p> <p><b>Recommended action to be taken: -</b></p> <p>Low           - Take note of the distress existence</p> <p>Medium       - Arrange for repair works</p> <p>High           - Arrange for repair works</p> <p><b><i>*Any depression more than 3mm depth with an area of more than 1sq.m at runway and high-speed area shall be repaired immediately</i></b></p>

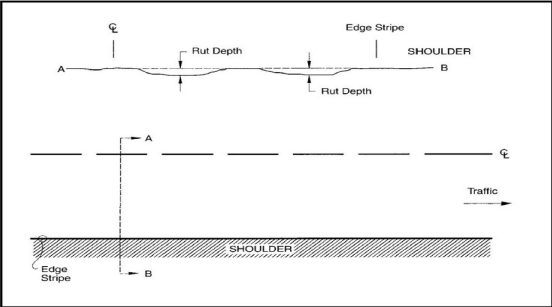
<p><b>Figure 10a: Rutting</b></p>

PAVEMENT DISTRESSES	DESCRIPTION	ILLUSTRATION								
<p>Rutting</p>	<p>Rutting is a longitudinal surface depression in the wheel path.</p> <p><b>Severity Levels</b></p> <table border="1" data-bbox="524 464 1431 571"> <thead> <tr> <th></th> <th>Low</th> <th>Medium</th> <th>High</th> </tr> </thead> <tbody> <tr> <td><b>RUT DEPTH</b></td> <td>Less than 13mm</td> <td>13mm to 25mm</td> <td>More than 25mm</td> </tr> </tbody> </table> <p><b>How to measure the severity: -</b> Measured the depth of the rutting by using a 3m straightedge, place across the rut area and measure the maximum depth of the depression.</p> <p><b>Recommended action to be taken: -</b></p> <p>Low - Take note of the distress existence</p> <p>Medium - Close monitoring</p> <p>High - Arrange for repair works</p> <p><i>*Any depression more than 3mm depth with an area of more than 1sq.m at the runway and high-speed area shall be repaired immediately.</i></p>		Low	Medium	High	<b>RUT DEPTH</b>	Less than 13mm	13mm to 25mm	More than 25mm

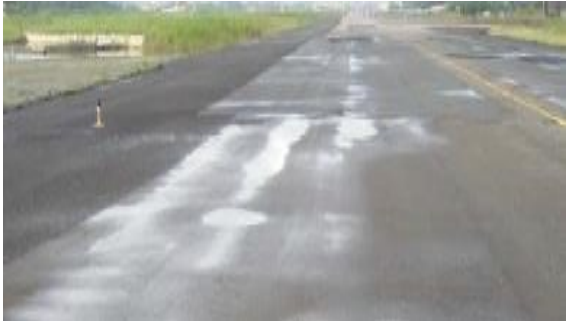
<p><b>Figure 10b: Rutting on pavement</b></p>
	Low	Medium	High							
<b>RUT DEPTH</b>	Less than 13mm	13mm to 25mm	More than 25mm

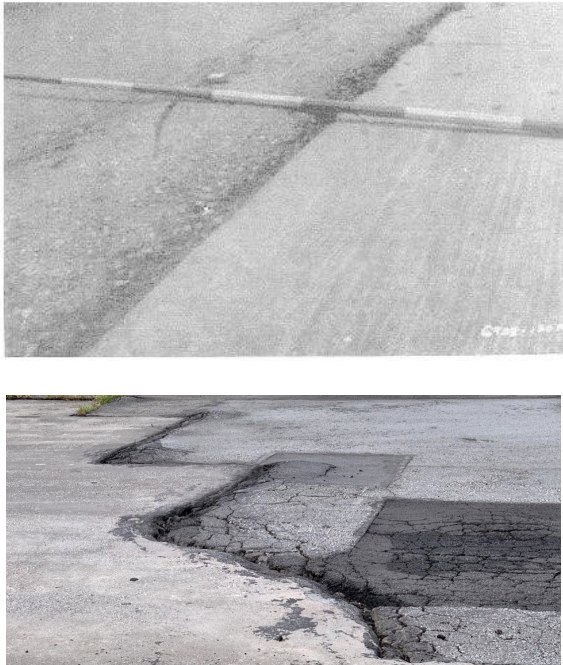
<p><b>Figure 11: Shoving</b></p>
	Low	Medium	High							
<b>PATTERN</b>	A slight amount of shoving has occurred and no breakup of the asphalt pavement	A significant amount of shoving has occurred, causing moderate roughness and little or no breakup of the asphalt pavement	A large amount of shoving has occurred, causing severe roughness and breakup of the asphalt pavement

PAVEMENT DISTRESSES	DESCRIPTION	ILLUSTRATION								
<p>Shoving (Caused by PQC Slabs)</p>	<p>Occurs when the asphalt concrete pavement adjoins with PQC pavement. The PQC pavement may occasionally increase in length and it shoves the asphalt concrete pavement, causing them to swell and crack.</p> <p><b>Severity Levels</b></p> <table border="1" data-bbox="535 564 1420 978"> <thead> <tr> <th data-bbox="535 564 712 603"></th> <th data-bbox="712 564 927 603">Low</th> <th data-bbox="927 564 1180 603">Medium</th> <th data-bbox="1180 564 1420 603">High</th> </tr> </thead> <tbody> <tr> <td data-bbox="535 603 712 978"><b>PATTERN</b></td> <td data-bbox="712 603 927 978">A slight amount of shoving has occurred and no breakup of the asphalt pavement</td> <td data-bbox="927 603 1180 978">A significant amount of shoving has occurred, causing moderate roughness and little or no breakup of the asphalt pavement</td> <td data-bbox="1180 603 1420 978">A large amount of shoving has occurred, causing severe roughness and breakup of the asphalt pavement</td> </tr> </tbody> </table> <p><b>How to measure the severity: -</b> Observe the condition of the shoving based on the pattern.</p> <p><b>Recommended action to be taken: -</b></p> <p>Low - Take note of the distress existence</p> <p>Medium - Arrange for repair works if occurred on runway or high-speed taxiway. Close monitoring at other areas</p> <p>High - Arrange for repair works</p>		Low	Medium	High	<b>PATTERN</b>	A slight amount of shoving has occurred and no breakup of the asphalt pavement	A significant amount of shoving has occurred, causing moderate roughness and little or no breakup of the asphalt pavement	A large amount of shoving has occurred, causing severe roughness and breakup of the asphalt pavement

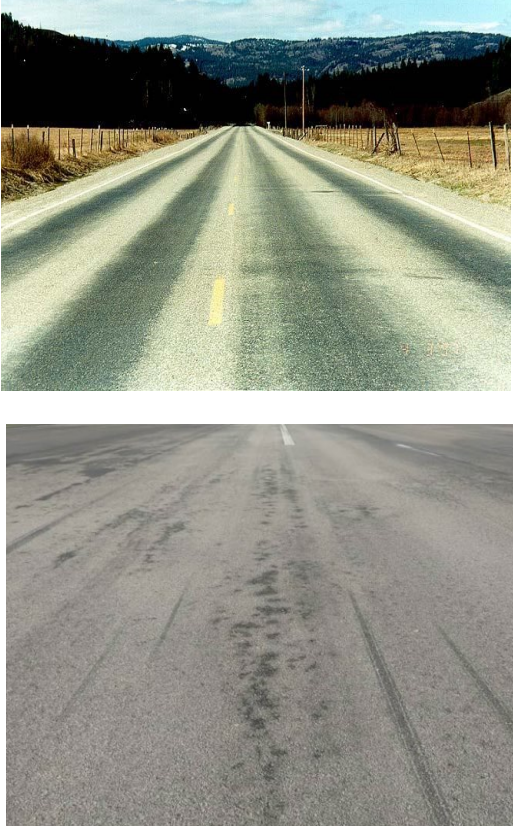
<p><b>Figure 2: Bleeding</b></p>
Low	Medium	High						
Asphalt does not stick to shoes or vehicles	Asphalt stick to shoes or vehicles	Asphalt stick to shoes or vehicles extensively

PAVEMENT DISTRESSES	DESCRIPTION	ILLUSTRATION						
<p>Bleeding</p>	<p>A film of bituminous material on the pavement surface that creates a shiny, glasslike, reflecting surface that usually becomes quite sticky caused by excessive amounts of asphaltic cements.</p> <p><b>Severity Levels</b></p> <table border="1" data-bbox="539 531 1413 719"> <thead> <tr> <th data-bbox="539 531 786 571">Low</th> <th data-bbox="786 531 1111 571">Medium</th> <th data-bbox="1111 531 1413 571">High</th> </tr> </thead> <tbody> <tr> <td data-bbox="539 571 786 719">Asphalt does not stick to shoes or vehicles</td> <td data-bbox="786 571 1111 719">Asphalt stick to shoes or vehicles</td> <td data-bbox="1111 571 1413 719">Asphalt stick to shoes or vehicles extensively</td> </tr> </tbody> </table> <p><b>How to measure the severity:</b> - Measured in the square meters of surface area.</p> <p><b>Recommended action to be taken:</b> -</p> <p>Low - Take note of the distress existence</p> <p>Medium - Close monitoring</p> <p>High - Arrange for repair works</p>	Low	Medium	High	Asphalt does not stick to shoes or vehicles	Asphalt stick to shoes or vehicles	Asphalt stick to shoes or vehicles extensively

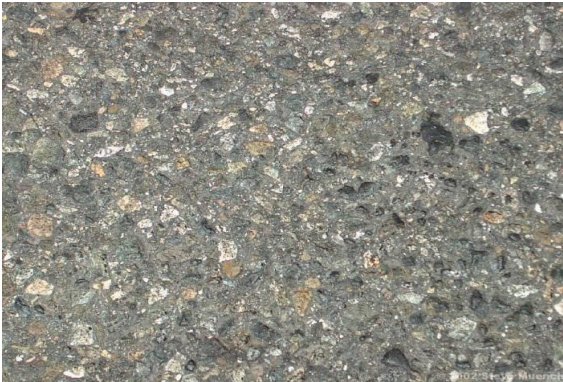
<p><b>Figure 8: Expose coarse aggregate</b></p>

PAVEMENT DISTRESSES	DESCRIPTION	ILLUSTRATION
<p>Polished Aggregates</p>	<p>Surface binder worn away to expose coarse aggregate or no rough or angular aggregate particles to provide skid resistance.</p> <p><b>Severity Levels</b> Not applicable. However, the degree of polishing may be reflected in a reduction of surface friction and the aggregate should be smooth to touch.</p> <p><b>Recommended action to be taken: -</b> Take note of the distress existence and arrange for repair works if the surface friction gives value lower than Maintenance Planning Level (MPL – based on the Grip Tester result).</p>

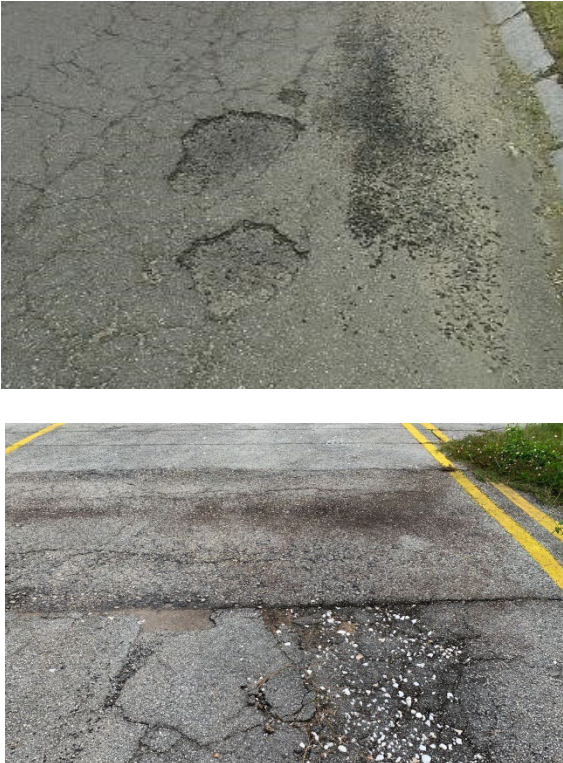
<p><b>Figure 9: Ravelling</b></p>
	Low	Medium	High											
<b>MEASUREMENT</b>	Aggregate coarse exposed $\frac{1}{4}$ of its diameter	Aggregate coarse exposed $\frac{1}{2}$ of its diameter	The top layer of aggregate coarse has eroded away											
<b>PATTERN</b>	Aggregate or binder has started to wear away. Lightly or no FOD potential	Aggregate or binder, or both has worn away. Moderate FOD potential. Surface texture is moderately rough and pitted.	Aggregate or binder, or both has worn away. High FOD potential. Surface texture is severely rough and pitted.

PAVEMENT DISTRESSES	DESCRIPTION	ILLUSTRATION												
<p>Ravelling and Weathering</p>	<p>Wearing away of the pavement surface caused by the dislodging of aggregate particles and loss of asphalt binder. Ravelling ranges from loss of fines to loss of some coarse aggregate and ultimately to a very rough and pitted surface with obvious loss of aggregate.</p> <p><b>Severity Levels</b></p>

<p><b>How to measure the severity: -</b> Observe the ride quality and the condition of the patch.</p>		Low	Medium	High	<b>MEASUREMENT</b>	Aggregate coarse exposed $\frac{1}{4}$ of its diameter	Aggregate coarse exposed $\frac{1}{2}$ of its diameter	The top layer of aggregate coarse has eroded away	<b>PATTERN</b>	Aggregate or binder has started to wear away. Lightly or no FOD potential	Aggregate or binder, or both has worn away. Moderate FOD potential. Surface texture is moderately rough and pitted.	Aggregate or binder, or both has worn away. High FOD potential. Surface texture is severely rough and pitted.

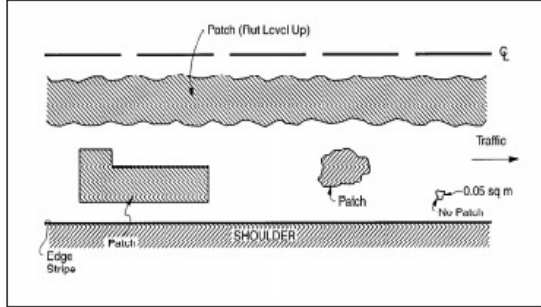
<p><b>Figure 7: Patching Variations</b></p>
	Low	Medium	High							
<b>PATTERN</b>	Patch in good condition and performing satisfactorily	Patch deteriorated and affect ride quality	Patch need replacement and cause FOD potential

PAVEMENT DISTRESSES	DESCRIPTION	ILLUSTRATION								
<p>Patching</p>	<p>Patching is an area of pavement surface that has been removed and replaced with patching material or an area of pavement surface that has had additional patching material applied.</p> <p><b>Severity Levels</b></p> <table border="1" data-bbox="526 531 1379 742"> <thead> <tr> <th></th> <th>Low</th> <th>Medium</th> <th>High</th> </tr> </thead> <tbody> <tr> <td><b>PATTERN</b></td> <td>Patch in good condition and performing satisfactorily</td> <td>Patch deteriorated and affect ride quality</td> <td>Patch need replacement and cause FOD potential</td> </tr> </tbody> </table> <p><b>How to measure the severity: -</b> Observe the ride quality and the condition of the patch.</p> <p><b>Recommended action to be taken: -</b></p> <p>Low - Take note of the distress existence</p> <p>Medium - Arrange for repair works if occurred on runway or high-speed taxiway. Close monitoring at other areas</p> <p>High - Arrange for repair works</p>		Low	Medium	High	<b>PATTERN</b>	Patch in good condition and performing satisfactorily	Patch deteriorated and affect ride quality	Patch need replacement and cause FOD potential

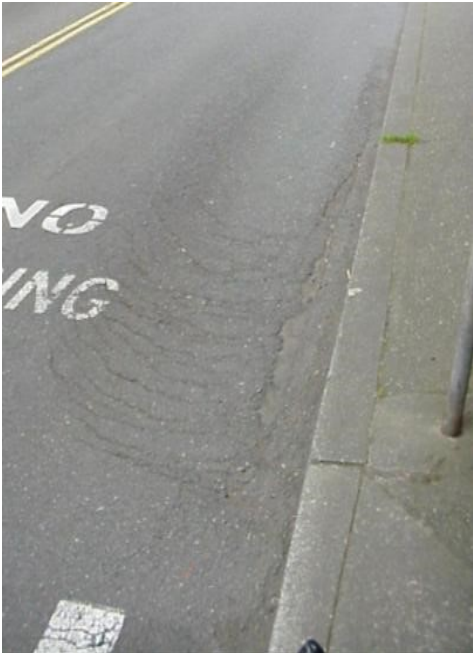
<p><b>Figure 12: Slippage Cracking</b></p>
	Low	Medium	High							
<b>PATTERN</b>	Cracks with no break-up	Cracks with some break-up and FOD potential	Cracks with considerable break-up and missing causing definite FOD

PAVEMENT DISTRESSES	DESCRIPTION	ILLUSTRATION								
Slippage Cracking	<p>Crescent or half-moon shaped cracks having two ends pointed away from the direction of traffic. Produced when braking or turning wheels cause the pavement surface to slide or deform.</p> <p><b>Severity Levels</b></p> <table border="1" data-bbox="535 531 1420 742"> <thead> <tr> <th></th> <th>Low</th> <th>Medium</th> <th>High</th> </tr> </thead> <tbody> <tr> <td><b>PATTERN</b></td> <td>Cracks with no break-up</td> <td>Cracks with some break-up and FOD potential</td> <td>Cracks with considerable break-up and missing causing definite FOD</td> </tr> </tbody> </table> <p><b>How to measure the severity: -</b> Observe the existence of the slippage cracking. Measured in the gap of the cracks in millimetres and area affected in meters.</p> <p><b>Recommended action to be taken: -</b></p> <p>Low - Take note of the distress existence</p> <p>Medium - Arrange for repair works if occurred on runway or high-speed taxiway. Close monitoring at other areas</p> <p>High - Arrange for repair works</p>		Low	Medium	High	<b>PATTERN</b>	Cracks with no break-up	Cracks with some break-up and FOD potential	Cracks with considerable break-up and missing causing definite FOD

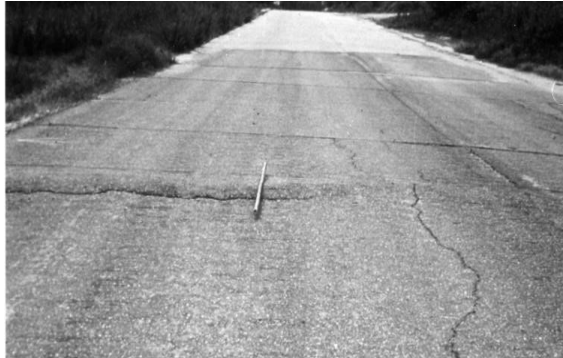
<p><b>Figure 13: Swell Distress</b></p>
		Low	Medium	High																					
MEASUREMENT	<b>RWY &amp; High-Speed TWY</b>	Less than 19mm	19mm to 37.5mm	More than 37.5mm																					
	<b>Other areas</b>	Less than 38mm	38mm to 75mm	More than 75mm																					
<b>PATTERN</b>		Barely visible and has minor effect on pavement ride quality	Visible and has significant effect on pavement ride quality	Obviously visible and severely affect the pavement ride quality

<p><b>How to measure the severity: -</b>            Observe the ride quality and the condition of the swell. The measurement can be taken using the 3m straightedge, place on the highest point of the swell and measure the height differential above the pavement.</p> <p><b>Recommended action to be taken: -</b></p> <p>Low - Take note of the distress existence</p> <p>Medium - Arrange for repair works if occurred on runway or high-speed taxiway. Close monitoring at other areas</p> <p>High - Arrange for repair works</p>						Low	Medium	High	MEASUREMENT	<b>RWY &amp; High-Speed TWY</b>	Less than 19mm	19mm to 37.5mm	More than 37.5mm	<b>Other areas</b>	Less than 38mm	38mm to 75mm	More than 75mm	<b>PATTERN</b>		Barely visible and has minor effect on pavement ride quality	Visible and has significant effect on pavement ride quality	Obviously visible and severely affect the pavement ride quality

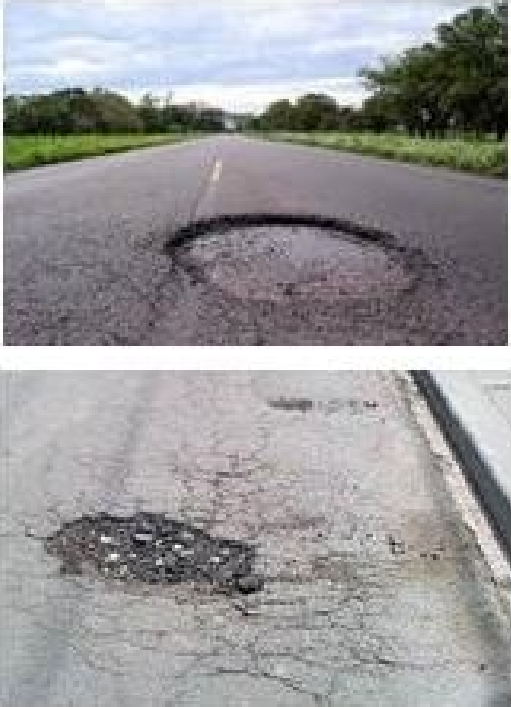
<p><b>Figure 14: Potholes</b></p>
DEPTH (mm)	AVERAGE DIAMETER (mm)																				
	102 – 203	203 – 457	More than 457																		
127 – 254	L	L	M																		
254 – 508	L	M	H																		
More than 508	M	M	H

<p><b>Recommended action to be taken: -</b></p> <p>Runway/Taxiway/Apron - Arrange for immediate repair works</p> <p>Road - Arrange for immediate repair works if it occurs on the heavy movement area</p>	DEPTH (mm)	AVERAGE DIAMETER (mm)			102 – 203	203 – 457	More than 457	127 – 254	L	L	M	254 – 508	L	M	H	More than 508	M	M	H

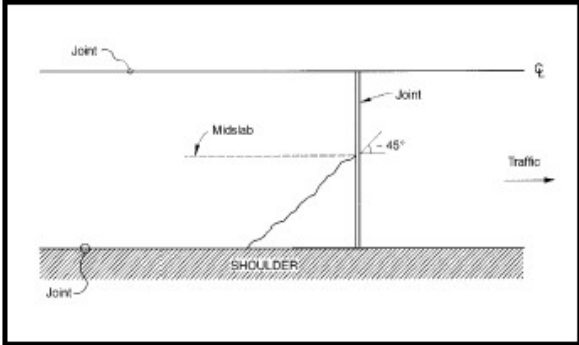
<p><b>Figure 16a: Depression</b></p>

PAVEMENT DISTRESSES	DESCRIPTION	ILLUSTRATION								
<p>Corner Breaks</p>	<p>A portion of the slab separated by a crack, which intersects the adjacent transverse and longitudinal joints, describing approximately a 45-degree angle with the direction of traffic. The length of the sides is from 0.3 m to one-half the width of the slab on each side of the corner.</p> <p><b>Severity Levels</b></p> <table border="1" data-bbox="499 564 1391 1150"> <thead> <tr> <th data-bbox="499 564 663 603"></th> <th data-bbox="663 564 887 603">Low</th> <th data-bbox="887 564 1128 603">Medium</th> <th data-bbox="1128 564 1391 603">High</th> </tr> </thead> <tbody> <tr> <td data-bbox="499 603 663 1150"><b>PATTERN</b></td> <td data-bbox="663 603 887 1150">Crack is not spalled for more than 10 percent of the length of the crack; there is no measurable faulting; and the corner piece is not broken into two or more pieces and has no loss of material and no patching</td> <td data-bbox="887 603 1128 1150">Crack is spalled at low severity for more than 10 percent of its total length; or faulting of crack or joint is &lt; 13 mm; and the corner piece is not broken into two or more pieces</td> <td data-bbox="1128 603 1391 1150">Crack is spalled at moderate to high severity for more than 10 percent of its total length; or faulting of the crack or joint is &gt; 13 mm; or the corner piece is SYMBOL broken into two or more pieces or contains patch material</td> </tr> </tbody> </table> <p><b>Recommended action to be taken: -</b></p> <p>Low - Take note of the distress existence</p> <p>Medium - Close monitoring</p>		Low	Medium	High	<b>PATTERN</b>	Crack is not spalled for more than 10 percent of the length of the crack; there is no measurable faulting; and the corner piece is not broken into two or more pieces and has no loss of material and no patching	Crack is spalled at low severity for more than 10 percent of its total length; or faulting of crack or joint is < 13 mm; and the corner piece is not broken into two or more pieces	Crack is spalled at moderate to high severity for more than 10 percent of its total length; or faulting of the crack or joint is > 13 mm; or the corner piece is SYMBOL broken into two or more pieces or contains patch material

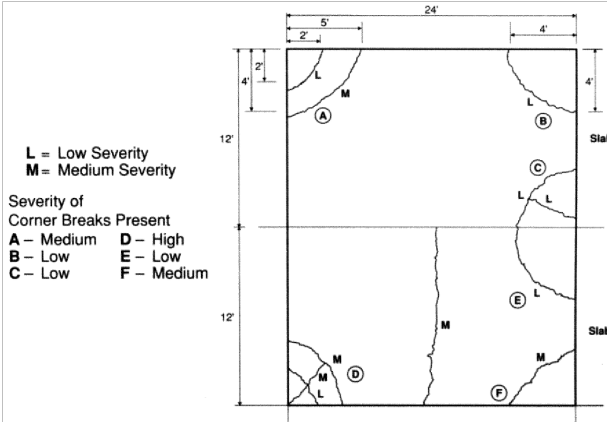
<p><b>Figure 16b: Various Severity Levels of Corner Breaks</b></p>
	Low	Medium	High							
<b>PATTERN</b>	Crack is not spalled for more than 10 percent of the length of the crack; there is no measurable faulting; and the corner piece is not broken into two or more pieces and has no loss of material and no patching	Crack is spalled at low severity for more than 10 percent of its total length; or faulting of crack or joint is < 13 mm; and the corner piece is not broken into two or more pieces	Crack is spalled at moderate to high severity for more than 10 percent of its total length; or faulting of the crack or joint is > 13 mm; or the corner piece is SYMBOL broken into two or more pieces or contains patch material

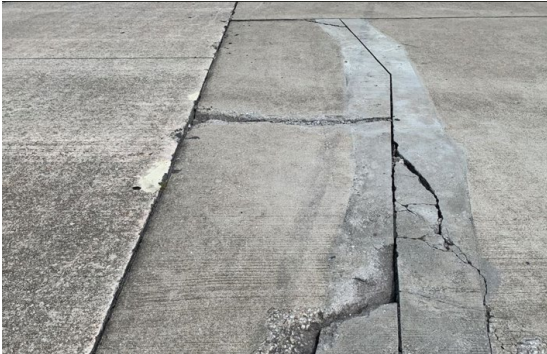
<p data-bbox="1491 655 1966 719"><b>Figure 16c: Corner Breaks at rigid pavement</b></p>

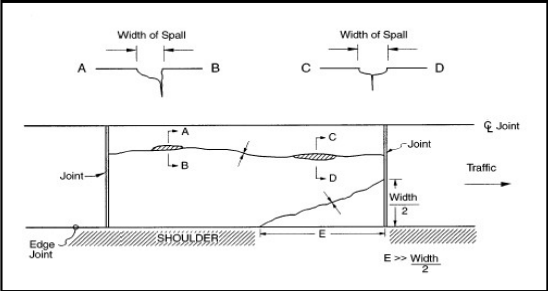
PAVEMENT DISTRESSES	DESCRIPTION	ILLUSTRATION								
<p>Longitudinal Cracking</p>	<p>Longitudinal Cracks that are predominantly parallel to the pavement centreline.</p> <p><b>Severity Levels</b></p> <table border="1" data-bbox="524 496 1417 842"> <thead> <tr> <th></th> <th>Low</th> <th>Medium</th> <th>High</th> </tr> </thead> <tbody> <tr> <td><b>Longitudinal</b></td> <td>Crack widths &lt; 3 mm, no spalling and no measurable faulting; or well-sealed and with a width that cannot be determined</td> <td>Crack widths 3 mm and &lt; 13 mm; or with spalling &lt; 75 mm; or faulting up to 13 mm</td> <td>Crack widths 13 mm; or with spalling 75 mm; or faulting 13 mm</td> </tr> </tbody> </table> <p><b>Recommended action to be taken: -</b></p> <p>Low - Take note of the distress existence</p> <p>Medium - Close monitoring</p> <p>High - Arrange for repair works</p>		Low	Medium	High	<b>Longitudinal</b>	Crack widths < 3 mm, no spalling and no measurable faulting; or well-sealed and with a width that cannot be determined	Crack widths 3 mm and < 13 mm; or with spalling < 75 mm; or faulting up to 13 mm	Crack widths 13 mm; or with spalling 75 mm; or faulting 13 mm

<p><b>Figure 17: Longitudinal Cracking</b></p>
	Low	Medium	High							
<b>Longitudinal</b>	Crack widths < 3 mm, no spalling and no measurable faulting; or well-sealed and with a width that cannot be determined	Crack widths 3 mm and < 13 mm; or with spalling < 75 mm; or faulting up to 13 mm	Crack widths 13 mm; or with spalling 75 mm; or faulting 13 mm

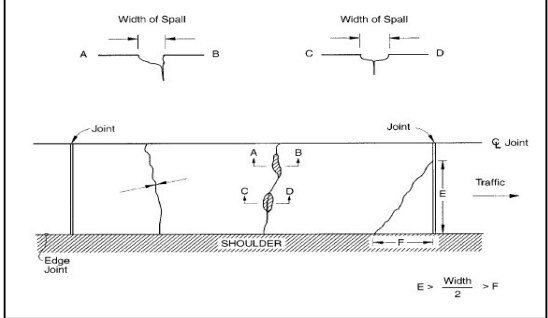
PAVEMENT DISTRESSES	DESCRIPTION	ILLUSTRATION								
<p>Transverse Cracking</p>	<p>Transverse Cracks that are predominantly perpendicular to the pavement centreline.</p> <p><b>Severity Levels</b></p> <table border="1" data-bbox="524 496 1420 810"> <thead> <tr> <th></th> <th>Low</th> <th>Medium</th> <th>High</th> </tr> </thead> <tbody> <tr> <td><b>Transverse</b></td> <td>Crack widths &lt; 3 mm, no spalling and no measurable faulting; or well-sealed and the width cannot be determined</td> <td>Crack widths 3 mm and &lt; 6 mm; or with spalling &lt; 75 mm; or faulting up to 6 mm</td> <td>Crack widths &lt; 6 mm, or with spalling &lt; 75 mm; or faulting up to 6 mm</td> </tr> </tbody> </table> <p><b>Recommended action to be taken: -</b></p> <p>Low - Take note of the distress existence</p> <p>Medium - Close monitoring</p> <p>High - Arrange for repair works</p>		Low	Medium	High	<b>Transverse</b>	Crack widths < 3 mm, no spalling and no measurable faulting; or well-sealed and the width cannot be determined	Crack widths 3 mm and < 6 mm; or with spalling < 75 mm; or faulting up to 6 mm	Crack widths < 6 mm, or with spalling < 75 mm; or faulting up to 6 mm

<p><b>Figure 18a: Transverse Cracking</b></p>

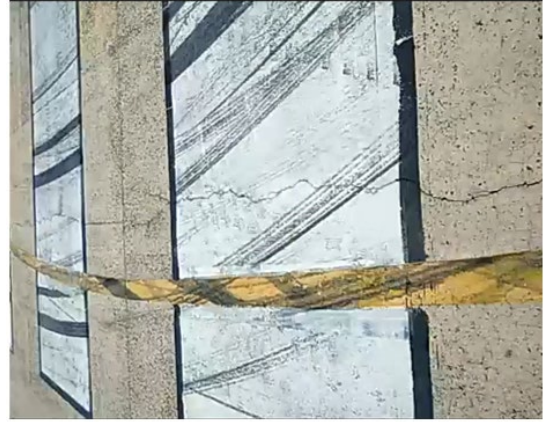
<p><b>Figure 18b: Transverse Cracking at rigid pavement</b></p>
	Low	Medium	High							
<b>Transverse</b>	Crack widths < 3 mm, no spalling and no measurable faulting; or well-sealed and the width cannot be determined	Crack widths 3 mm and < 6 mm; or with spalling < 75 mm; or faulting up to 6 mm	Crack widths < 6 mm, or with spalling < 75 mm; or faulting up to 6 mm

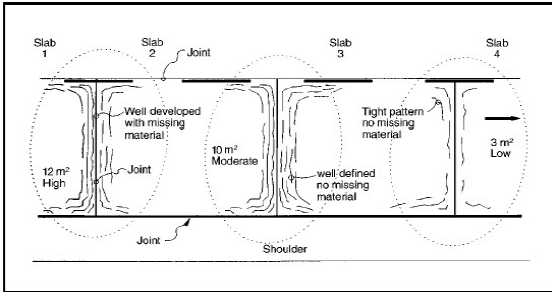
PAVEMENT DISTRESSES	DESCRIPTION	ILLUSTRATION								
<p>Durability Cracking ("<b>D</b>" CRACKING)</p>	<p>Closely spaced crescent-shaped hairline cracking pattern. Occurs adjacent to joints, cracks, or free edges; initiating in slab corners. Dark coloring of the cracking pattern and surrounding area</p> <p><b>Severity Levels</b></p> <table border="1" data-bbox="542 531 1413 911"> <thead> <tr> <th></th> <th>Low</th> <th>Medium</th> <th>High</th> </tr> </thead> <tbody> <tr> <td><b>PATTERN</b></td> <td>"D" cracks are tight, with no loose or missing pieces, and no patching is in the affected area</td> <td>"D" cracks are well-defined, and some small pieces are loose or have been displaced.</td> <td>"D" cracking has a well-developed pattern, with a significant amount of loose or missing material. Displaced pieces, up to 0.1 m<sup>2</sup>, may have been patched.</td> </tr> </tbody> </table> <p><b>Recommended action to be taken: -</b></p> <p>Low - Take note of the distress existence</p> <p>Medium - Close monitoring</p> <p>High - Arrange for repair works</p>		Low	Medium	High	<b>PATTERN</b>	"D" cracks are tight, with no loose or missing pieces, and no patching is in the affected area	"D" cracks are well-defined, and some small pieces are loose or have been displaced.	"D" cracking has a well-developed pattern, with a significant amount of loose or missing material. Displaced pieces, up to 0.1 m <sup>2</sup> , may have been patched.

<p><b>Figure 19: Depression</b></p>
	Low	Medium	High							
<b>PATTERN</b>	"D" cracks are tight, with no loose or missing pieces, and no patching is in the affected area	"D" cracks are well-defined, and some small pieces are loose or have been displaced.	"D" cracking has a well-developed pattern, with a significant amount of loose or missing material. Displaced pieces, up to 0.1 m <sup>2</sup> , may have been patched.

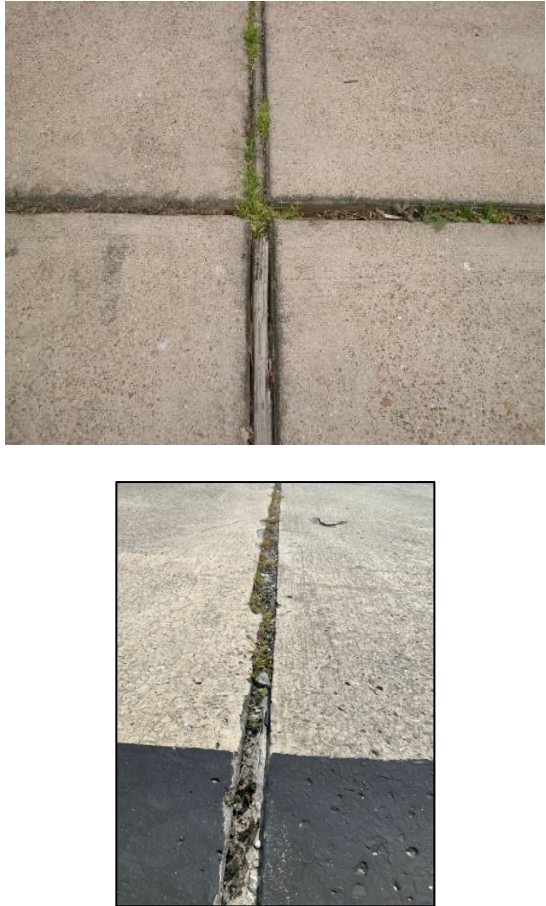
PAVEMENT DISTRESSES	DESCRIPTION	ILLUSTRATION								
<p>Joint Seal Damage</p>	<p>Joint seal damage is any condition which enables incompressible materials or water to infiltrate the joint from the surface. Typical types of joint seal damage are extrusion, hardening, adhesive failure (bonding), cohesive failure (splitting), or complete loss of sealant, intrusion of foreign material in the joint, weed growth in the joint.</p> <p><b>Severity Levels</b></p> <table border="1" data-bbox="542 600 1413 877"> <thead> <tr> <th data-bbox="542 600 719 635"></th> <th data-bbox="719 600 943 635">Low</th> <th data-bbox="943 600 1155 635">Medium</th> <th data-bbox="1155 600 1413 635">High</th> </tr> </thead> <tbody> <tr> <td data-bbox="542 635 719 877"><b>PATTERN</b></td> <td data-bbox="719 635 943 877">Joint seal damage as described above exists over less than 10 percent of the joint</td> <td data-bbox="943 635 1155 877">Joint seal damage as described above exists over 10-50 percent of the joint</td> <td data-bbox="1155 635 1413 877">Joint seal damage as described above exists over more than 50 percent of the joint</td> </tr> </tbody> </table> <p><b>Recommended action to be taken: -</b></p> <p>Low - Take note of the distress existence</p> <p>Medium - Close monitoring</p> <p>High - Arrange for repair works</p>		Low	Medium	High	<b>PATTERN</b>	Joint seal damage as described above exists over less than 10 percent of the joint	Joint seal damage as described above exists over 10-50 percent of the joint	Joint seal damage as described above exists over more than 50 percent of the joint

<p><b>Figure 20: Joint Seal Damage</b></p>
	Low	Medium	High							
<b>PATTERN</b>	Joint seal damage as described above exists over less than 10 percent of the joint	Joint seal damage as described above exists over 10-50 percent of the joint	Joint seal damage as described above exists over more than 50 percent of the joint

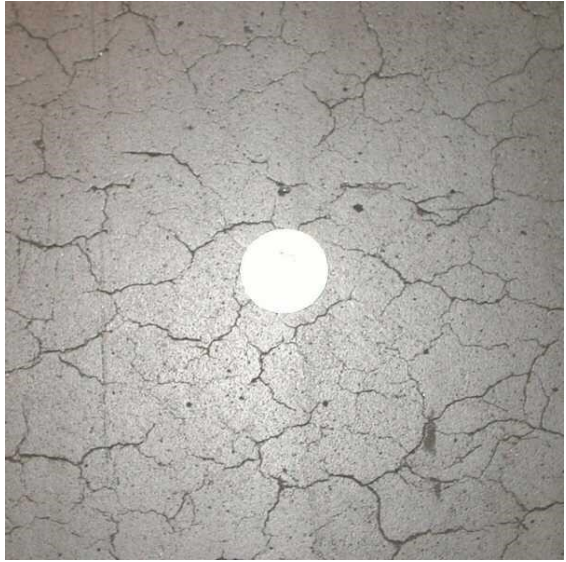
PAVEMENT DISTRESSES	DESCRIPTION	ILLUSTRATION								
<p>Scalling, Map Cracking</p>	<p>Map cracking and crazing refers to a network of shallow, fine or hairline cracks that extend only through the upper surface of the concrete.</p> <p><b>Severity Levels</b></p> <table border="1" data-bbox="528 497 1413 775"> <thead> <tr> <th></th> <th>Low</th> <th>Medium</th> <th>High</th> </tr> </thead> <tbody> <tr> <td><b>PATTERN</b></td> <td>Crazing or map cracking exists over significant slab area. The surface is in good condition with no scalling</td> <td>Slab is scaled over 5% or less of the surface with some FOD potential</td> <td>Slab is severely scaled causing a high FOD potential. More than 5% of the surface is affected</td> </tr> </tbody> </table> <p><b>Recommended action to be taken: -</b></p> <p>Low - Take note of the distress existence</p> <p>Medium - Close monitoring</p> <p>High - Arrange for repair works</p>		Low	Medium	High	<b>PATTERN</b>	Crazing or map cracking exists over significant slab area. The surface is in good condition with no scalling	Slab is scaled over 5% or less of the surface with some FOD potential	Slab is severely scaled causing a high FOD potential. More than 5% of the surface is affected

<p><b>Figure 23: Scalling</b></p>
	Low	Medium	High							
<b>PATTERN</b>	Crazing or map cracking exists over significant slab area. The surface is in good condition with no scalling	Slab is scaled over 5% or less of the surface with some FOD potential	Slab is severely scaled causing a high FOD potential. More than 5% of the surface is affected

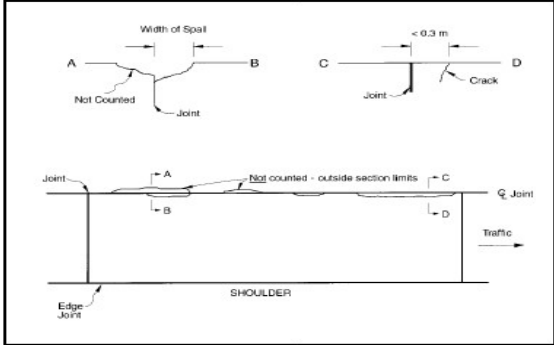
<p><b>Recommended action to be taken: -</b></p> <p>Low - Take note of the distress existence</p> <p>Medium - Close monitoring</p> <p>High - Arrange for repair works</p>		Low	Medium	High	<b>WIDTH</b>	Less than 75mm	75 to 150mm	More than 150mm	<b>PATTERN</b>	Measured to the face of the joint, with loss of material, or spalls with no loss of material and no patching	Measured to the face of the joint, with loss of material	Measured to the face of the joint, with loss of material or is broken into two or more pieces or contains patch material

<p><b>Figure 24a: Spalling of Longitudinal Joints</b></p>

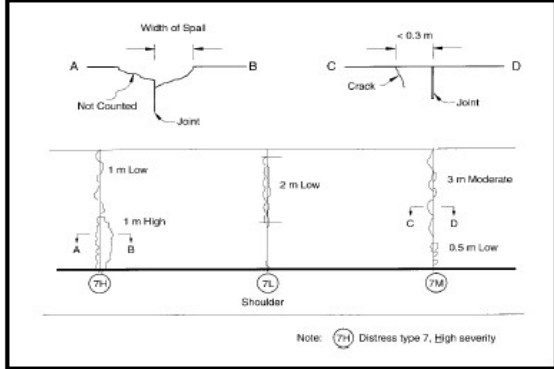
<p><b>Figure 24b: Spalling of Transverse Joints</b></p>
	Low	Medium	High											
<b>WIDTH</b>	Less than 75mm	75 to 150mm	More than 150mm											
<b>PATTERN</b>	Measured to the face of the joint, with loss of material, or spalls with no loss of material and no patching	Measured to the face of the joint, with loss of material	Measured to the face of the joint, with loss of material or is broken into two or more pieces or contains patch material

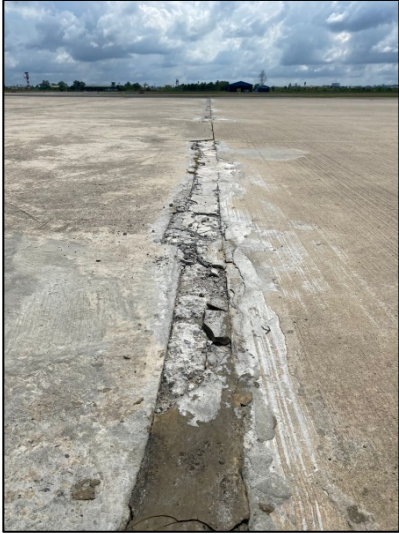
<p data-bbox="1473 836 2016 874"><b>Figure 24c: Spalling at rigid pavement</b></p>
