Temporary Maintenance Instruction TMI 139-548

Forward section - Main gearbox rod attachment structure - Detailed inspection

All AW139 Helicopters

This TMI provides the instructions and requirements to perform the detailed inspection of the Main Gearbox Forward Reinforcement P/N 3P5333A12052.

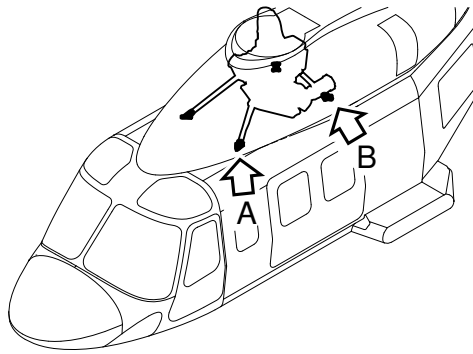
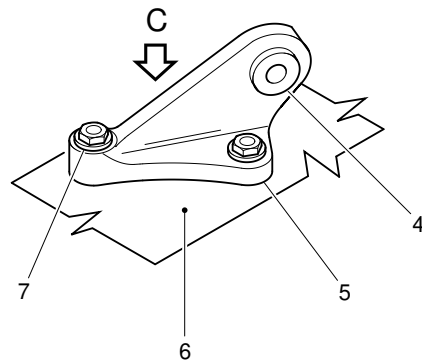
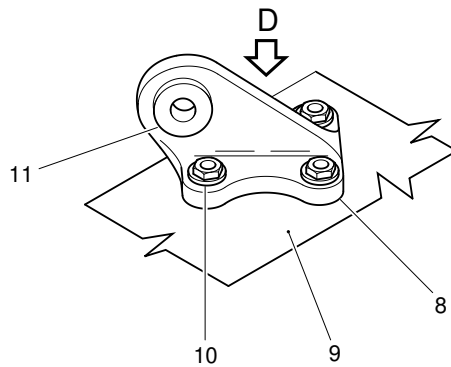
Figure 1 (Sheet 2 of 9) Forward section - Main gearbox rod attachment structure - Detailed inspection

LEFT FITTINGS SHOWN
(TYPICAL FOR RIGHT FITTINGS)

MAIN GEARBOX MOUNT
RODS NOT SHOWN
FOR CLARITY

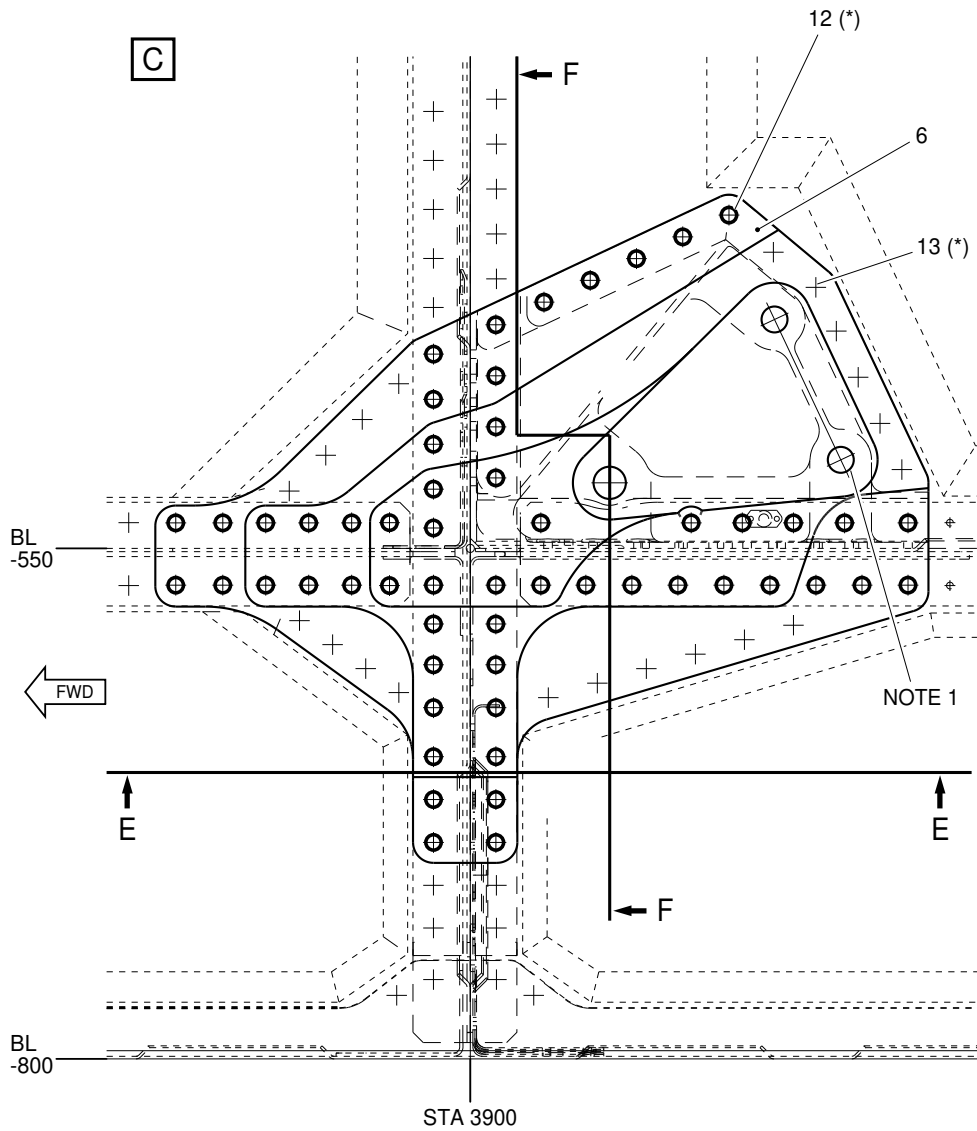
Figure 1 (Sheet 3 of 9) Forward section - Main gearbox rod attachment structure - Detailed inspection

Note 1: Left forward fitting (5) not shown

- 18.5 Examine the left-forward top plate (6) in the area of the three nuts that attach the forward left fitting (5). Make sure that there are no cracks that start from the fasteners holes.

- 18.6 Examine the heads/collars of the pin-rivets (16) and the heads of the rivets (17) for signs of looseness.
- 18.7 Examine the components of the structure around the heads/collars of the pin-rivets (16) and around the heads of the rivets (17) for cracks that starts from the fasteners holes.

- 18.8 Examine the flanges of the lightening holes (18) in the structure for cracks.
- 18.9 Refer to [step 27](#) if you find that:
- The fasteners (16) and (17) are loose

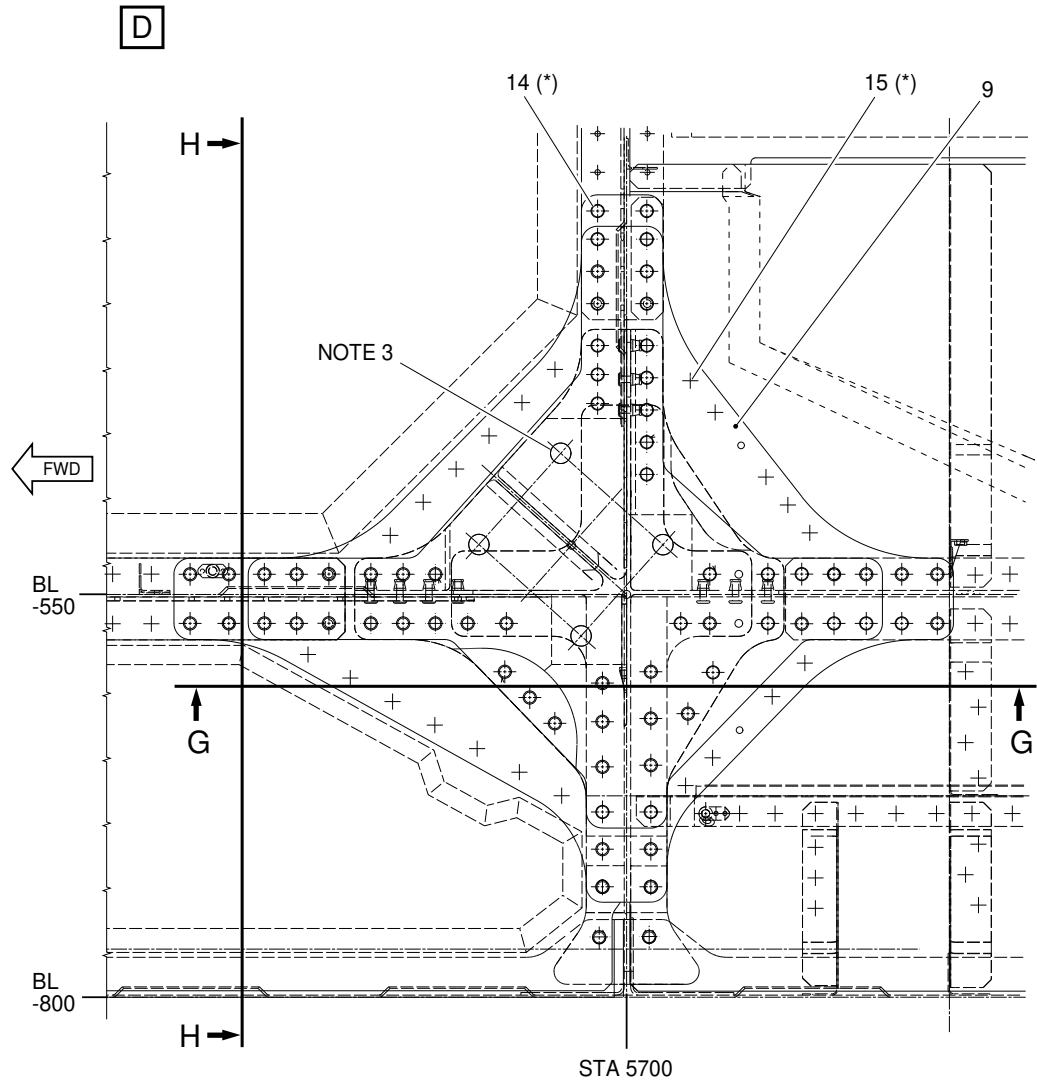
Figure 1 (Sheet 6 of 9) Forward section - Main gearbox rod attachment structure - Detailed inspection

Note 3: Left aft fitting (8) not shown

- 20.1 Examine the four nuts that lock the four bolts (10) and the aft left fitting (8). Make sure that the cotter pins are correctly installed.
- 20.2 Examine the left-aft top plate (9) in the area of the four nuts that attach the aft left fitting (8). Make sure that there are no cracks that start from the fasteners holes.

- 20.3 Examine the heads/collars of the pin-rivets (19) and the heads of the rivets (20) for signs of looseness.
- 20.4 Examine the components of the structure around the heads/collars of the pin-rivets (19) and around the heads of the rivets (20) for cracks that starts from the fasteners holes.

- 20.5 Examine the flanges of the lightening holes (21) in the structure for cracks.
- 20.6 Refer to [step 27](#) if you find that:
- The fasteners (19) and (20) are loose

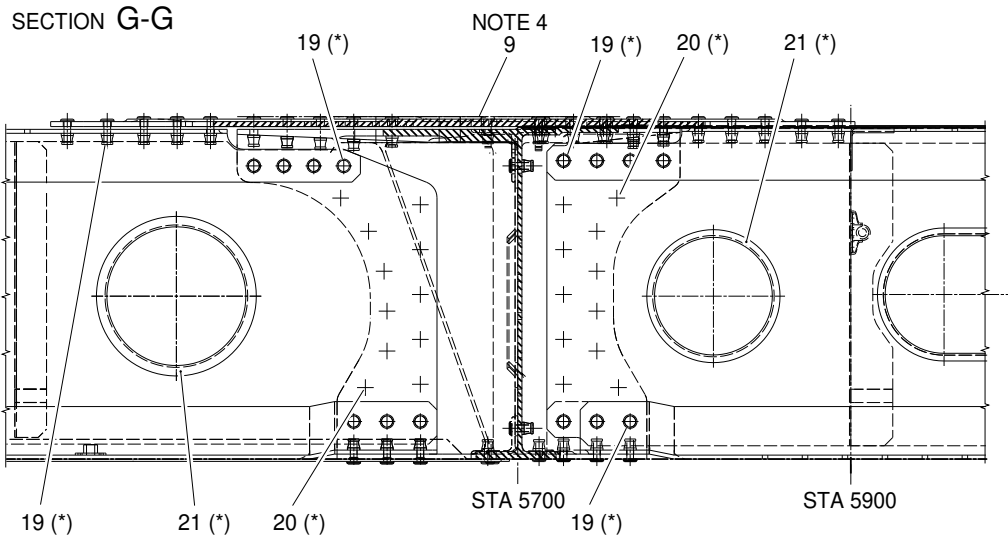
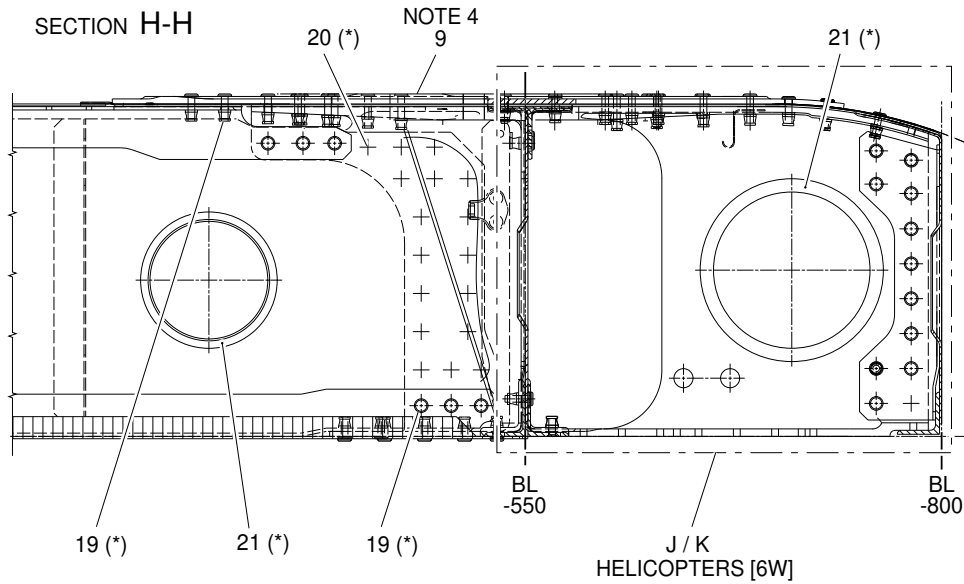
Figure 1 (Sheet 7 of 9) Forward section - Main gearbox rod attachment structure - Detailed inspection

Note 4: Left aft fitting (8) not shown
