Temporary Maintenance Instruction TMI 139-488 Rev B

Tail section - Bonded skin panels – Detailed inspection

All AW139 Helicopters

This TMI provides the instructions and requirements to perform the detailed inspection of the bonded skin panels installed on the tail section. All the information reported in the subsequent pages will be introduced into the IETP revision 39.

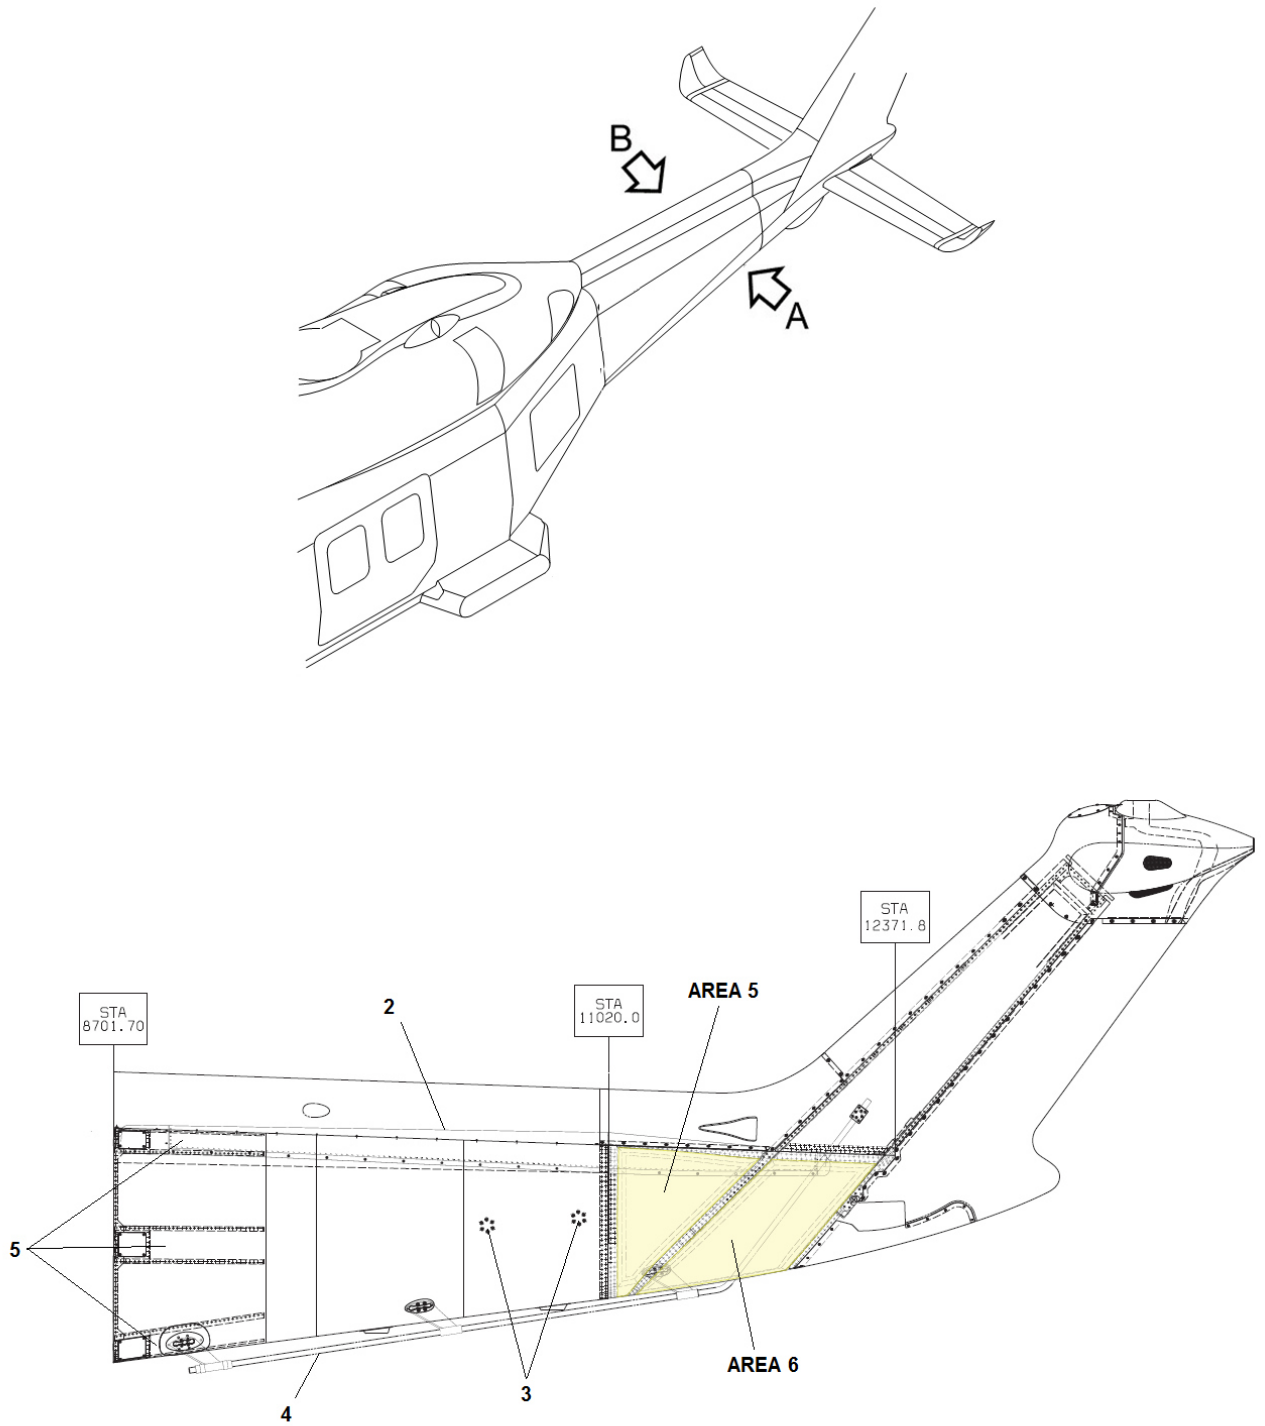
Figure 1 Tail section - Bonded skin panels - Detailed inspection (Sheet 1 of 6)

FOR AREA DELIMITATIONS SEE SHEET 2

- 4.12 If necessary, install the strake (2, Figure 1) if you found no bond separation or the found defects are in the given limits. Refer to 39-A-53-41-02-00A-720A-A.

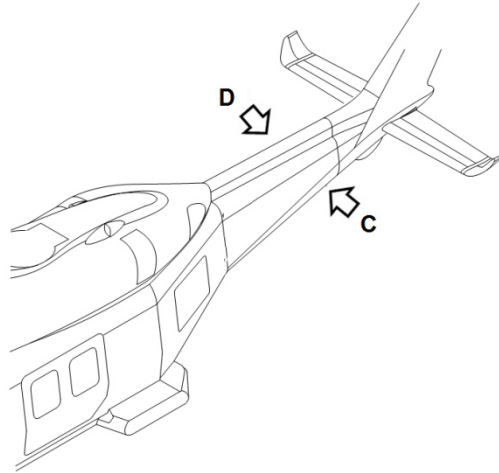
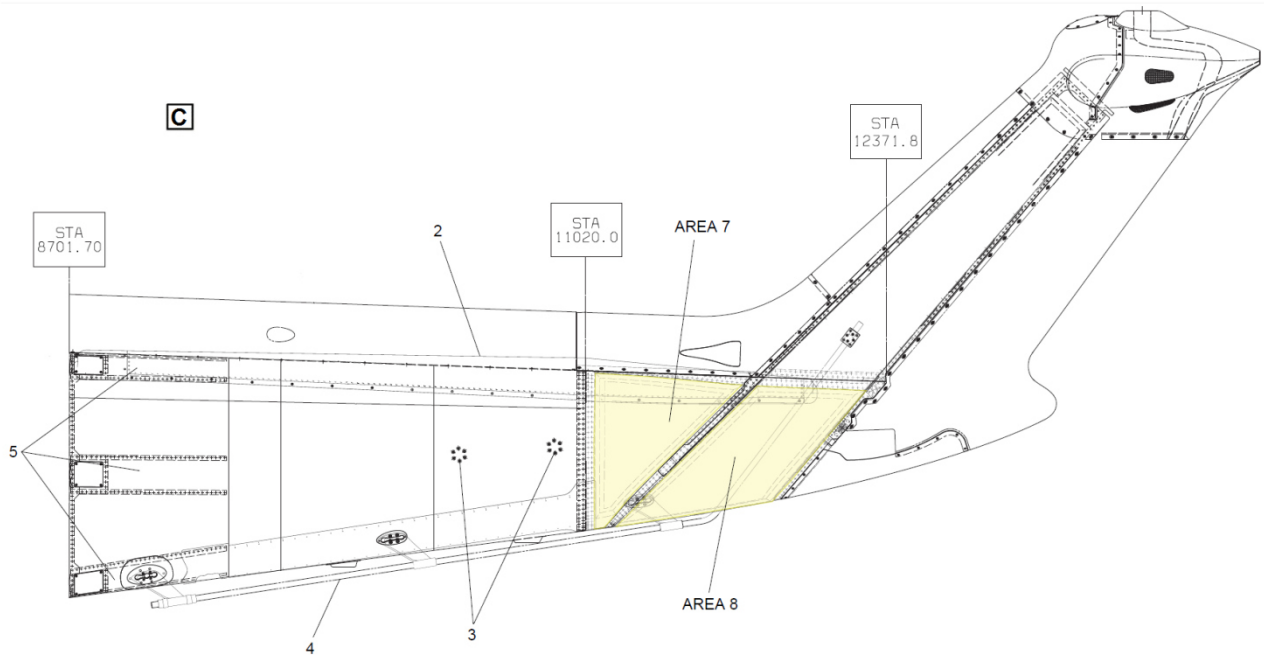
Figure 1 Tail section - Bonded skin panels - Detailed inspection (Sheet 3 of 6)

FOR AREA DELIMITATIONS SEE ALSO SHEET 4

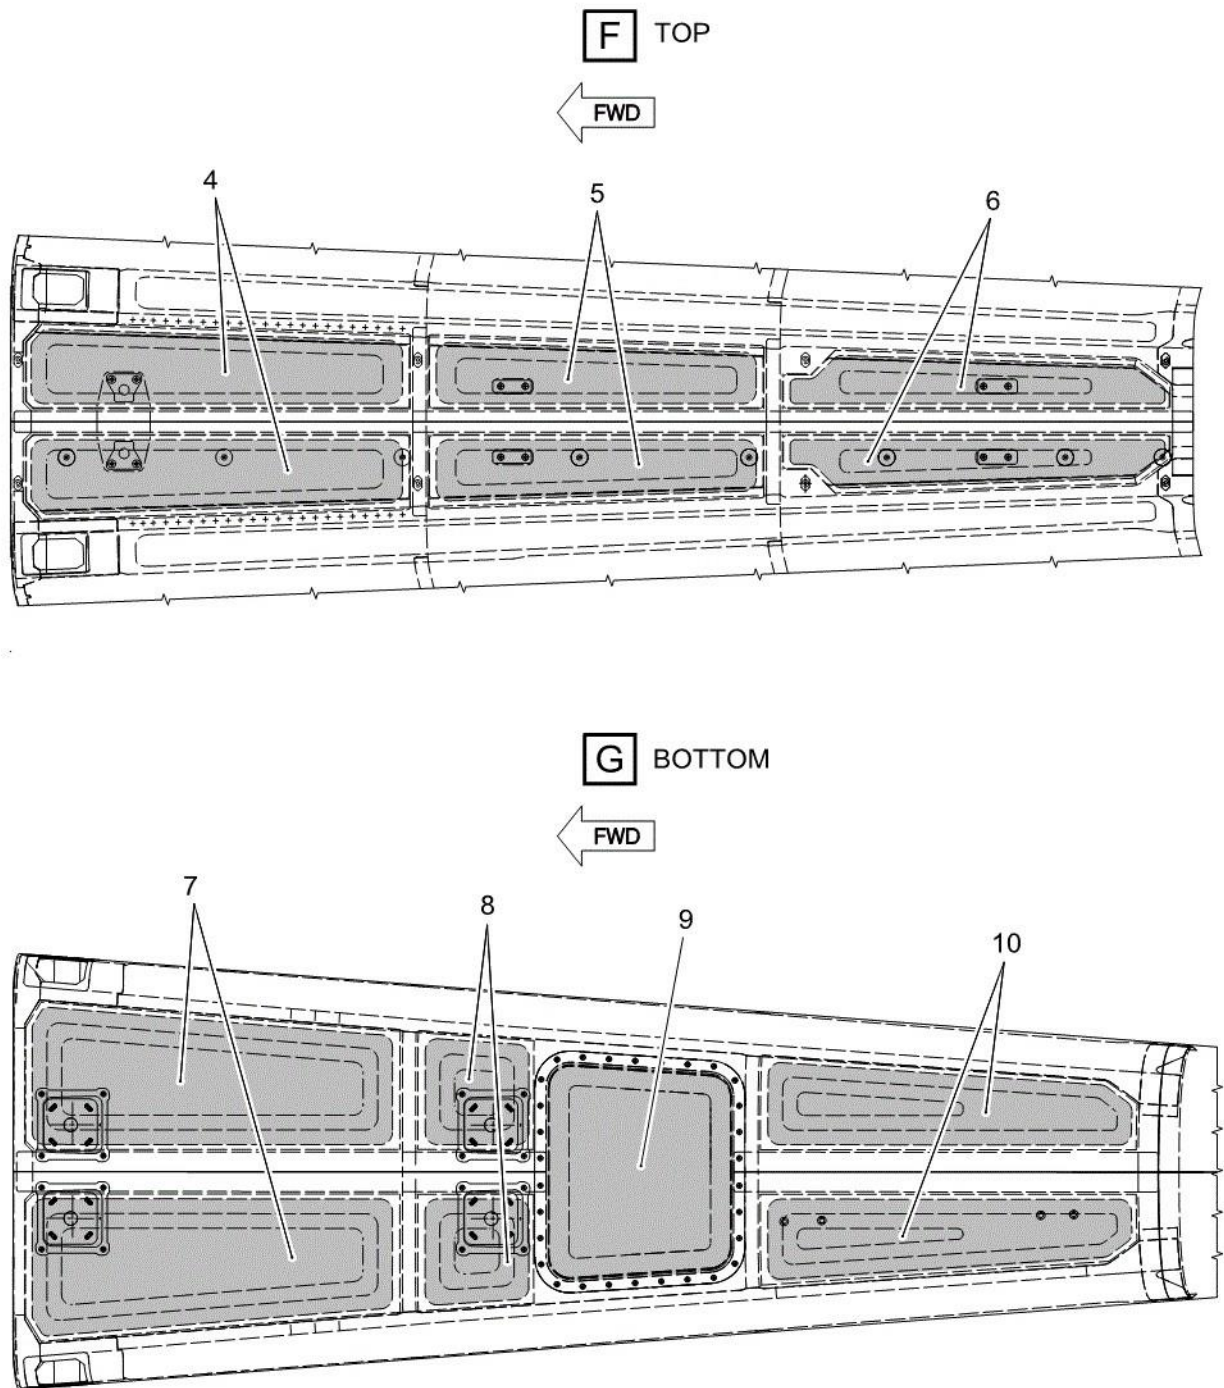
Figure 1 Tail section - Bonded skin panels - Detailed inspection (Sheet 6 of 6)

TAIL BOOM ASSY
P/N 3G5350A00136

- 13 Get access to the bottom side of the tail section (Figure 1 sheet 6).
- 14 Do the same procedure given in the Step 5 for the skin panels (7) , (8), (9) and (10) (Figure 1 sheet 6) on the bottom side of the tail section. Only do the operations applicable to the bottom side of the tail section.
- 15 Tell the Manufacturer if, at the end of this inspection, you found defects that are more than the given limits.
