GENERAL INFORMATION

RO NUMBER	RMN-22-269	DESCRIPTION	RADOME
CUSTOMER	GALAXY AEROSPACE	PART NUMBER	355A81-1030-100
REMOVED FROM A/C REG	M502-1	SERIAL NUMBER	N/A

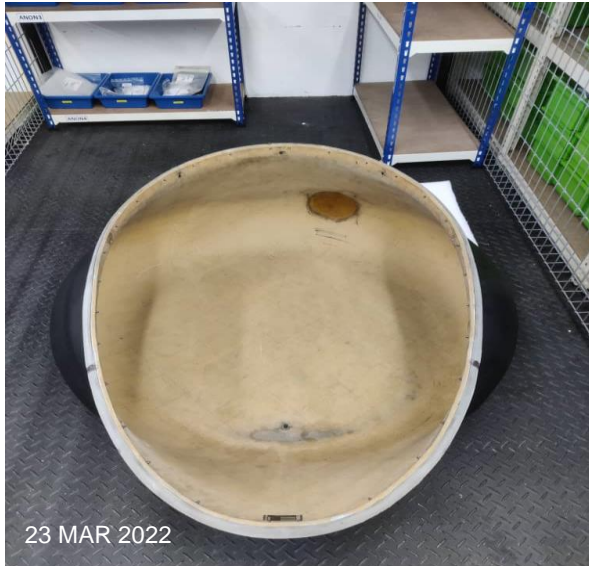
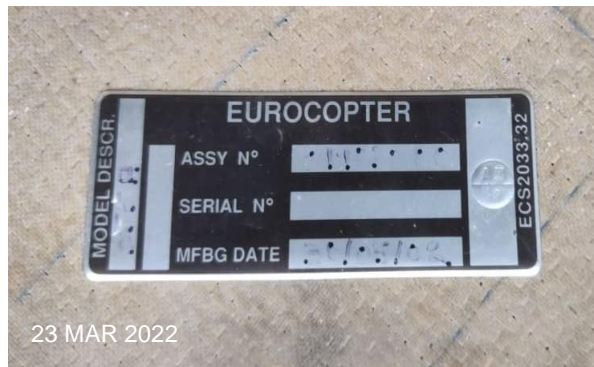
FIGURE 1

- Preliminary inspection found that P/N: 355A81-1030-100 matched.

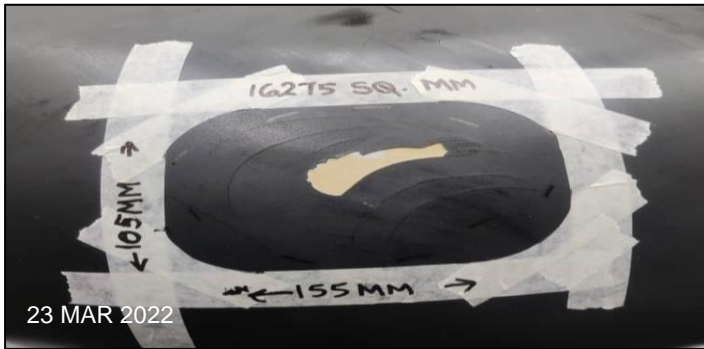
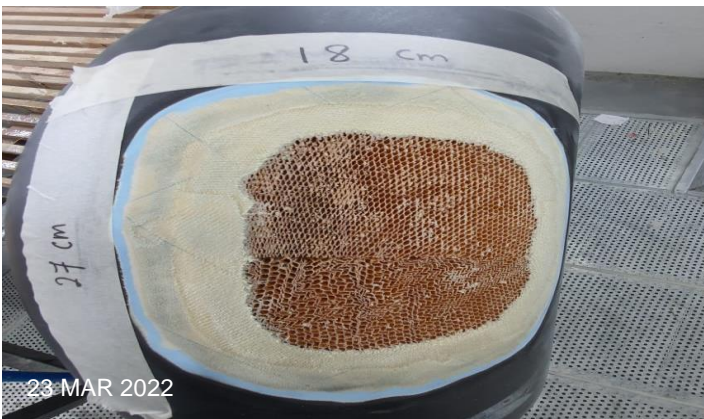
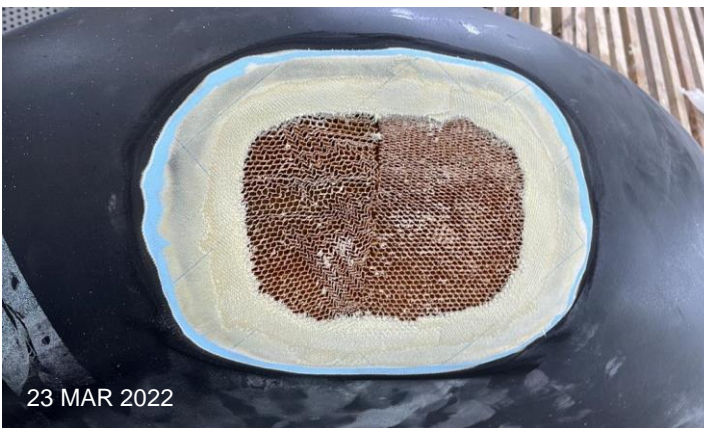
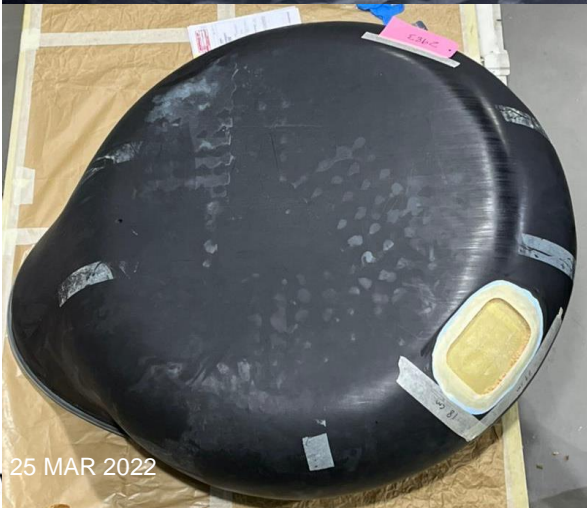
FIGURE 3

- Found delamination on L/H front area size 105 mm x 155 mm 16275 sq mm or 25.2 sq inch.
- Found paint crack approximately 170 mm.

- Inspect Radome as per MTC 20-03-01-101.
- Sand all around damaged areas as per MTC 20-03-06-409
- Prepare the surfaces before bonding the repair parts as per MTC 20-06-01-101
- Repair by removing damaged honeycomb core and replacing core as per MTC 20-03-06-418 and 20-03-07-101
- Install Vacuum Bag MTC 20-03-06-40
- Repair by removing damaged delamination (outer and inner) and replacing delamination as per MTC 20-03-06-418 and 20-03-07-101
- Install Vacuum Bag MTC 20-03-06-406
- Unit to be painted as per Standard Practices Manual 20-04-05-413.
- Total repair area size 18 cm x 27 cm = 486 sq cm or 75.3 sq inch.
