# SAFETY INFORMATION NOTICE

**SUBJECT: EQUIPMENT AND FURNISHINGS**

**Helicopter Hoist Operator (HHO) harness**

### No. 3704-S-25

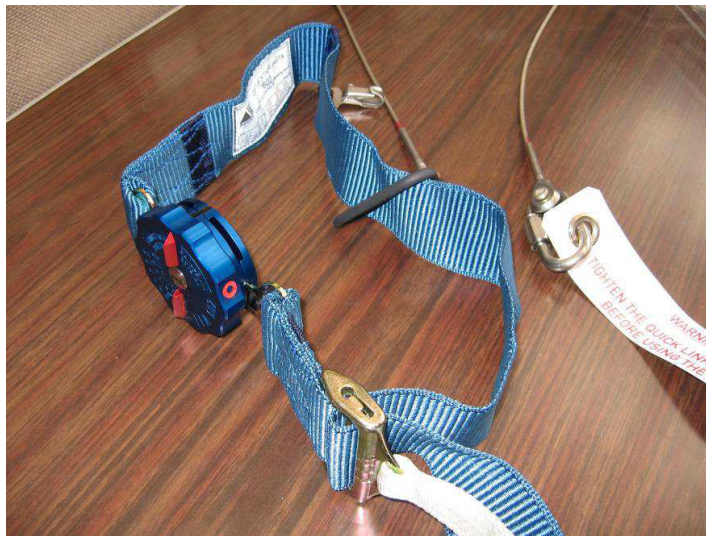
This harness is the "blue" hoist belt equipped with a buckle "EFA 602" type as presented on the picture here after:

- To ensure adequate protection, this harness must be adjusted to properly fit the user's waist. Do not use this harness if you are unable to adjust it to fit properly.
- The buckle should lock when all belt straps are engaged in the equipped buckle. When inserting and locking, check that locking is well efficient and verify that the belt is fastened by pulling the straps apart.
