**No. 3991-S-52**

# SAFETY INFORMATION NOTICE

**SUBJECT: DOORS**

**PILOT - COPILOT - SLIDING DOORS - Loss in flight**

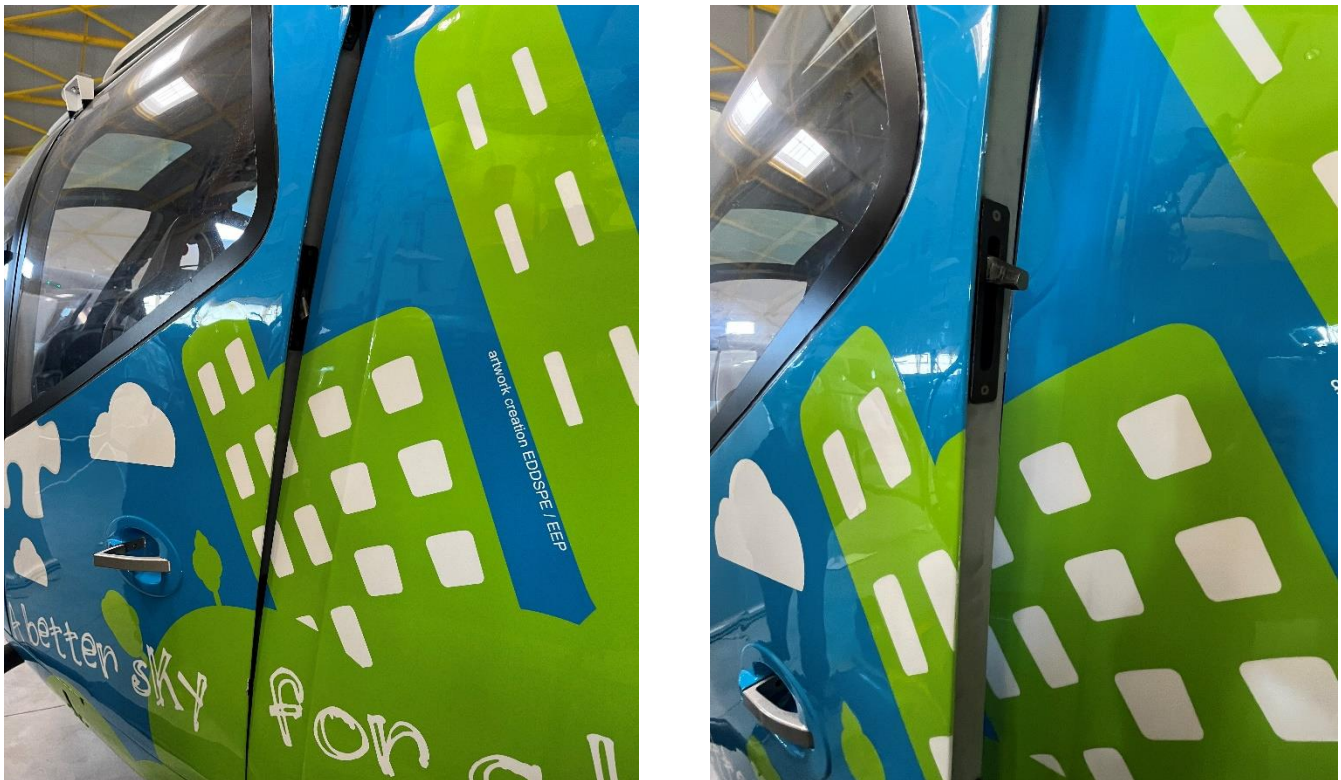
Airbus Helicopters has been informed of a case of opening and loss of a sliding door in flight, probably linked to incorrect locking (2 possible configurations shown in Figure 1).

Figure 1: 2 possible configurations of the lock before loss of the door in flight - Simulation carried out by Airbus Helicopters.

This opening led to the door being torn off. The helicopter managed to land without further damage. The loss of a helicopter component in flight can have serious consequences for flight safety and for people on the ground. Airbus Helicopters therefore draws your attention to the importance of the pre-flight inspection (FLM section 4.2, Station 2) to ensure that the door is correctly closed, or locked open. Once the check has been carried out, the door must no longer be manipulated. If the door is moved, the check must be carried out again (Caution: the door locked indication is not visible in the cockpit).
