SERVICE BULLETIN

N° 189-333

ATA 28 – FUEL PROBE POWER SUPPLY CHECK

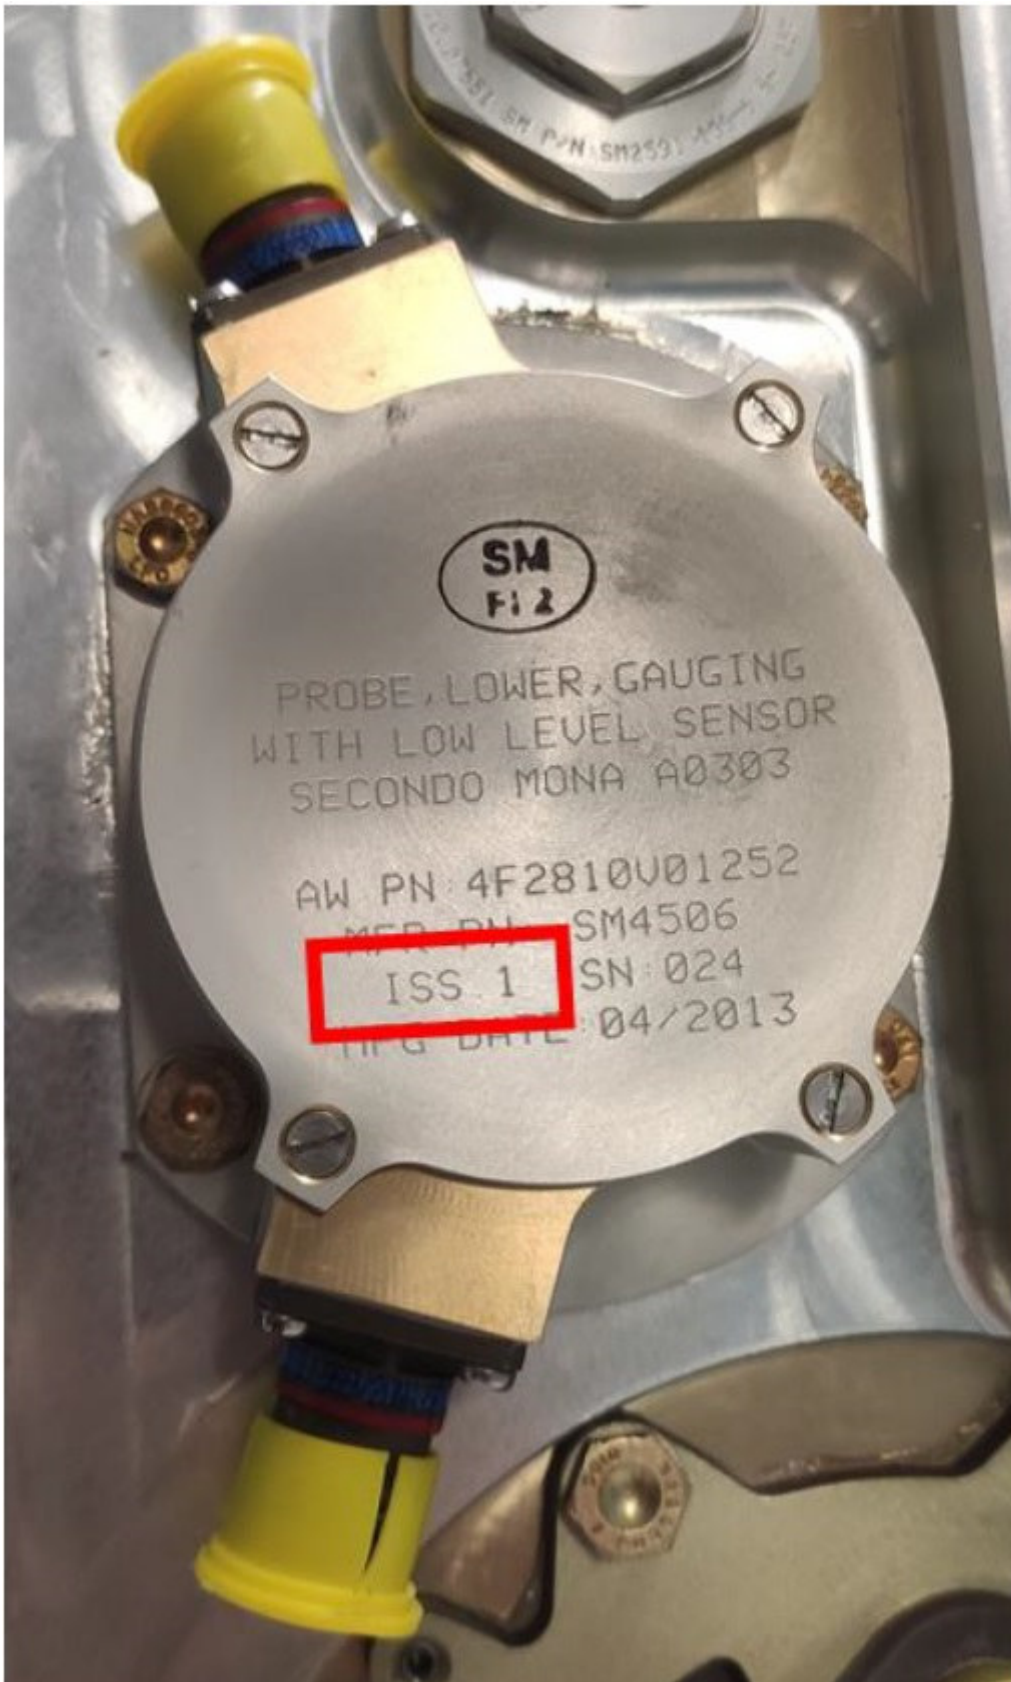
1. In accordance with DM 89-A-00-20-00-00A-120A-A, prepare the helicopter on ground for a safe maintenance. Disconnect the battery, all electrical power sources and/or the external power supply.
2. In accordance with applicable steps of DM 89-B-28-41-09-00A-520A-A, get access to the Number 5 rear fuel probe and check the S/N and the issue marked.
3. With reference to Figure 1, if the fuel probe is marked with "Issue A" no further actions are required. Skip to Step 6.

4. With reference to Figure 1 and in accordance with AMP DM 89-B-28-41-09-00A-520A-A, if the fuel probe is marked with "Issue 1" remove the probe P/N 8G2810V04351 from the helicopter.
5. With reference to AMP DM 89-B-28-41-09-00A-720A-A; install a new fuel probe P/N 8G2810V04351 marked with "Issue A" or with S/N not listed in the "Effectivity" section of this SB.
6. In accordance with applicable steps of DM 89-B-28-41-10-00A-520A-A, get access to the Number 5 forward fuel probe and check the S/N and the issue marked.
7. With reference to Figure 1, if the fuel probe is marked with "Issue A" no further actions are required. Skip to Step 10.

8. With reference to Figure 1 and in accordance with AMP DM 89-B-28-41-10-00A-520A-A, if the fuel probe is marked with "Issue 1" remove the probe P/N 8G2810V04251 from the helicopter.
9. With reference to AMP DM 89-B-28-41-10-00A-720A-A, install a new fuel probe P/N 8G2810V04251 marked with "Issue A" or with S/N not listed in the "Effectivity" section of this SB.
10. Return the helicopter to flight configuration and record for compliance with this Service Bulletin on the helicopter logbook.
11. Send the attached compliance form to the following mail box:
