SERVICE BULLETIN

N° **109EP-177**

**ATA 62 – INSPECTION OF MAIN ROTOR SCISSOR CHAIN**

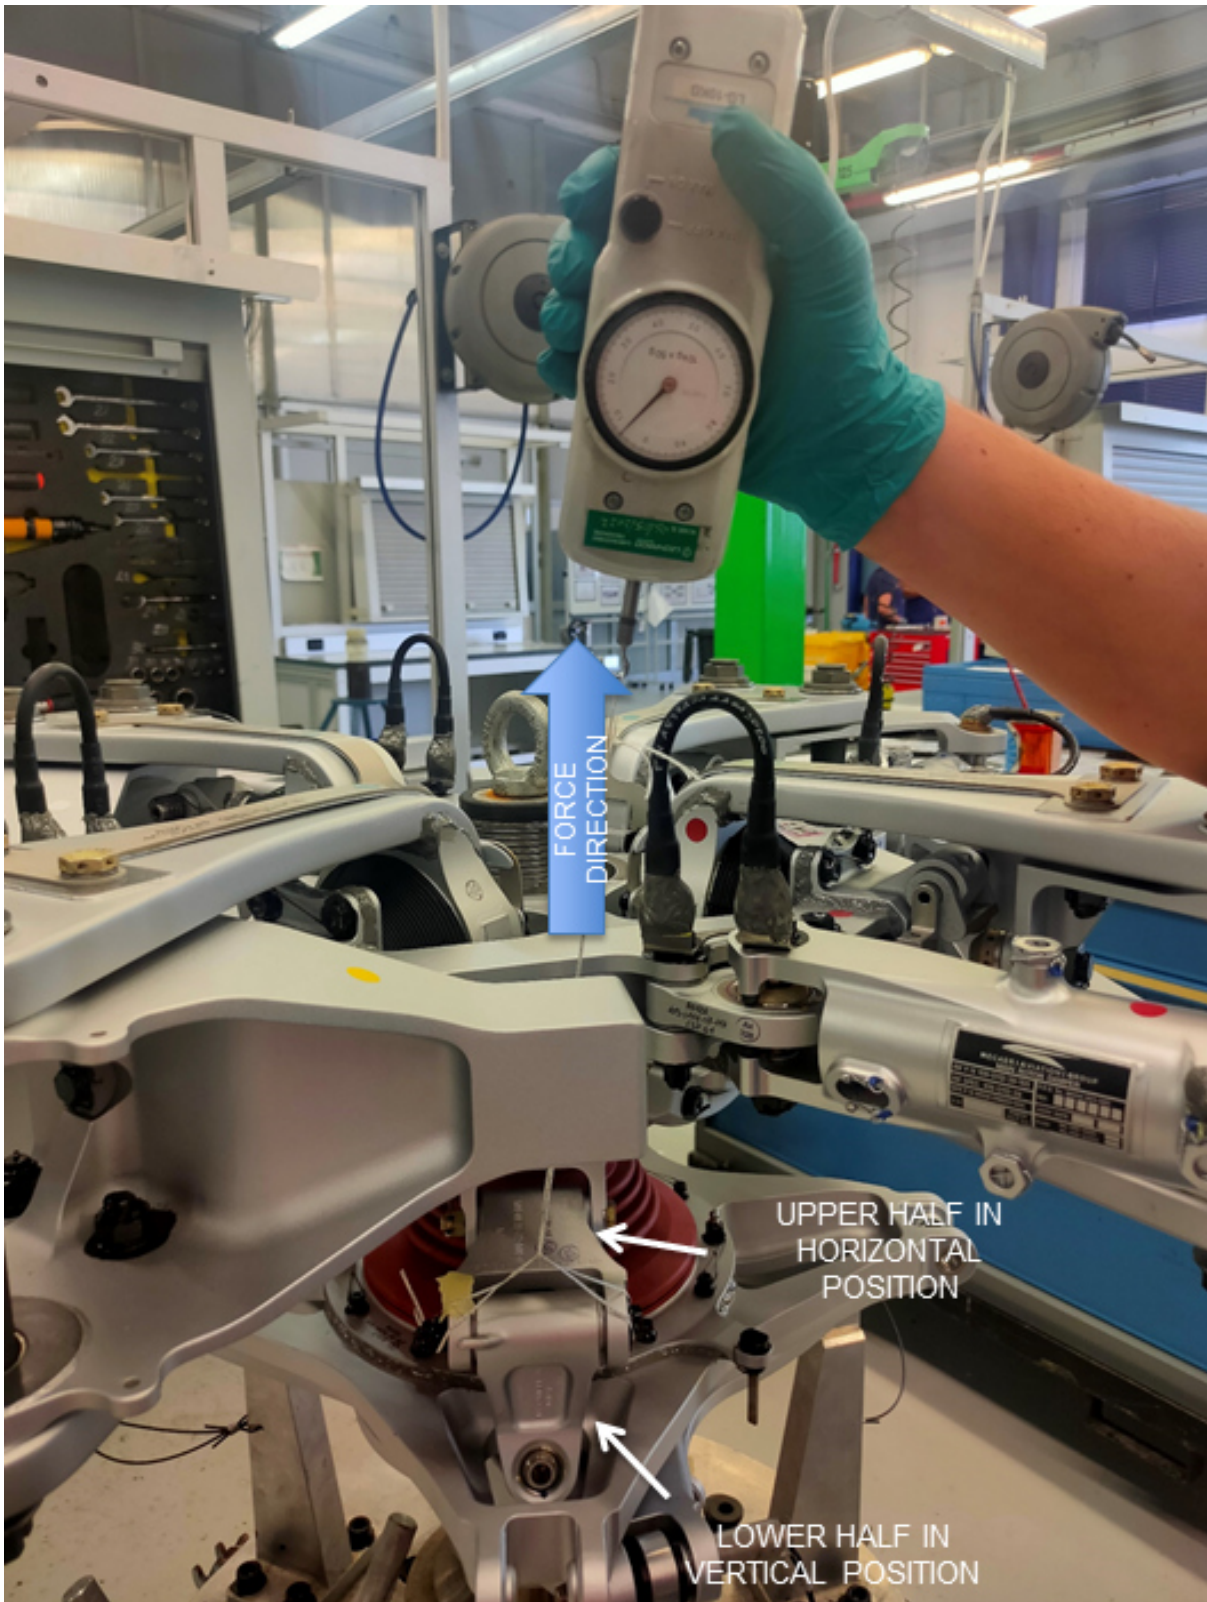
**Figure A1**

on the fulcrum point of the rotating scissor assy, measure the force along the vertical direction needed to lift the rotating scissor assy.

For reference only: the scissor in the picture could not be fully representative of the item actually installed on the aircraft

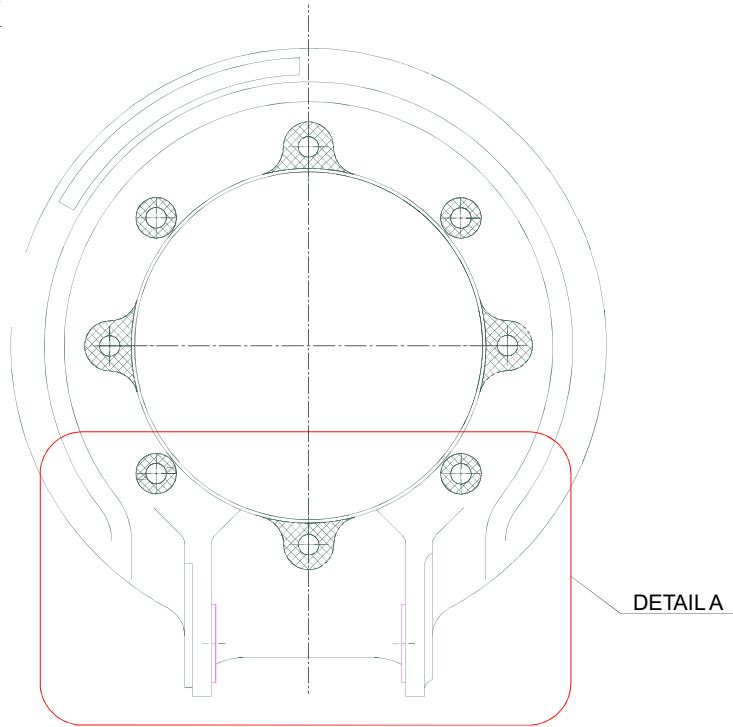
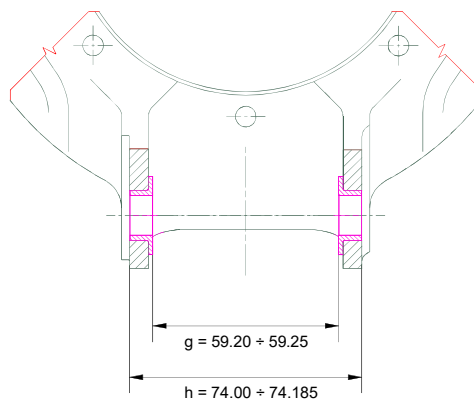
**Figure B4**

### Scissor Bracket Flange Assy

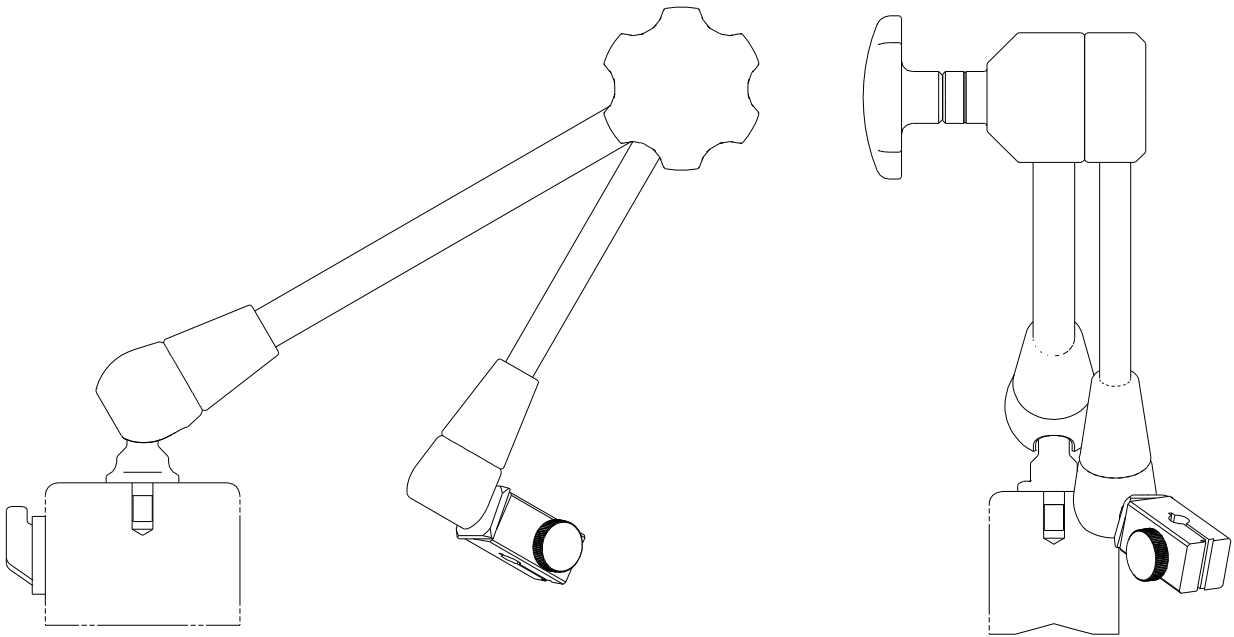
**Figure C1**

**3G6005G04751**  
**SUPPORT ARM, DIAL GAUGE**  
**(FOR REFERENCE)**

**3G6005G01531**  
**SUPPORT DIAL GAUGE**  
**(FOR REFERENCE)**

(B2) Equivalent P/N may be locally supplied or manufactured i.a.w. Annex C – Axial play measurement on board the helicopter.

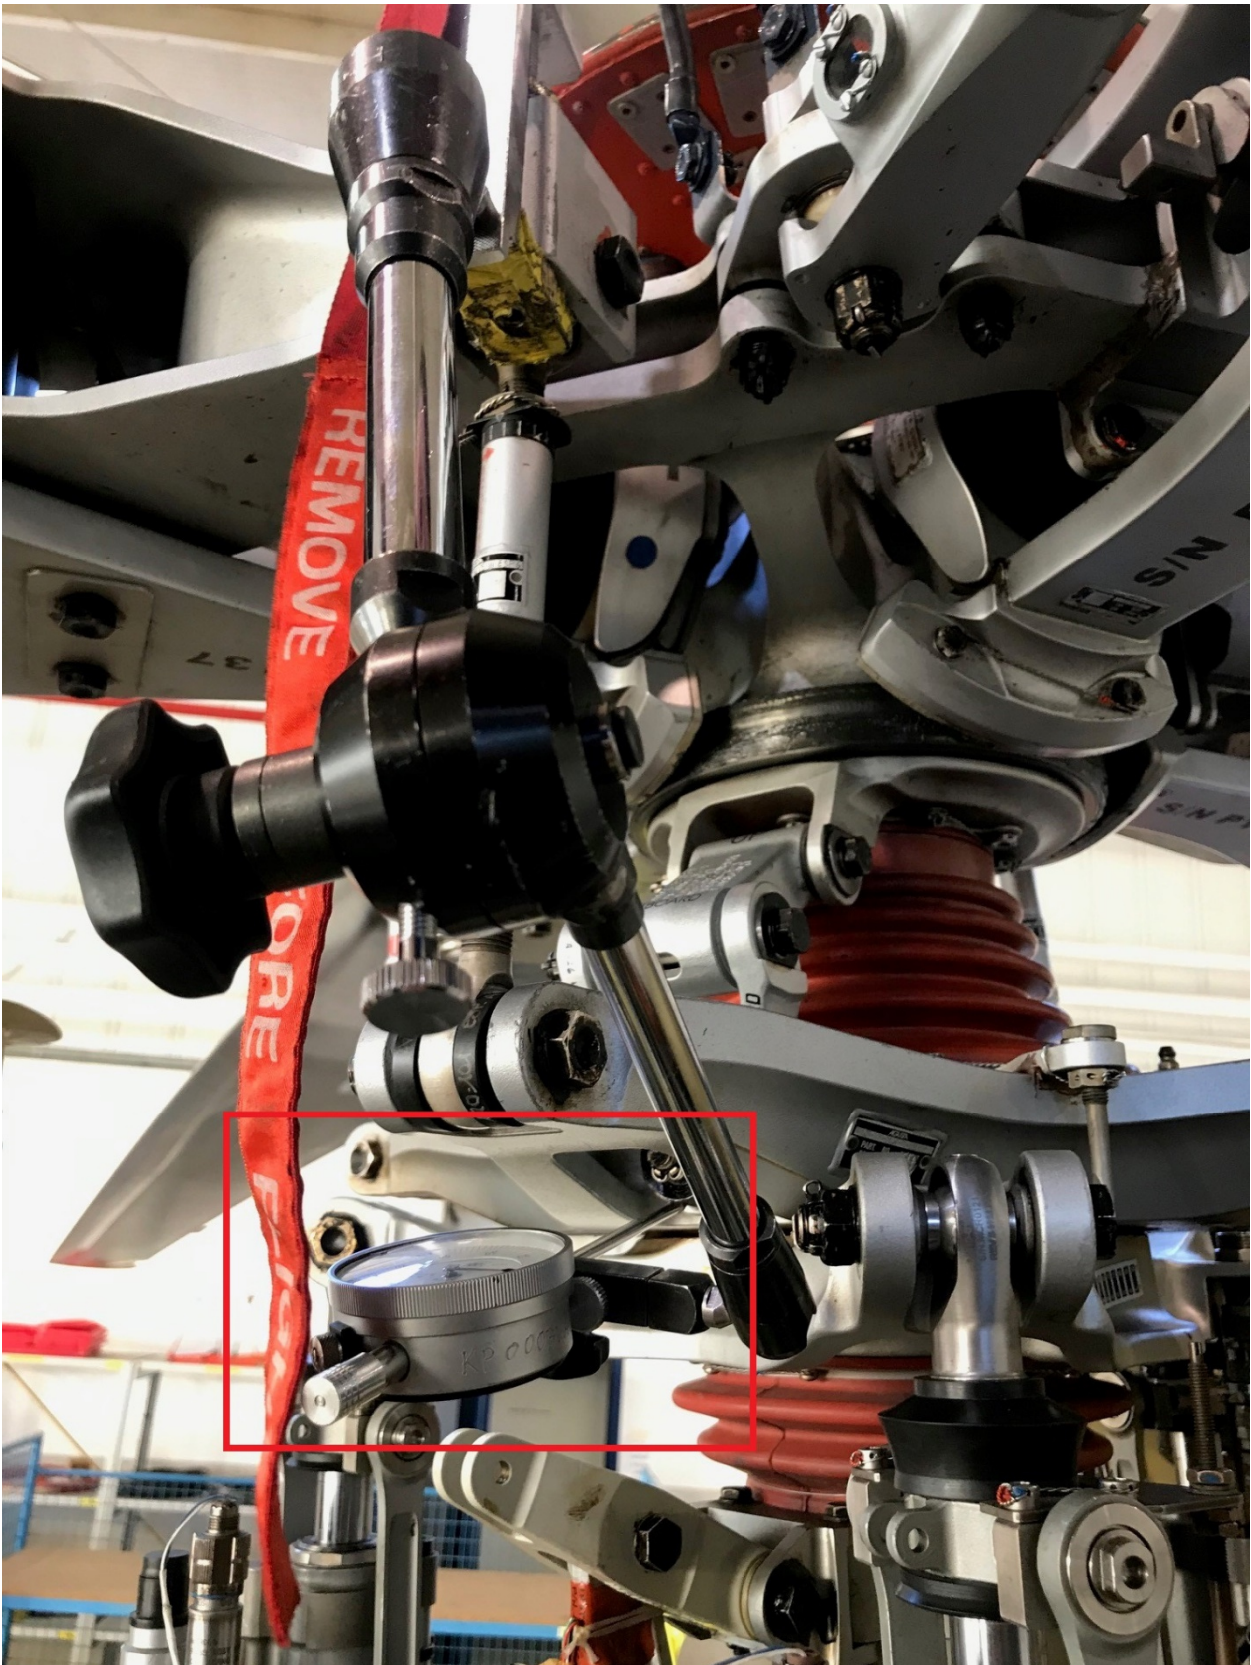
Figure C3

For reference only
