SERVICE INFORMATION LETTER SIL0124 August 2, 2024 rev 1

Regular Check and Overhaul Flow Diagram Correction

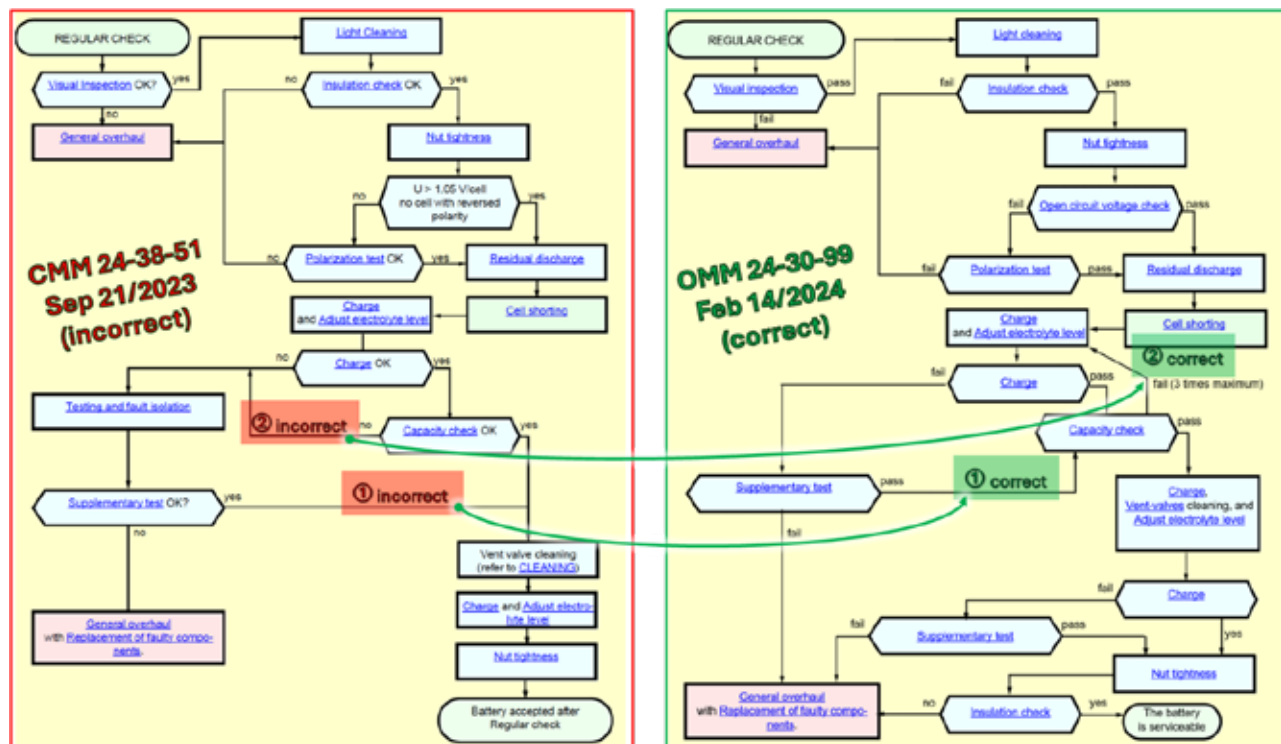
Figure 1 Utilize the Regular Check flow diagram from the Saft OMM 24-30-99 Feb 14/2024 for corrections ① and ②.

A correction to the Regular Check flow diagram in CMM 24-38-51 is pending. The flowchart, in Chapter 7, should direct the technician back to the Capacity Check after a successful Supplementary Test. It incorrectly directs the technician to conduct a Vent valve cleaning following a successful Supplementary Test. Additionally, the Regular Check flow diagrams in CMM 24-38-51, CMM 24-31-20 and CMM 24-31-15 does not give an option to loop back to charge from a failed capacity test for up to 3 times.

Table 1 Apply the following corrections to the Regular Check flowchart

For battery type	utilize the OMM Regular Check flow diagram and
2758,	apply correction ① and ②
1658-6,	apply correction ②
4078-2 / 40678-2,	apply correction ②

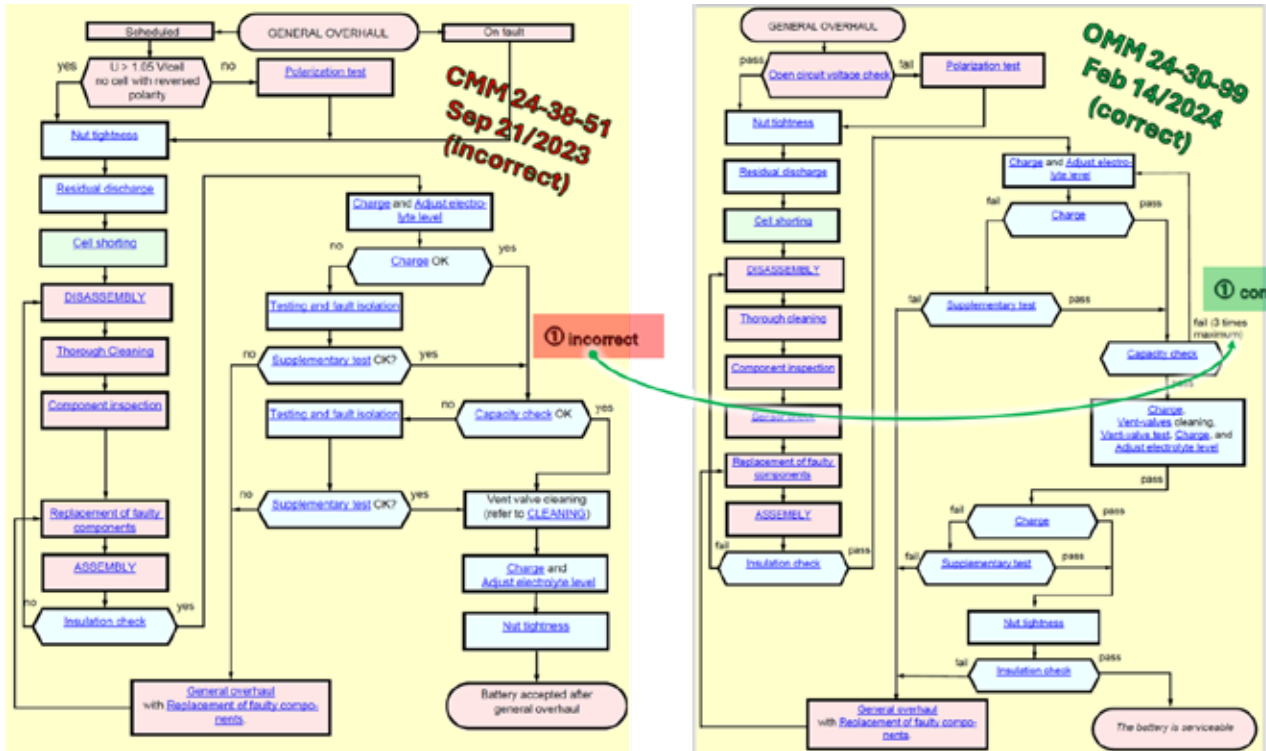
Figure 2 Utilize the Overhaul flow diagram from the Saft OMM 24-30-99 Feb 14/2024 for correction ①

Table 2 Apply the following corrections to the Overhaul flowchart

For battery type	utilize the OMM Overhaul flow diagram and
2758,	apply correction ①
1658-6,	
4078-2 / 40678-2,
